# Professional Snagging Inspection Report

Post-completion inspection

Inspection date: 18 July 2026

South Wales Snagging Co was instructed to undertake a visual, non-destructive post-completion snagging inspection of an anonymised new-build property in South Wales. This report records visible defects, incomplete items and areas requiring developer or aftercare attention based on the condition observed on 18 July 2026.

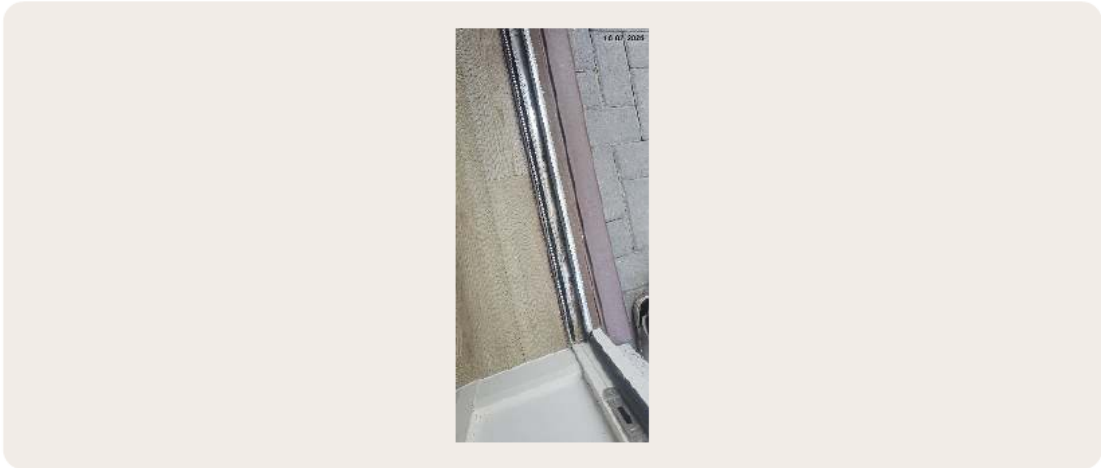
# Defect 2

**OBSERVATION**  
The threshold is full of construction debris.

**RECOMMENDED ACTION**  
Remove the debris or contamination using a suitable non-damaging cleaning method and leave the area clean and ready for normal use.

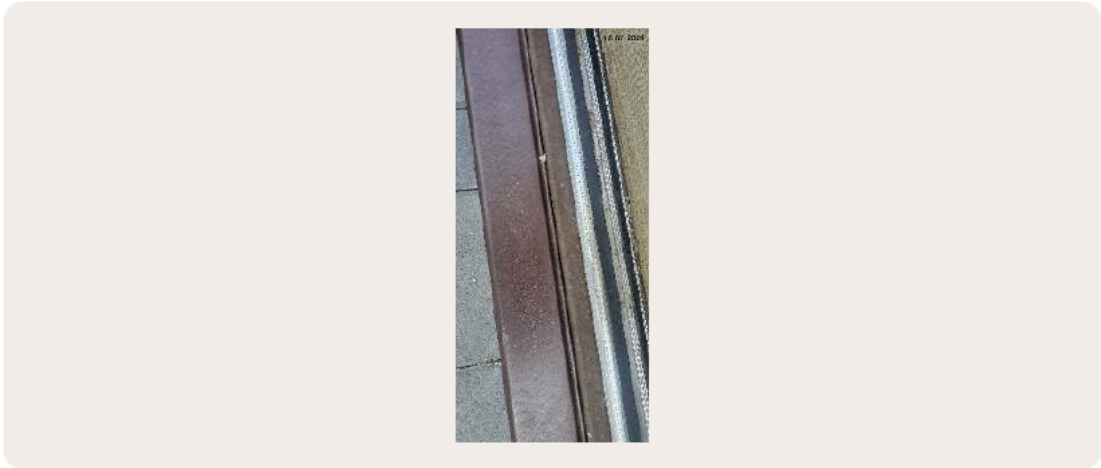
# Defect 3

**OBSERVATION**  
The threshold extension is not securely fixed.

**RECOMMENDED ACTION**  
Adjust, secure, ease, repair or replace the affected item as required, then make good disturbed finishes and confirm correct operation.

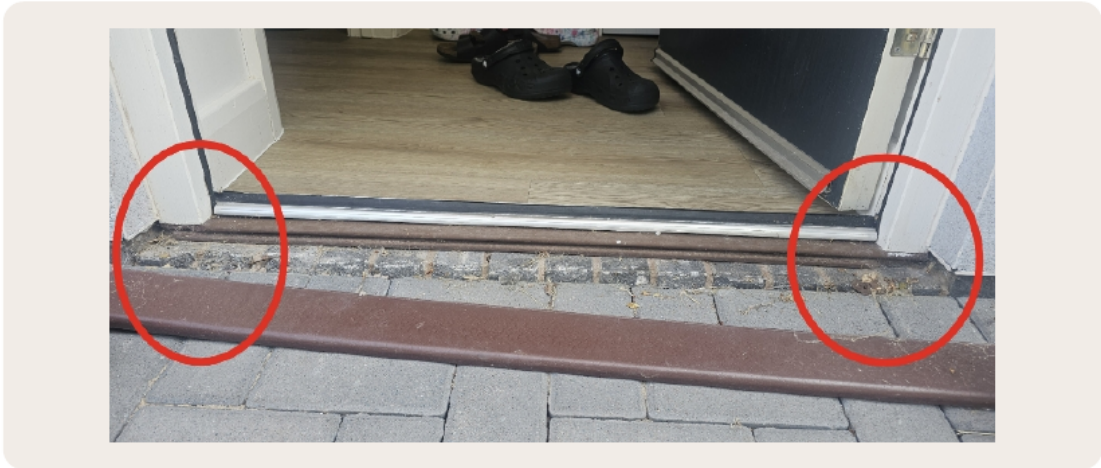
# Defect 4

**OBSERVATION**  
The front door threshold is damaged on both sides.

**RECOMMENDED ACTION**  
Adjust, secure, ease, repair or replace the affected item as required, then make good disturbed finishes and confirm correct operation.

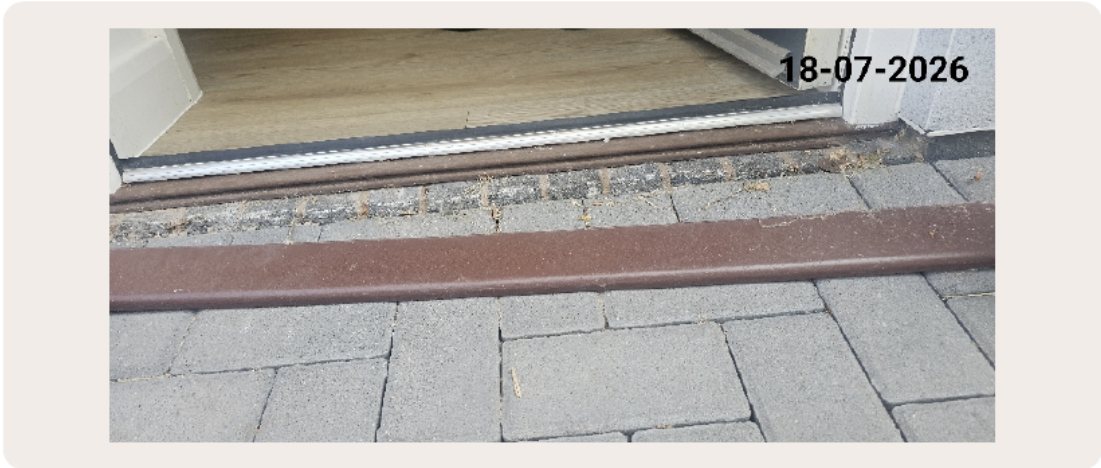
# Defect 5

**OBSERVATION**  
The front door threshold has not been sealed.

**WHY THIS MATTERS**  
External and wet-area junctions should be continuously sealed to reduce the risk of water ingress, staining and deterioration. Open or poorly finished joints can allow moisture to enter concealed interfaces.

**RECOMMENDED ACTION**  
Remove unsuitable or incomplete material, clean and prepare the joint, then apply a compatible sealant to form a neat, continuous and durable weather seal.

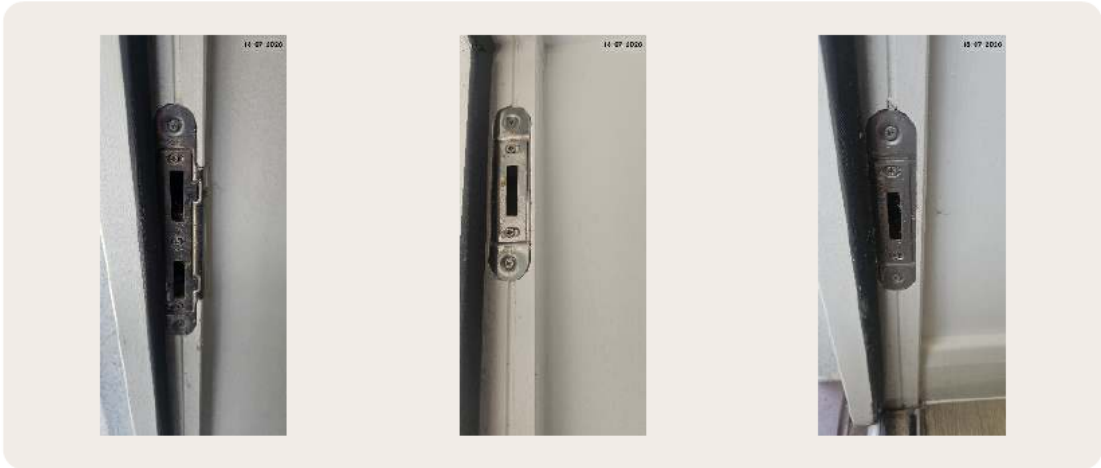
Defect 6

**OBSERVATION**  
Rust is present on the front door keeps.

**RECOMMENDED ACTION**  
Adjust, secure, ease, repair or replace the affected item as required, then make good disturbed finishes and confirm correct operation.

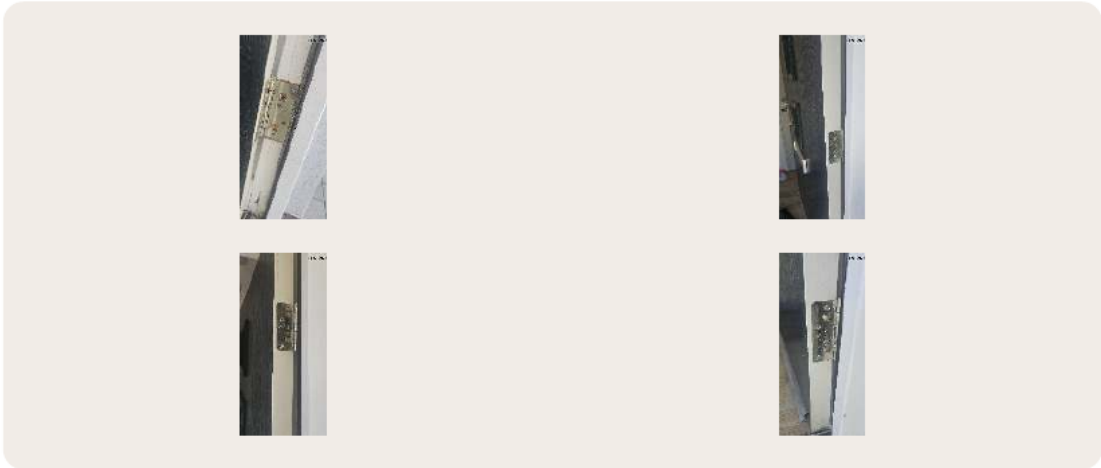
# Defect 7

**OBSERVATION**  
Bare timber is exposed behind the front door hinge and has not been sealed or decorated.

**RECOMMENDED ACTION**  
Prepare the affected area, fill and sand as required, then redecorate to achieve a neat and uniform finish.

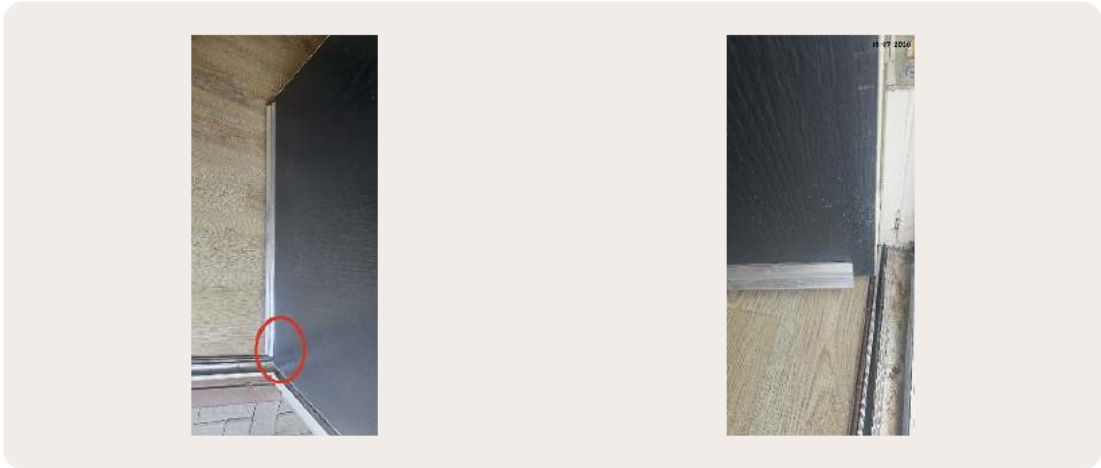
Defect 8

The weather bar cover is missing.

Adjust, secure, ease, repair or replace the affected item as required, then make good disturbed finishes and confirm correct operation.

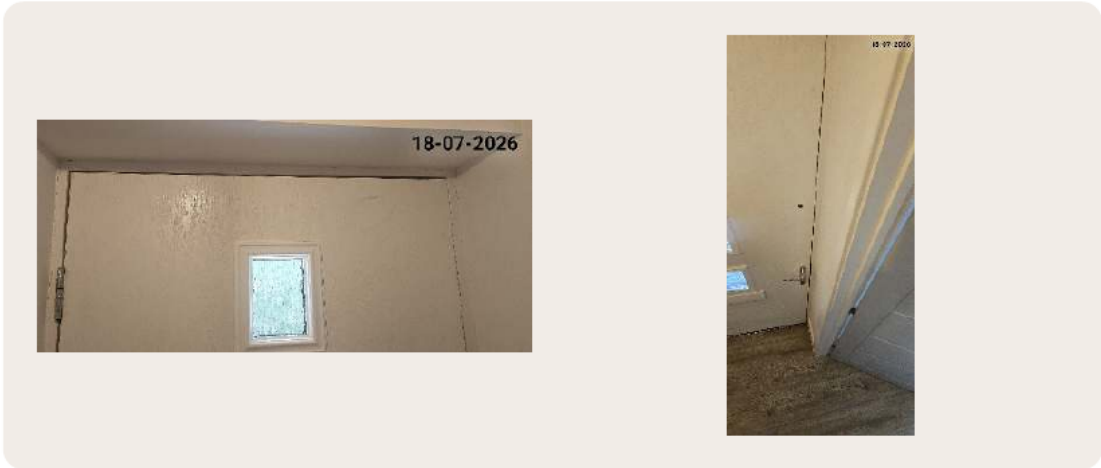
# Defect 9

**OBSERVATION**  
The front door has an uneven margin and requires adjustment.

**RECOMMENDED ACTION**  
Adjust, secure, ease, repair or replace the affected item as required, then make good disturbed finishes and confirm correct operation.

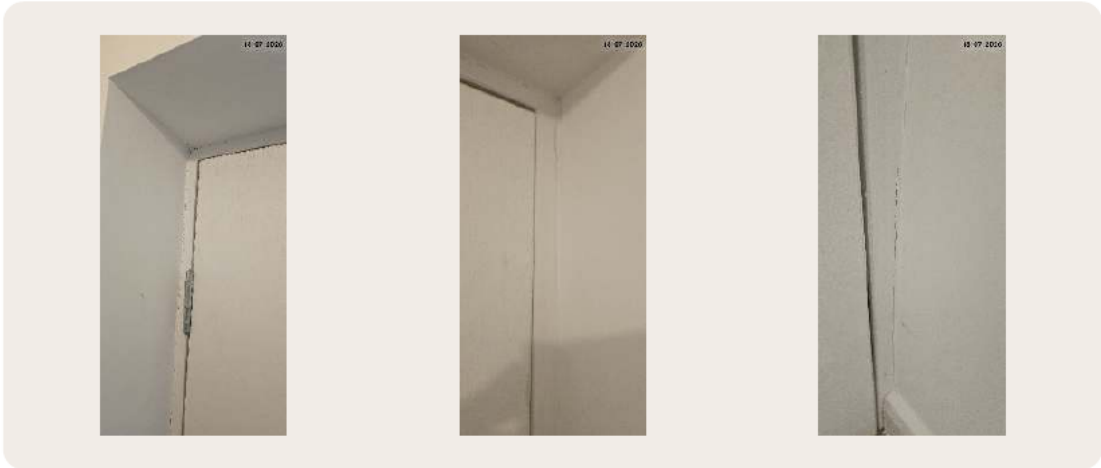
# Defect 11

A visible shrinkage gap has opened in the caulked junction around the front door.

Prepare the affected junction, remove loose caulk, apply suitable decorator's caulk, smooth it neatly and redecorate to match the surrounding finish.

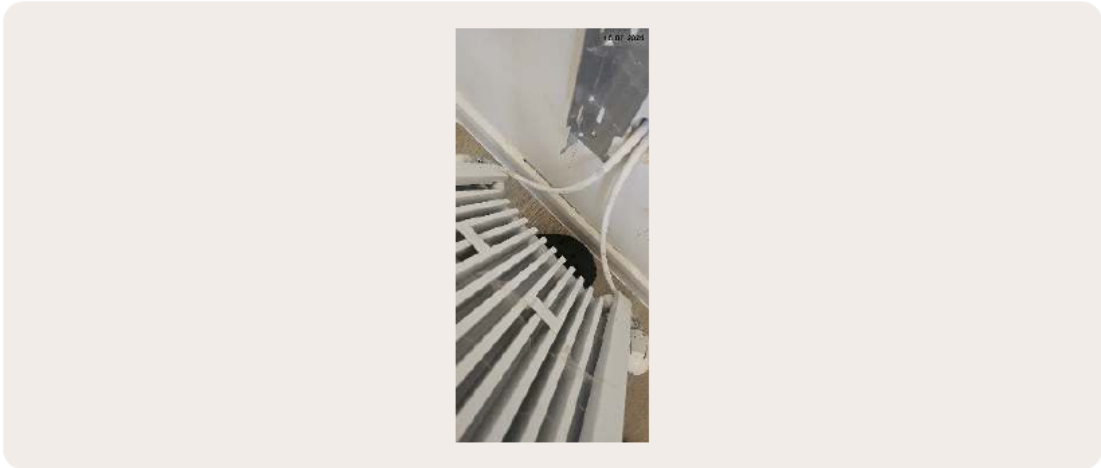
# Defect 12

**OBSERVATION**  
The hallway skirting board has not been fully decorated, leaving an incomplete and visually inconsistent finish.

**RECOMMENDED ACTION**  
Prepare the affected area, fill and sand as required, then redecorate to achieve a neat and uniform finish.

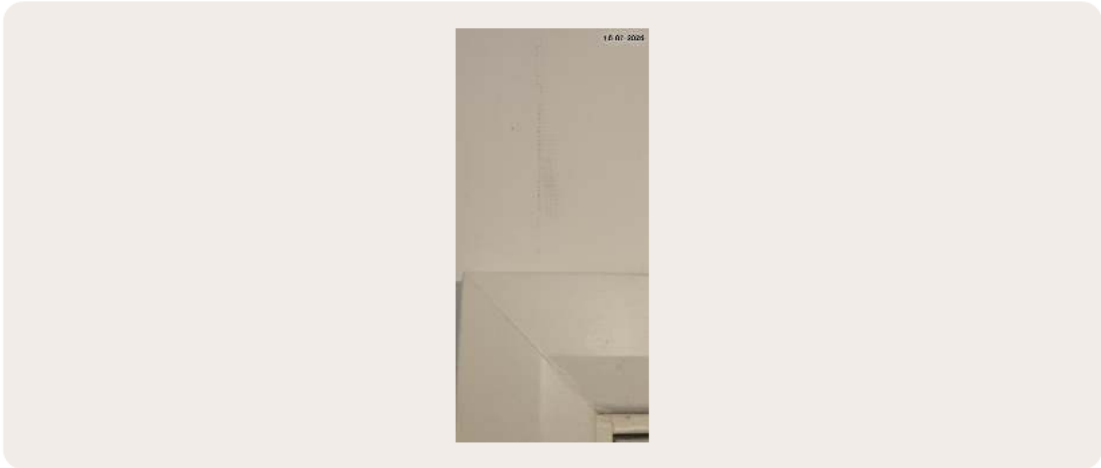
# Defect 14

**OBSERVATION**  
Scrim tape remains visible above the cloakroom door, indicating that the plasterboard joint has not received a complete finishing coat.

**RECOMMENDED ACTION**  
The plasterer / dryliner should investigate the affected area, remove loose or failed material, correct the alignment or substrate as required, re-tape and apply suitable finishing coats before decoration.

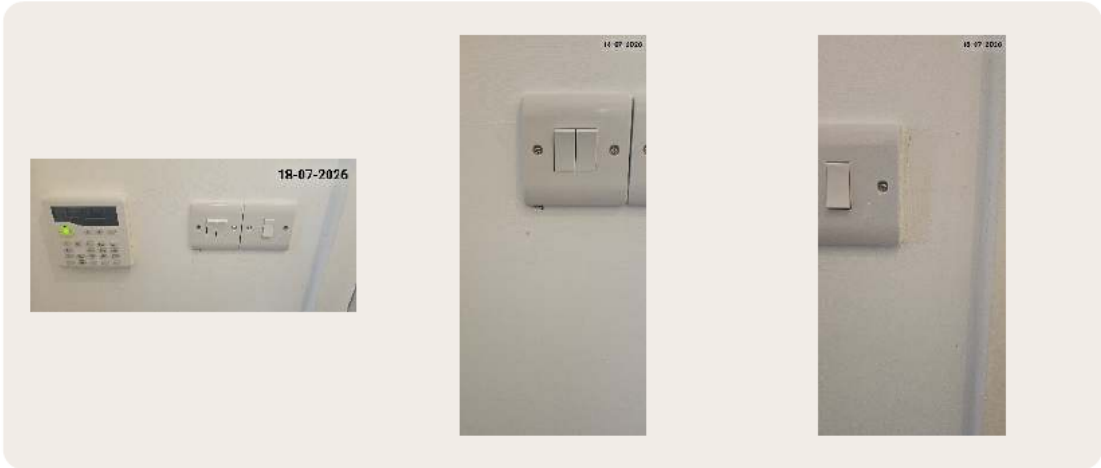
Defect 17

**OBSERVATION**  
The finish around the switches and sockets is incomplete.

**WHY THIS MATTERS**  
Electrical items should be securely installed and protected against damage. Visible damage, unsuitable fixings or incomplete external protection may present a safety risk.

**RECOMMENDED ACTION**  
Arrange inspection and remedial work by a competent electrician. Isolate the item where necessary, repair or replace affected parts and provide updated electrical confirmation where required.

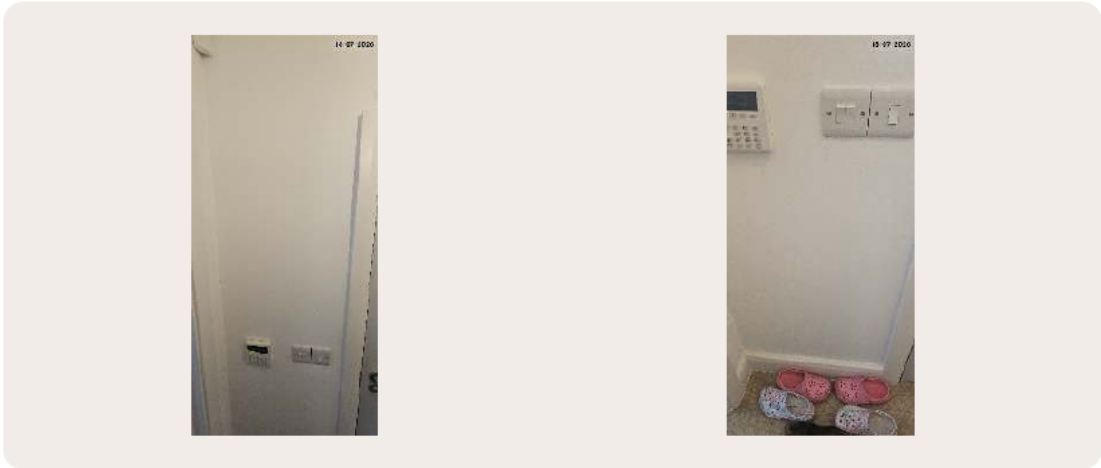
# Defect 18

**OBSERVATION**  
Paint coverage is insufficient and the underlying surface is grinning through.

**RECOMMENDED ACTION**  
Prepare the affected area, fill and sand as required, then redecorate to achieve a neat and uniform finish.

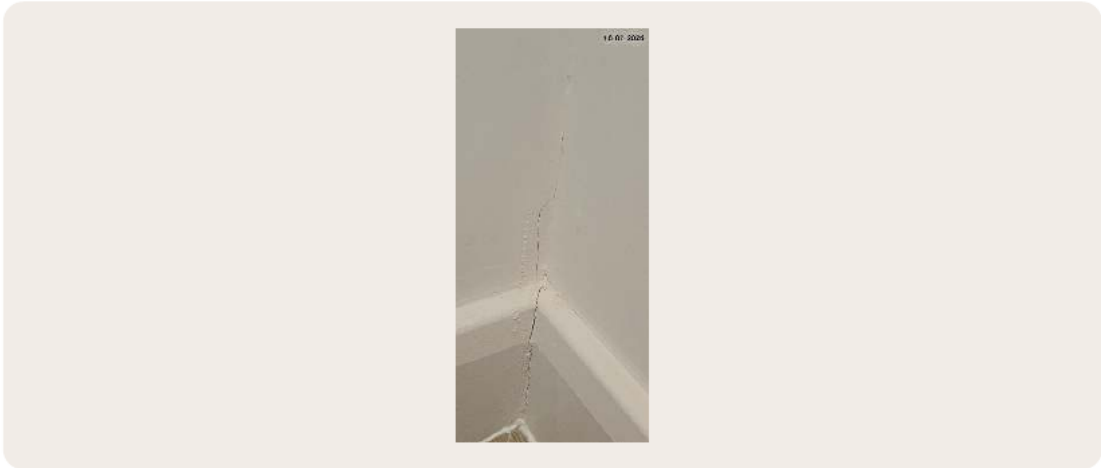
# Defect 19

**OBSERVATION**  
Joint tape remains visible at the internal corner above the skirting board, indicating incomplete plasterboard finishing.

**RECOMMENDED ACTION**  
The plasterer / dryliner should investigate the affected area, remove loose or failed material, correct the alignment or substrate as required, re-tape and apply suitable finishing coats before decoration.

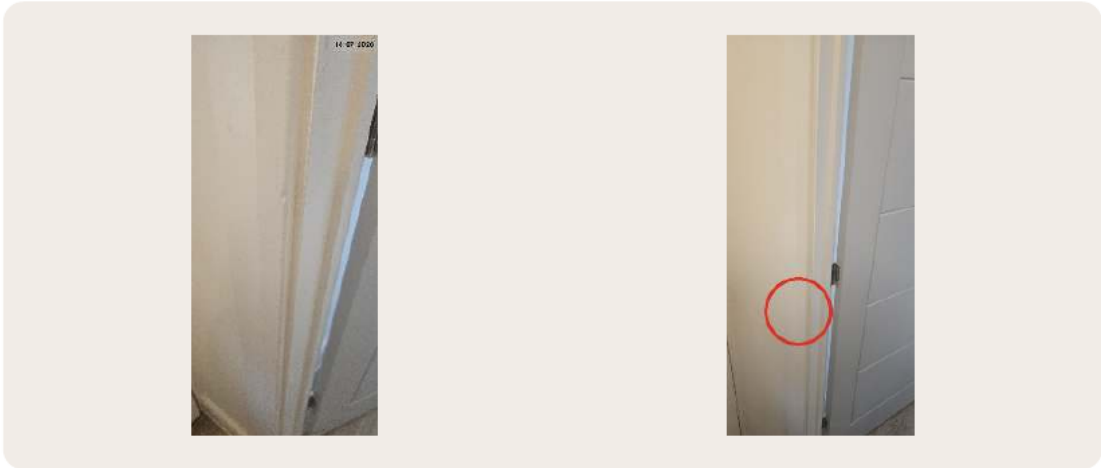
# Defect 25

**OBSERVATION**  
A localised indentation is visible in the architrave finish.

**RECOMMENDED ACTION**  
Prepare the affected area, fill and sand as required, then redecorate to achieve a neat and uniform finish.

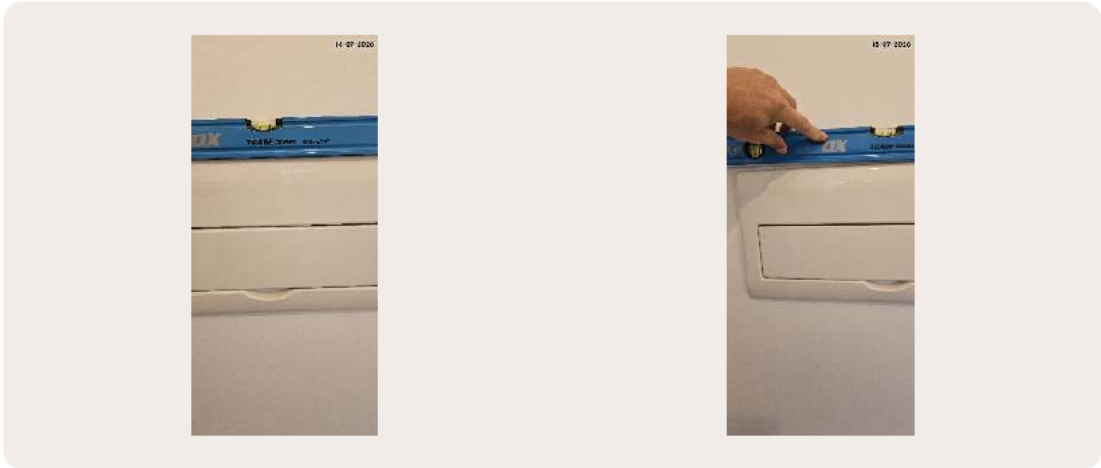
Defect 26

**OBSERVATION**  
The consumer unit is out of level.

**WHY THIS MATTERS**  
Electrical items should be securely installed and protected against damage. Visible damage, unsuitable fixings or incomplete external protection may present a safety risk.

**RECOMMENDED ACTION**  
Arrange inspection and remedial work by a competent electrician. Isolate the item where necessary, repair or replace affected parts and provide updated electrical confirmation where required.

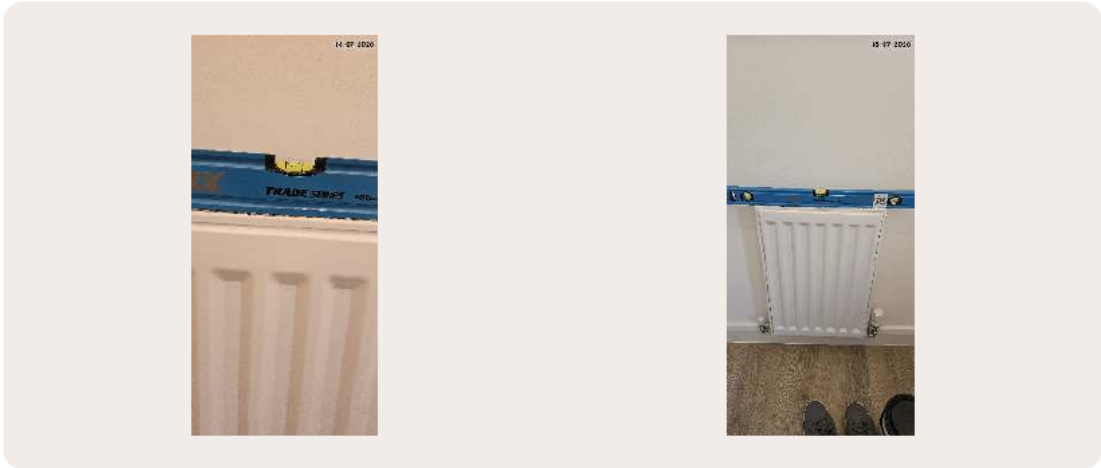
# Defect 27

**OBSERVATION**  
The radiator is out of level.

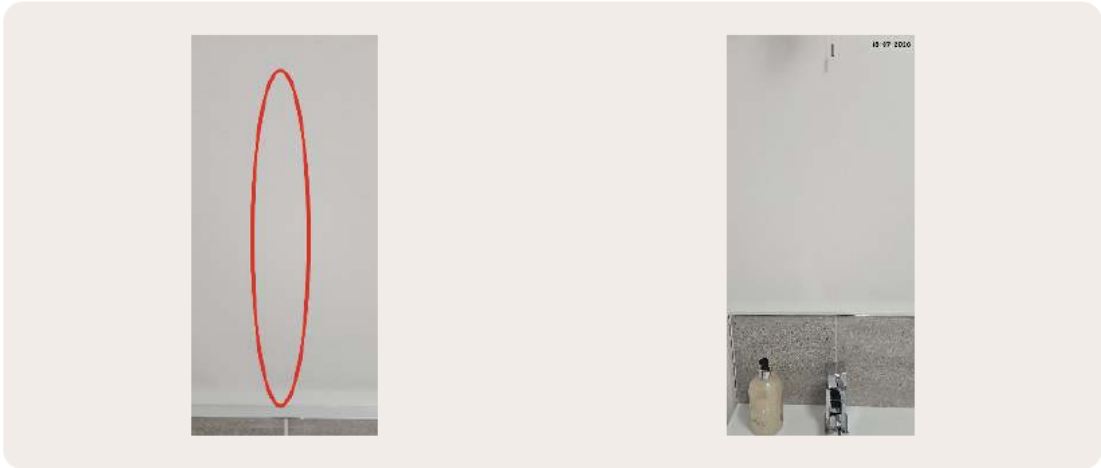
**OBSERVATION**  
Pencil marks remain on the wall above the wash-hand basin.

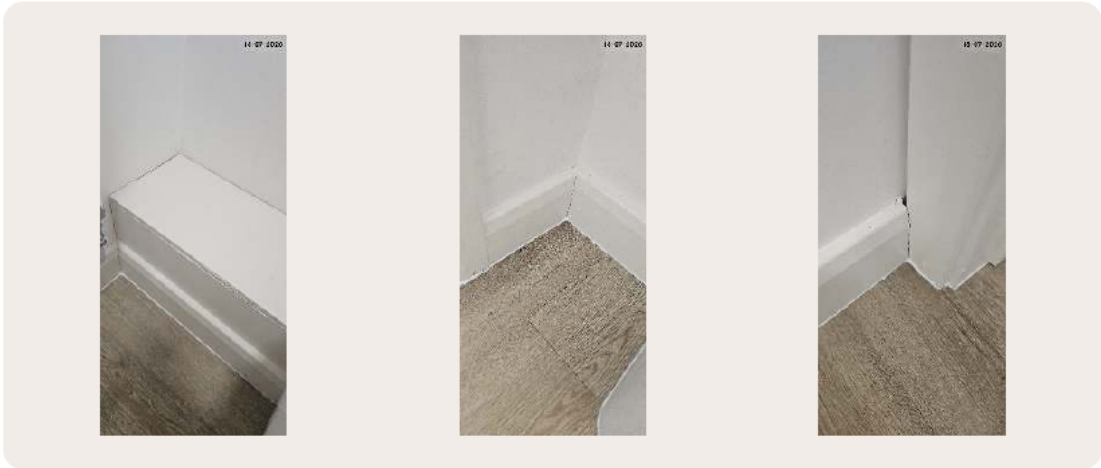
**OBSERVATION**  
Widespread shrinkage gaps are present at decorative junctions throughout the cloakroom.

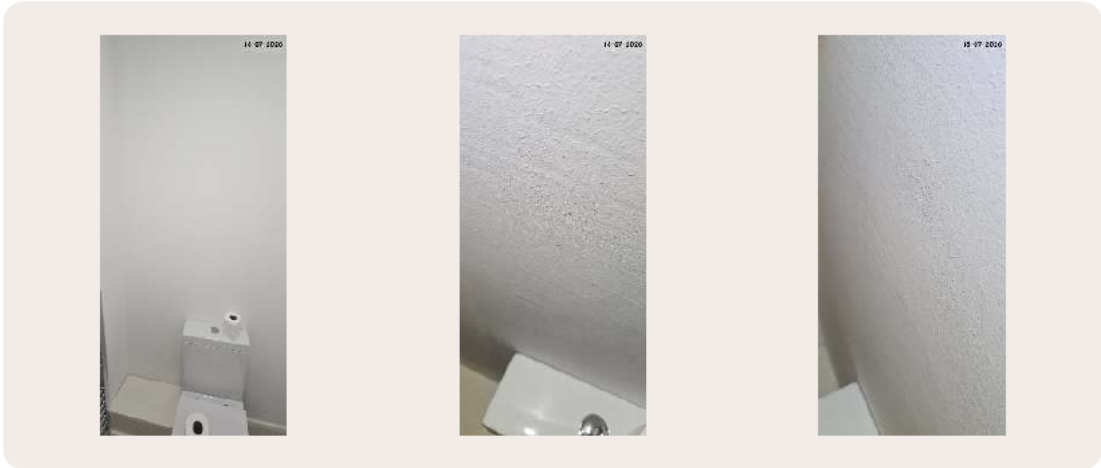
**OBSERVATION**  
Circular jointing or sanding marks remain visible on the wall behind the WC.

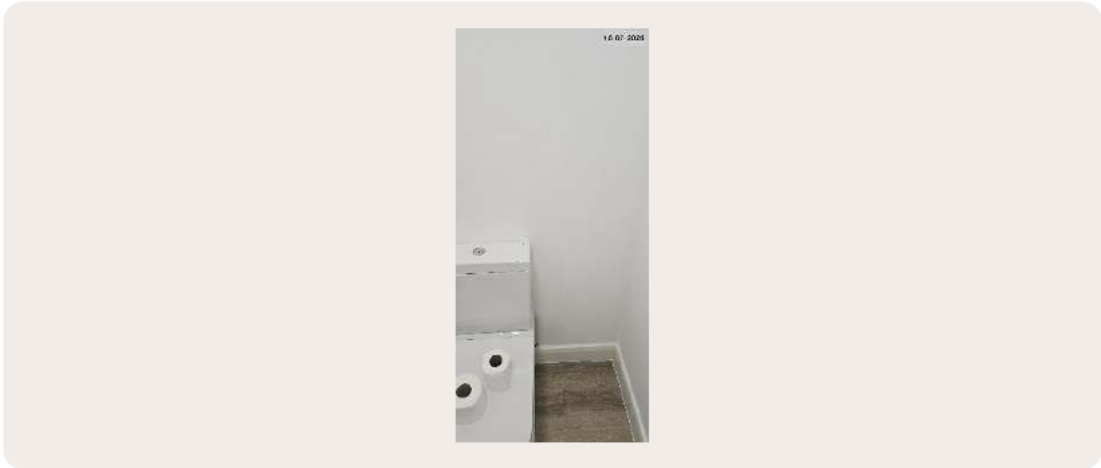
**OBSERVATION**  
The wall finish to the right-hand side of the WC is poor.

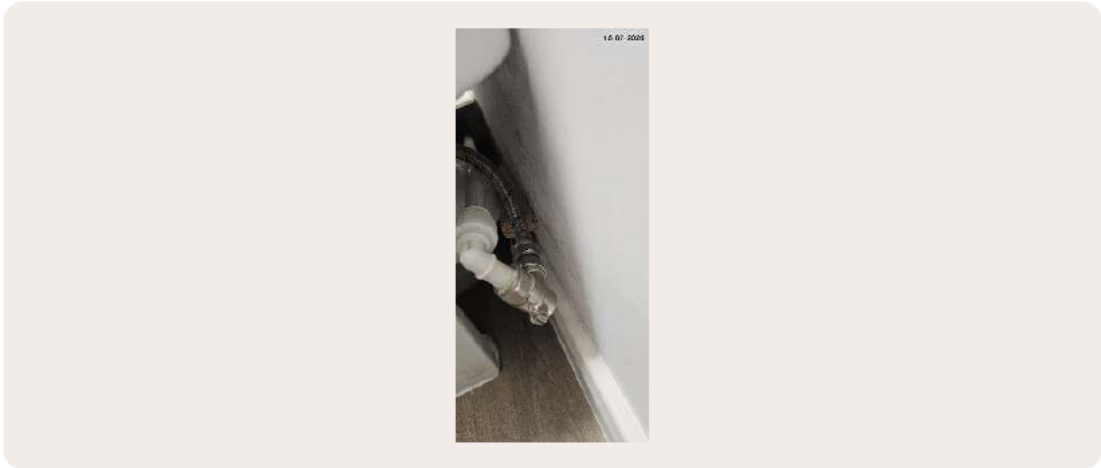
**OBSERVATION**  
The wall finish behind the WC is incomplete, and a timber wedge appears to have been used to support the pan connector.

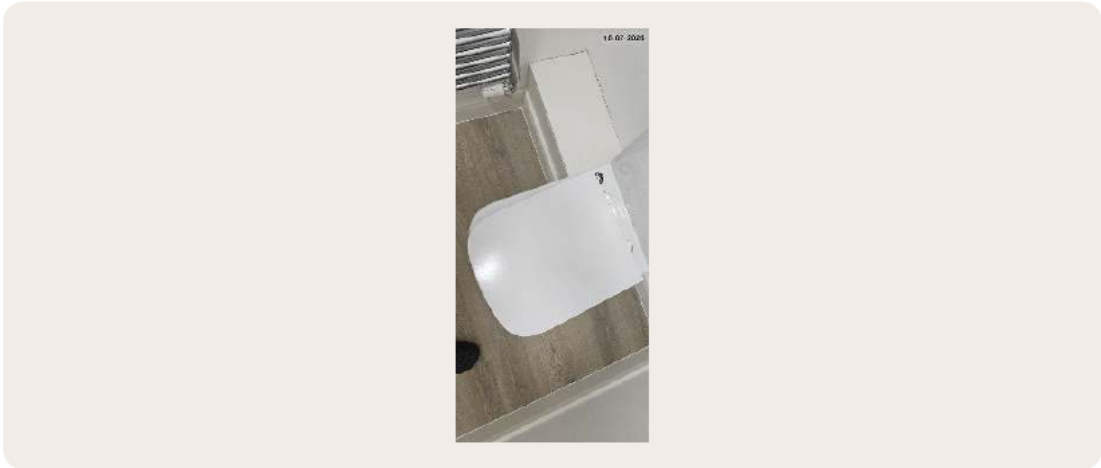
**OBSERVATION**  
The toilet seat is loose.

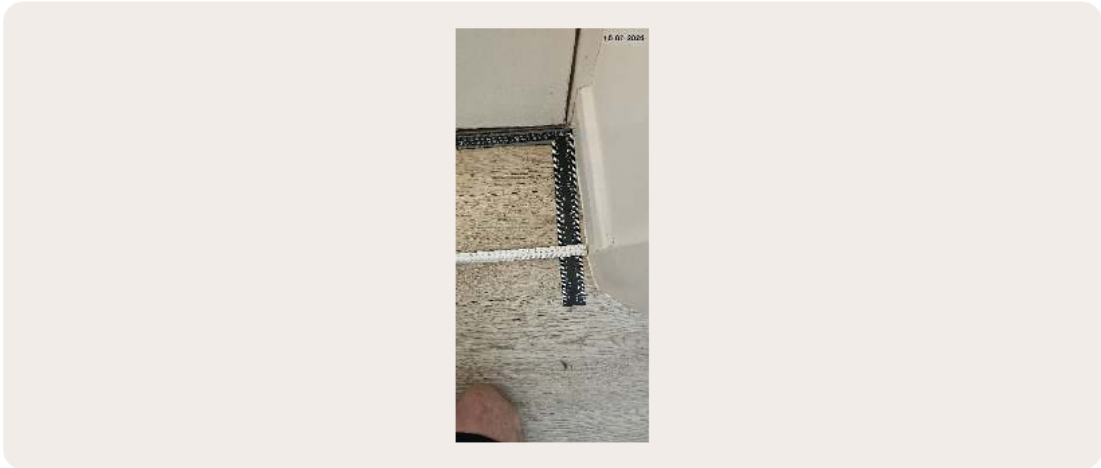
**OBSERVATION**  
The right-hand side of the front door reveal is 10mm out of square.

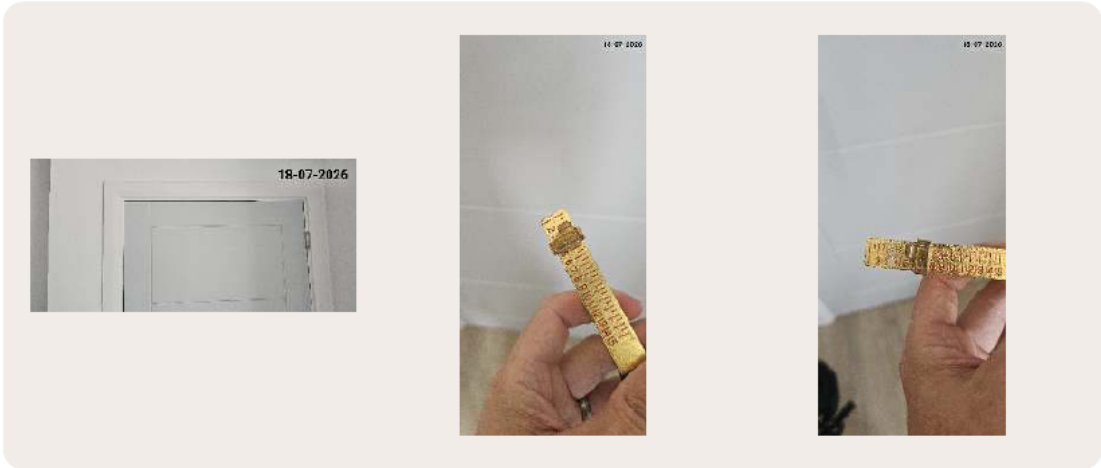
**OBSERVATION**  
The lounge door has an uneven margin.

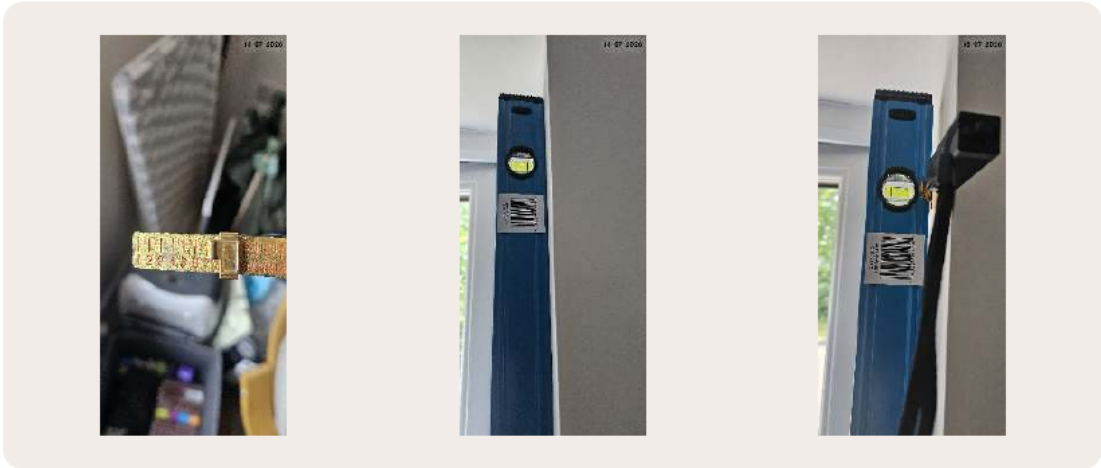
**OBSERVATION**  
The right-hand window reveal is out of plumb and requires correction.

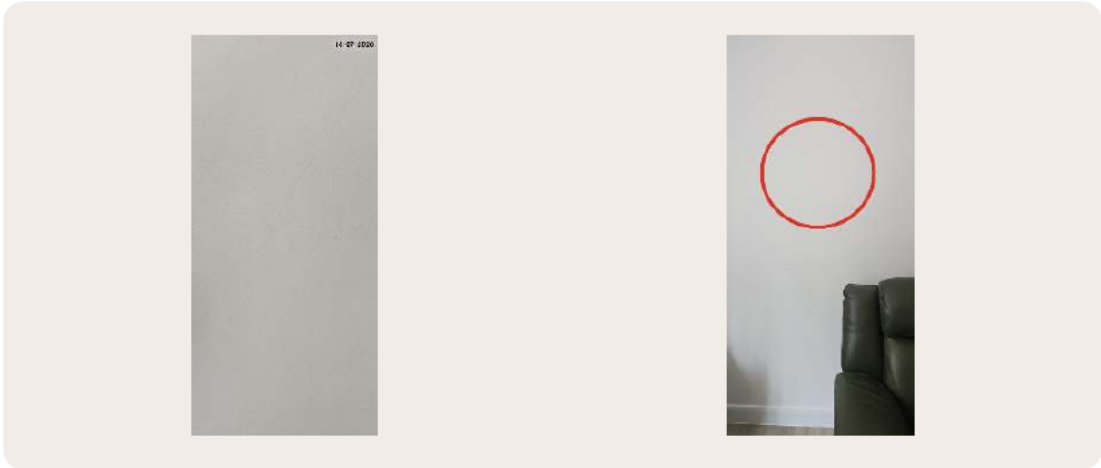
**OBSERVATION**  
Localised indentations are visible in the wall finish above the sofa.

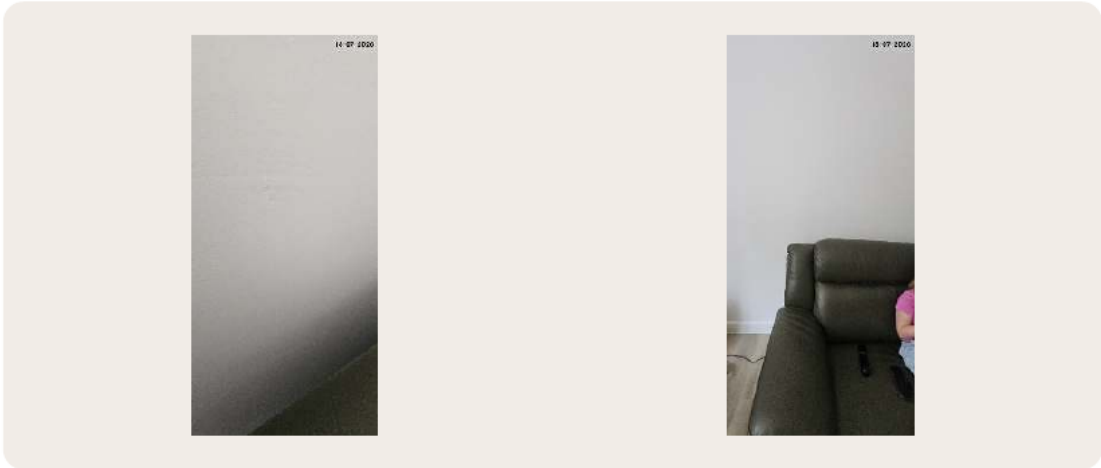
**OBSERVATION**  
Filler above the sofa remains unsanded and is visible through the finished surface.

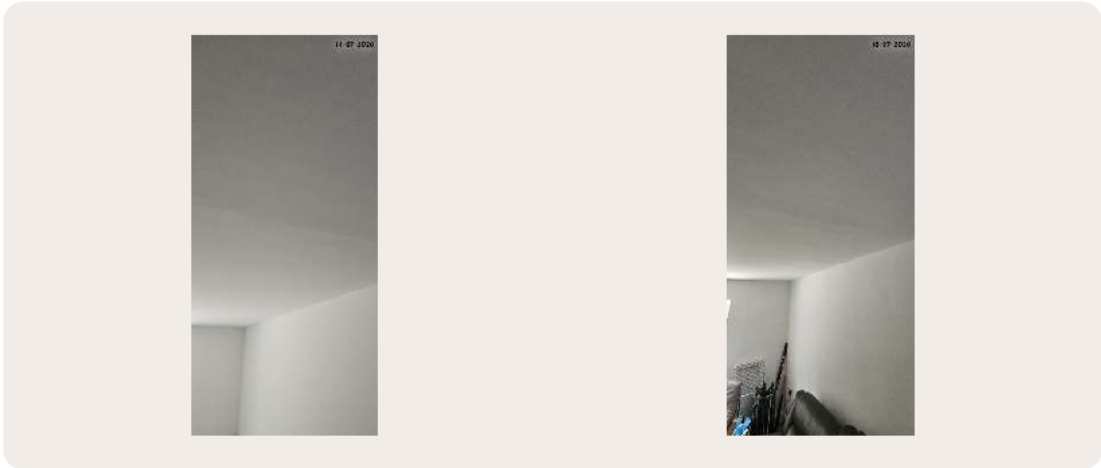
**OBSERVATION**  
The plasterboard joint in the lounge ceiling remains visible through the finished surface.

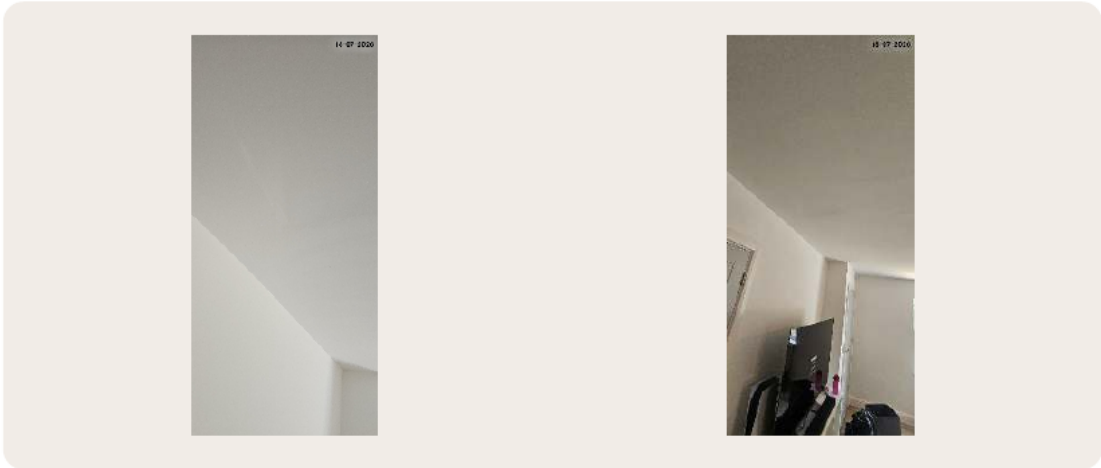
**OBSERVATION**  
The lounge ceiling board joints remain visible and have not been finished to a smooth, consistent standard.

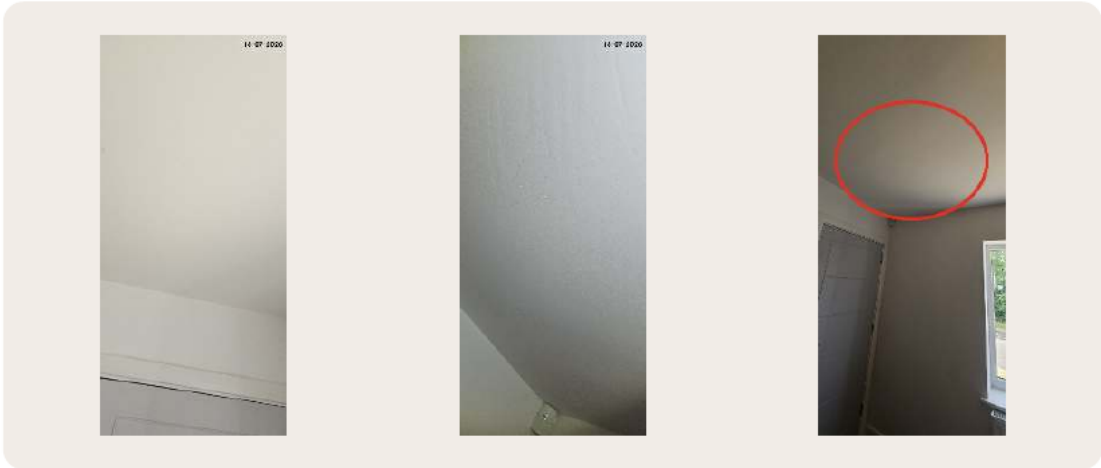
**OBSERVATION**  
Visible sanding marks remain on the lounge ceiling surface.

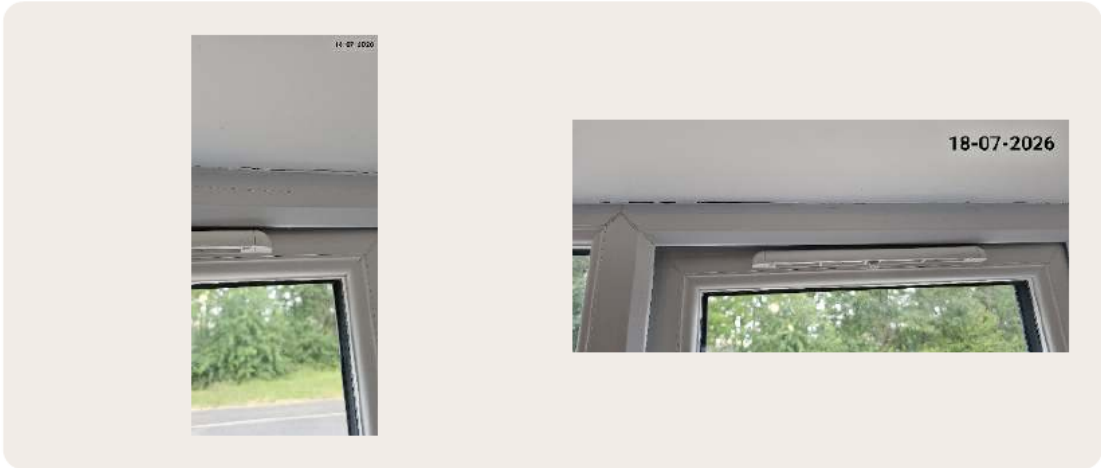
**OBSERVATION**  
A visible knife or tool mark has damaged the surface of the uPVC window frame.

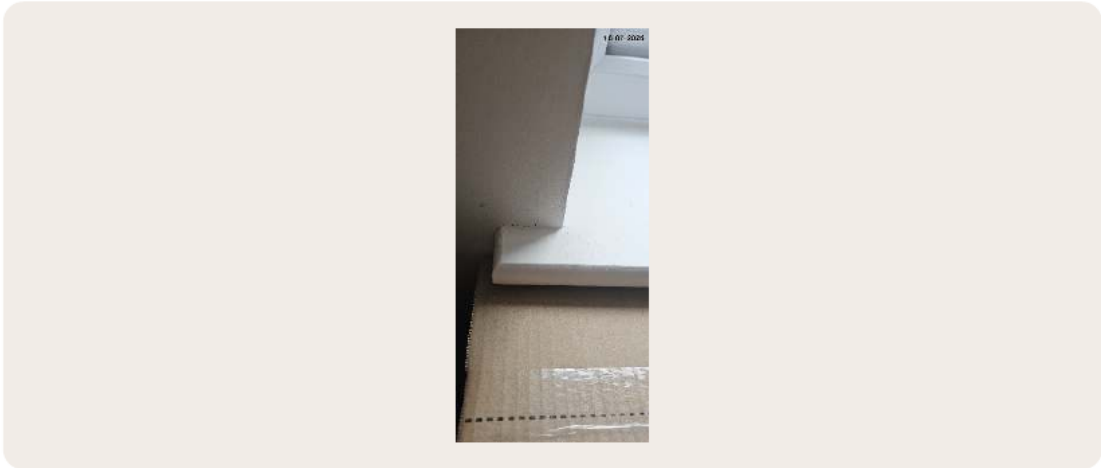
**OBSERVATION**  
The external corner tape at the gable-end window is uneven and remains visible through the finished surface.

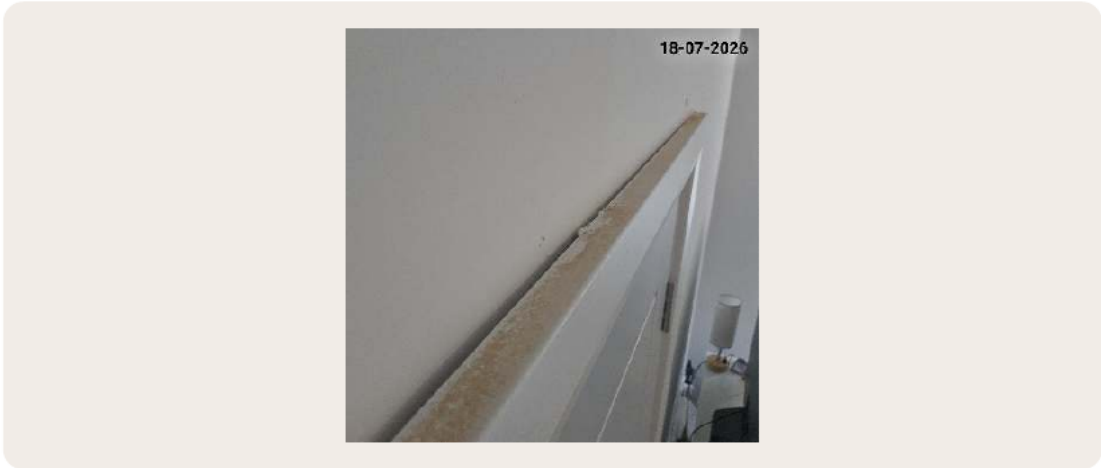
**OBSERVATION**  
The architrave head has not been fully decorated, leaving an incomplete finish at recorded location 1 of 3.

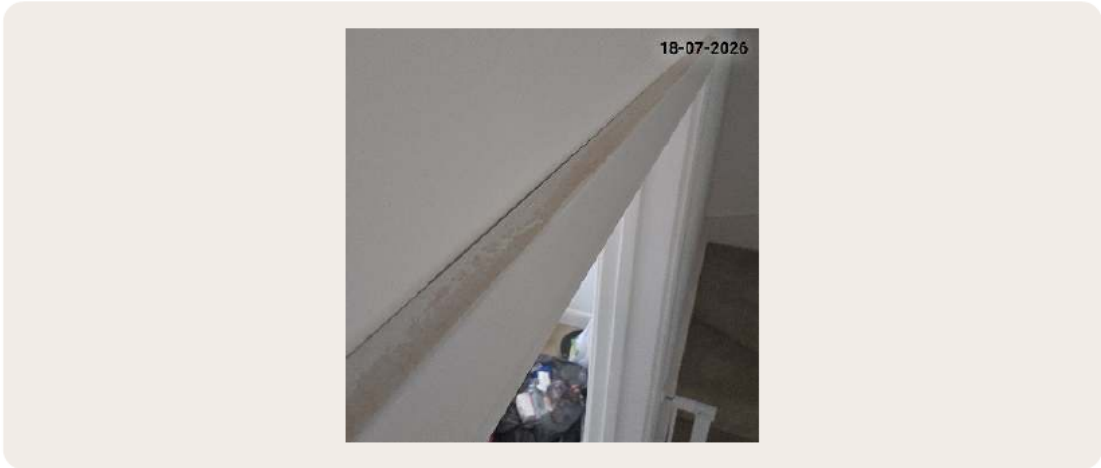
**OBSERVATION**  
The architrave head has not been fully decorated, leaving an incomplete finish at recorded location 2 of 3.

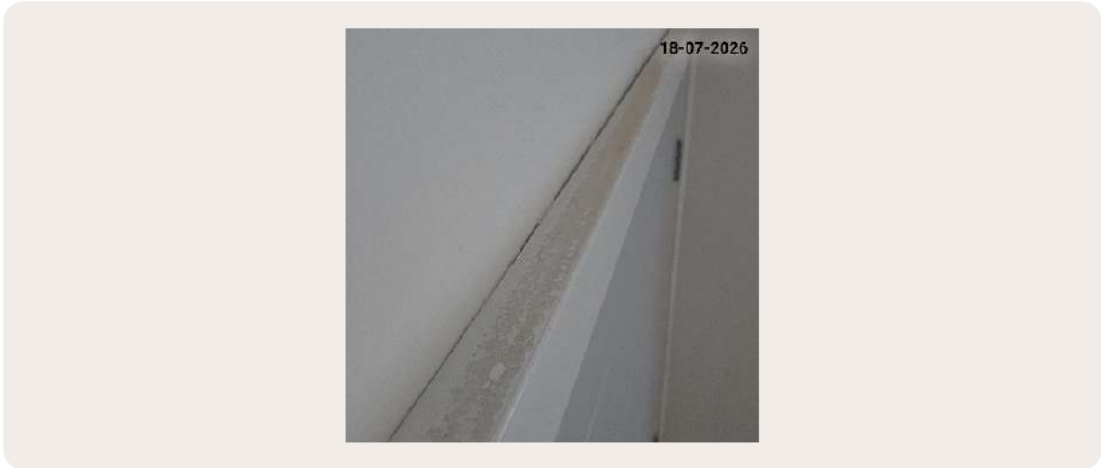
**OBSERVATION**  
The architrave head has not been fully decorated, leaving an incomplete finish at recorded location 3 of 3.

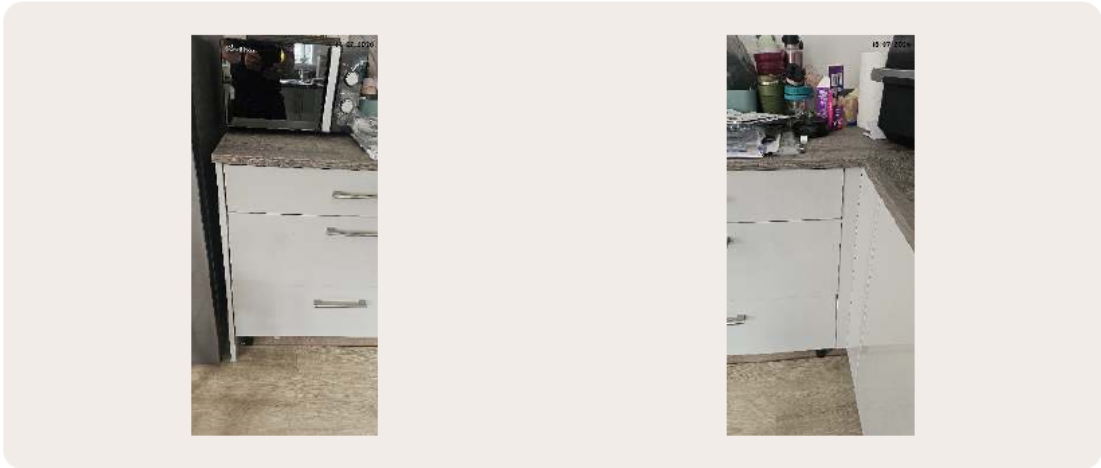
**OBSERVATION**  
The kitchen drawer fronts are misaligned.

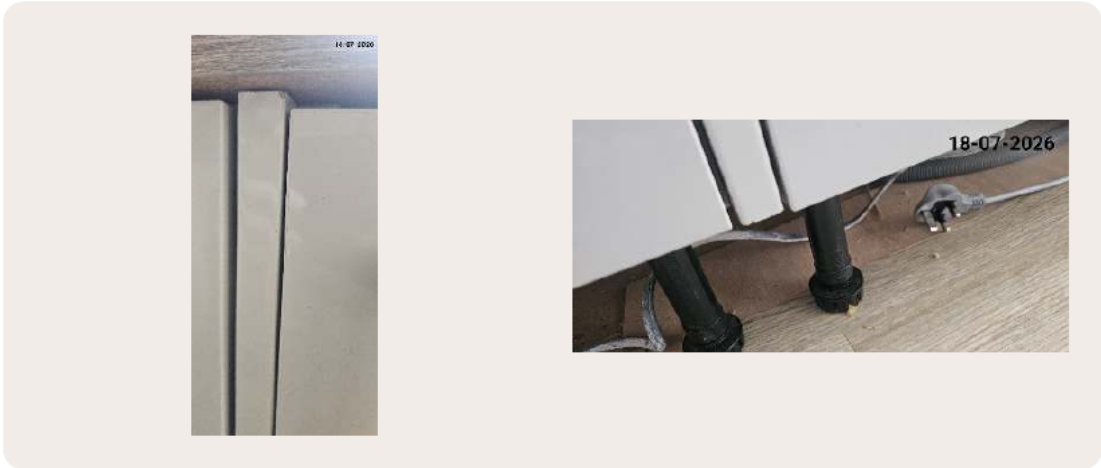
**OBSERVATION**  
The filler panel adjacent to the sink unit is damaged at the top and bottom.

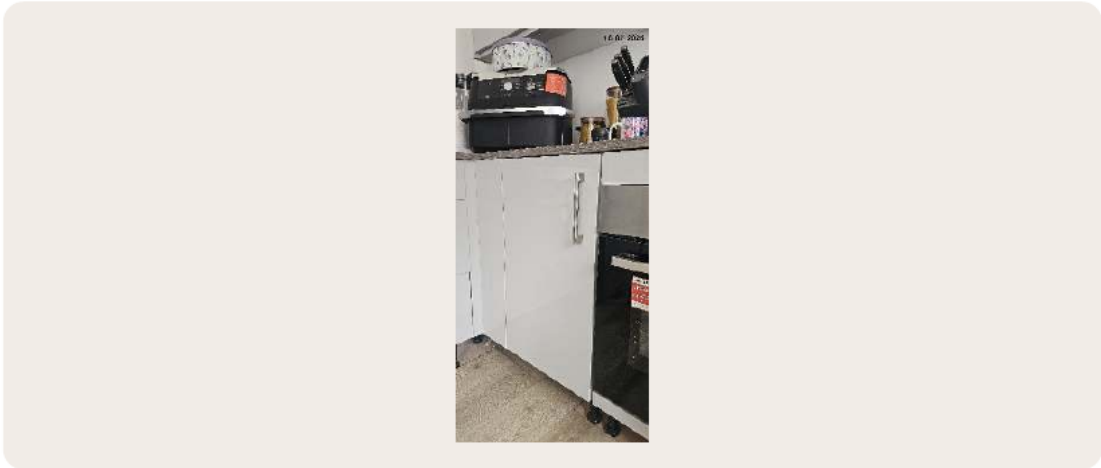
**OBSERVATION**  
A kitchen unit door is misaligned.

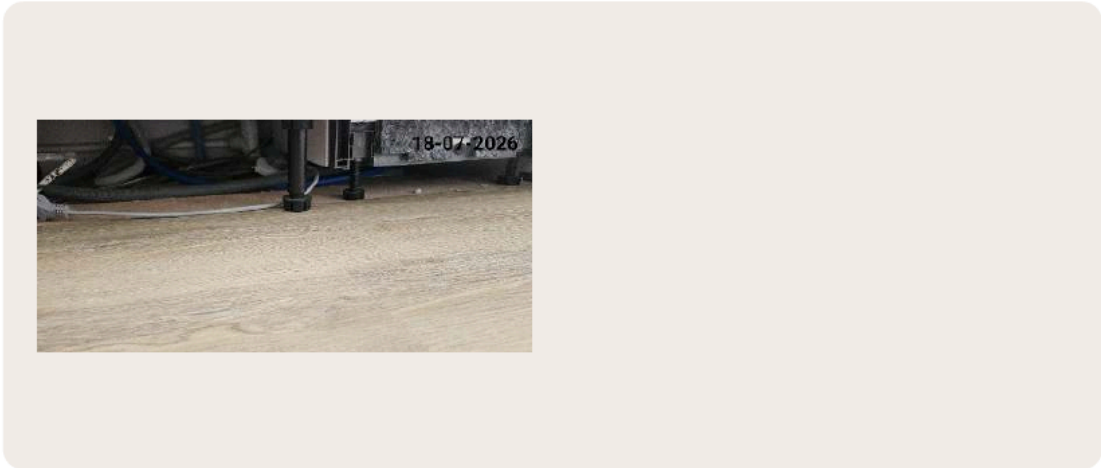
**OBSERVATION**  
The dishwasher has not been connected to the plumbing.

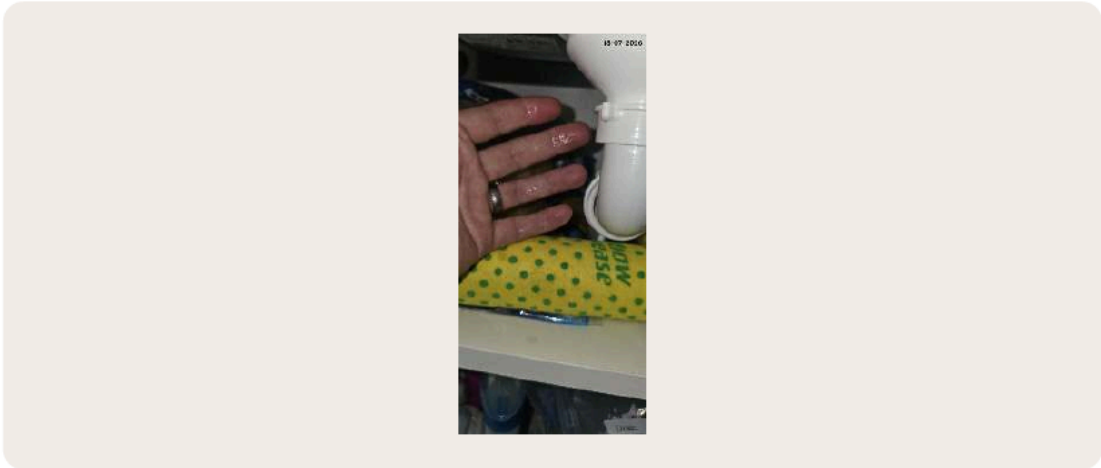
**OBSERVATION**  
The sink waste connection is leaking.
