# Professional Snagging Inspection Report

Post-completion inspection

Inspection date: 18 July 2026

South Wales Snagging Co was instructed to undertake a visual, non-destructive post-completion snagging inspection of an anonymised new-build property in South Wales. This report records visible defects, incomplete items and areas requiring developer or aftercare attention based on the condition observed on 18 July 2026.

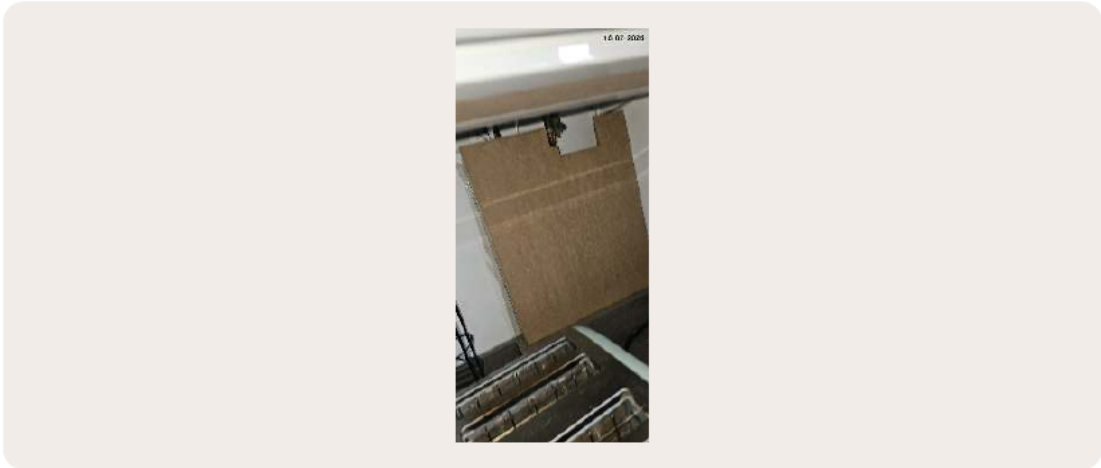
**OBSERVATION**  
Decoration is incomplete to the boxing beneath the boiler housing.

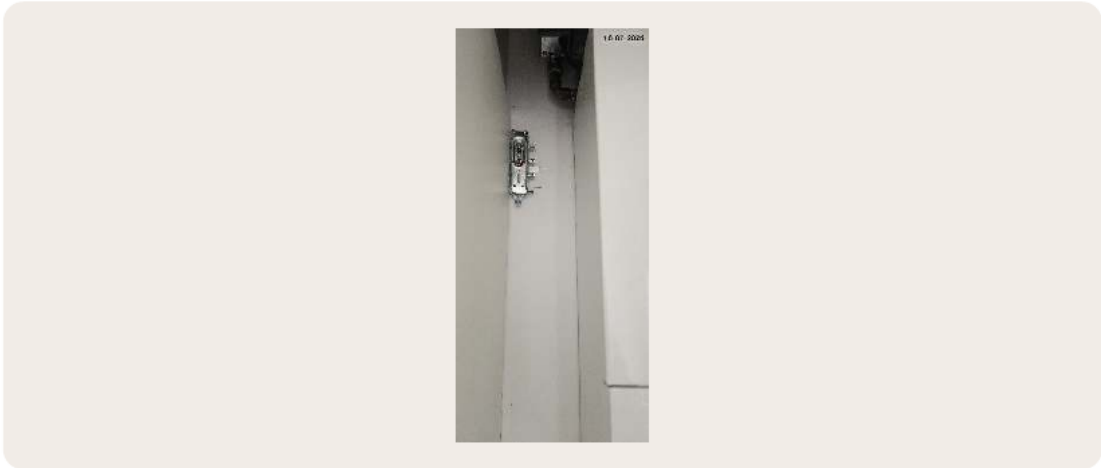
**OBSERVATION**  
Pencil marks remain on the wall within the boiler housing.

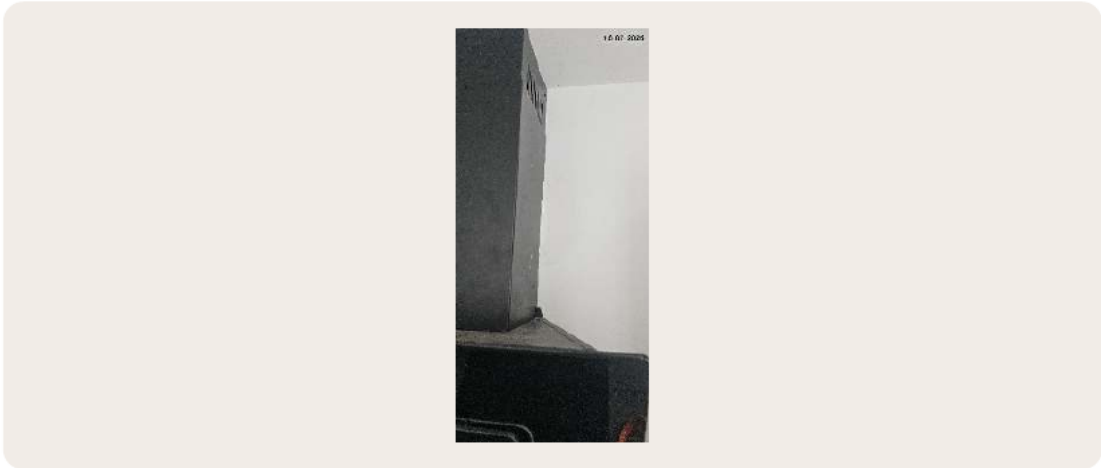
**OBSERVATION**  
Filler beside the cooker hood chimney has not been sanded or decorated.

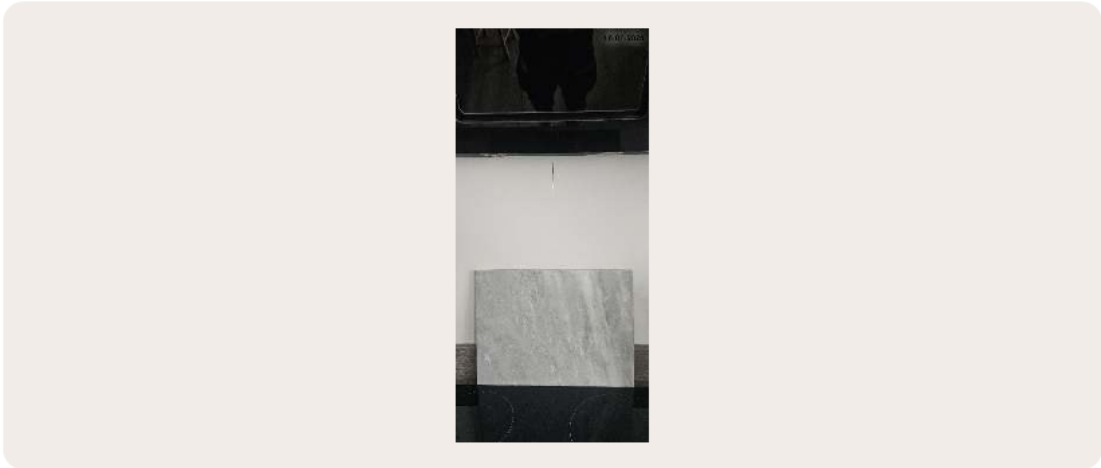
**OBSERVATION**  
A pencil line remains on the wall beneath the cooker hood.

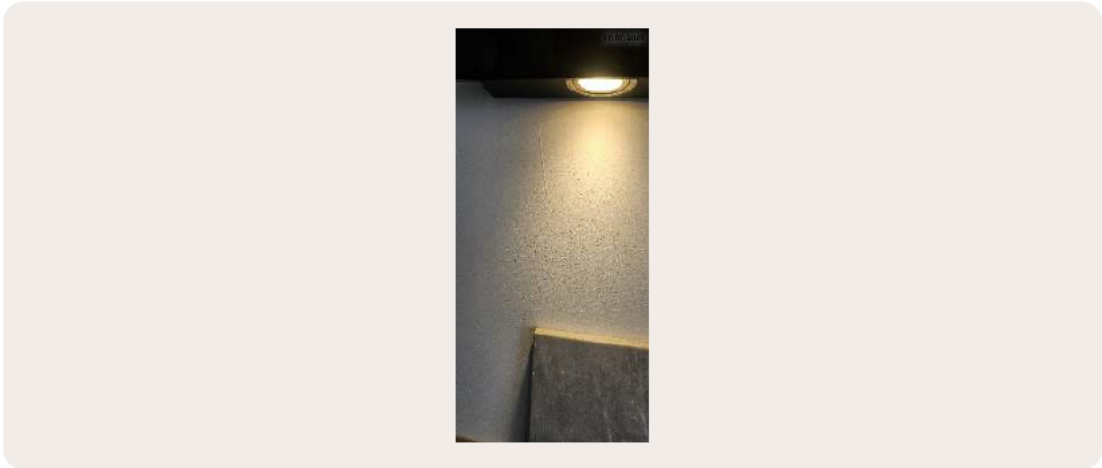
**OBSERVATION**  
A visible paint run remains on the wall beneath the cooker hood.

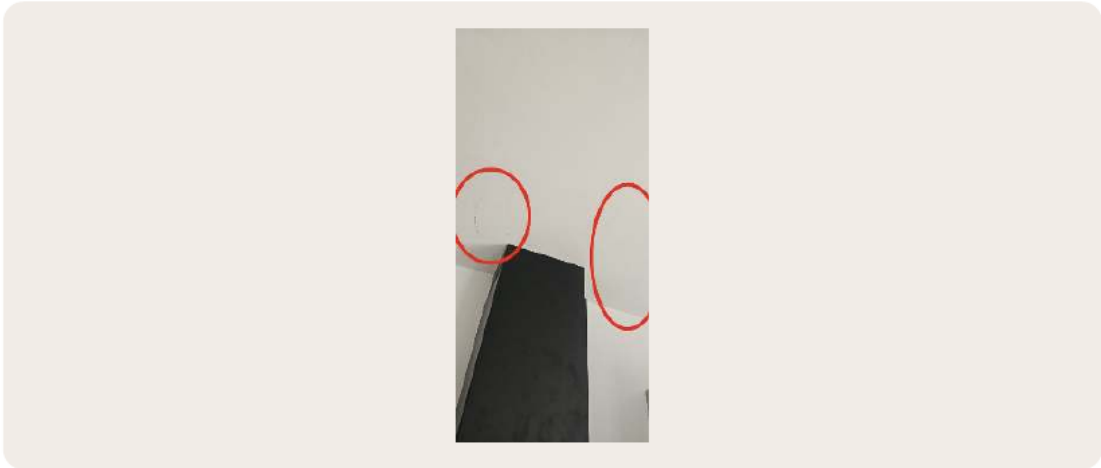
**OBSERVATION**  
Visible trade marks remain on the ceiling around the cooker hood chimney.

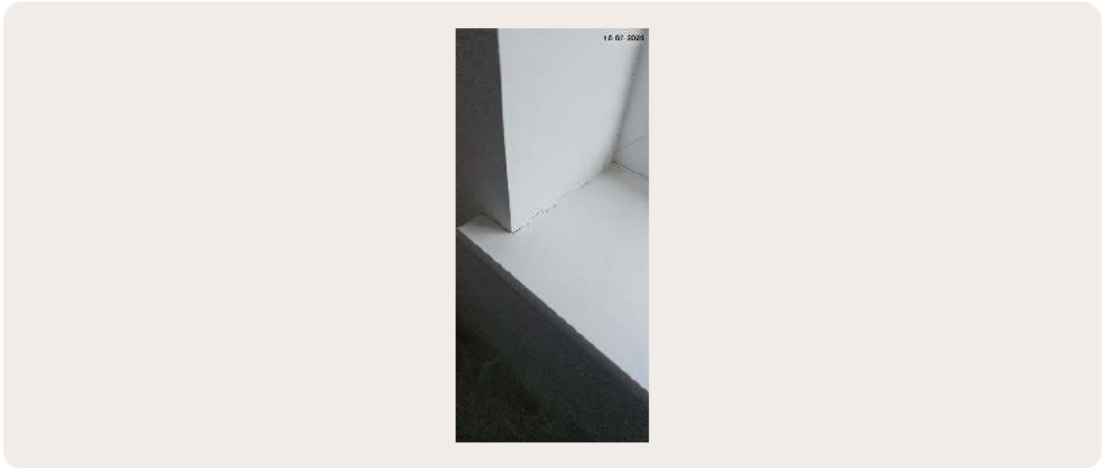
**OBSERVATION**  
A visible shrinkage gap has opened around the bedroom 3 window junction at recorded location 2 of 2.

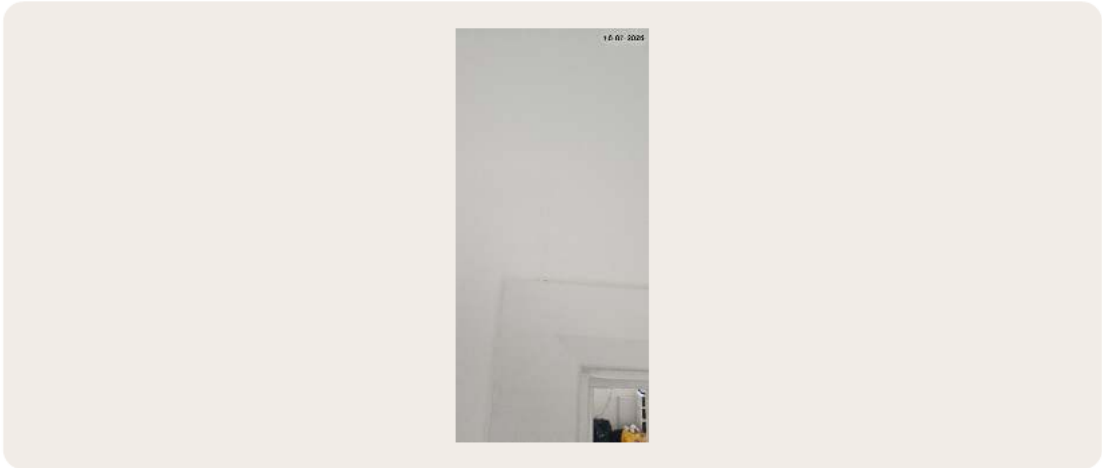
**OBSERVATION**  
Joint tape above the architrave has debonded and is visibly raised from the finished surface.

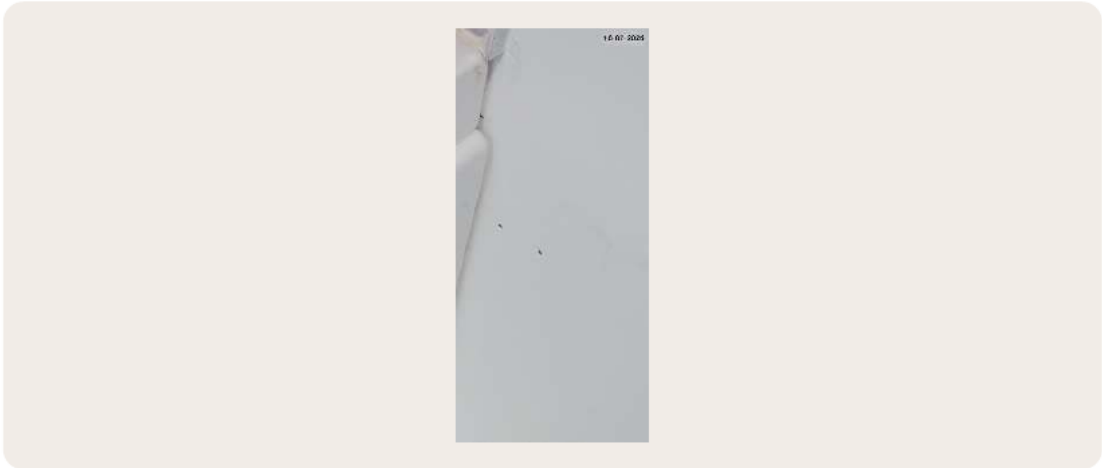
**OBSERVATION**  
Holes remain in the wall beside the bath panel.

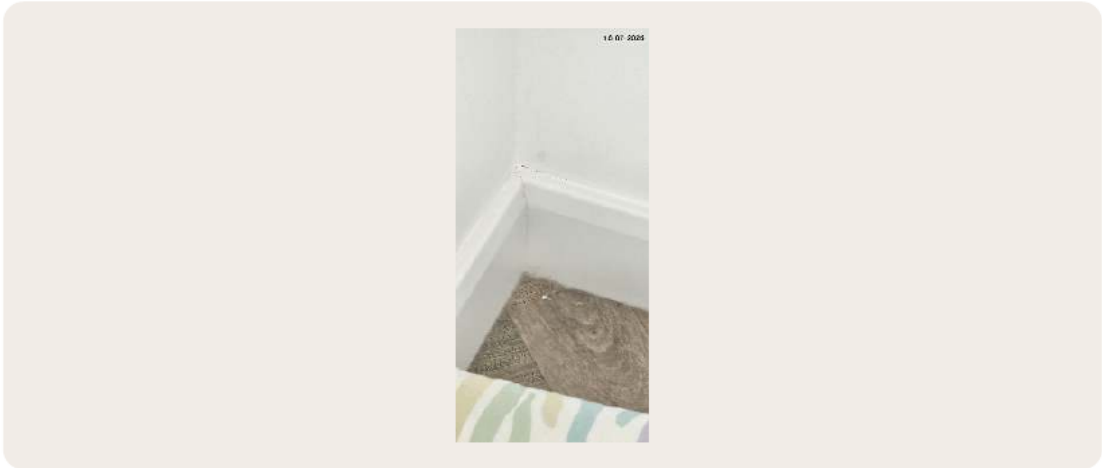
**OBSERVATION**  
A visible shrinkage gap has opened at a bedroom 1 skirting-board junction at recorded location 2 of 3.

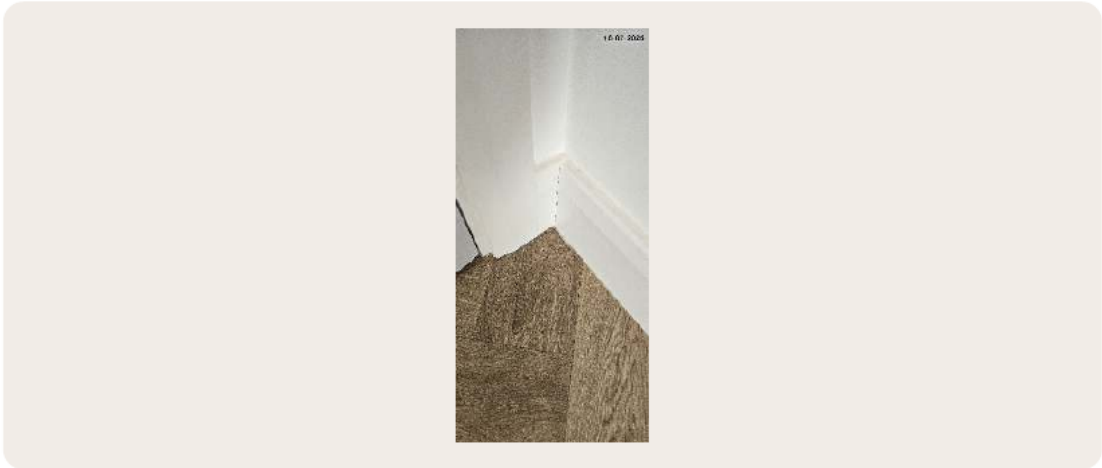
**OBSERVATION**  
A visible shrinkage gap has opened at a bedroom 1 skirting-board junction at recorded location 3 of 3.

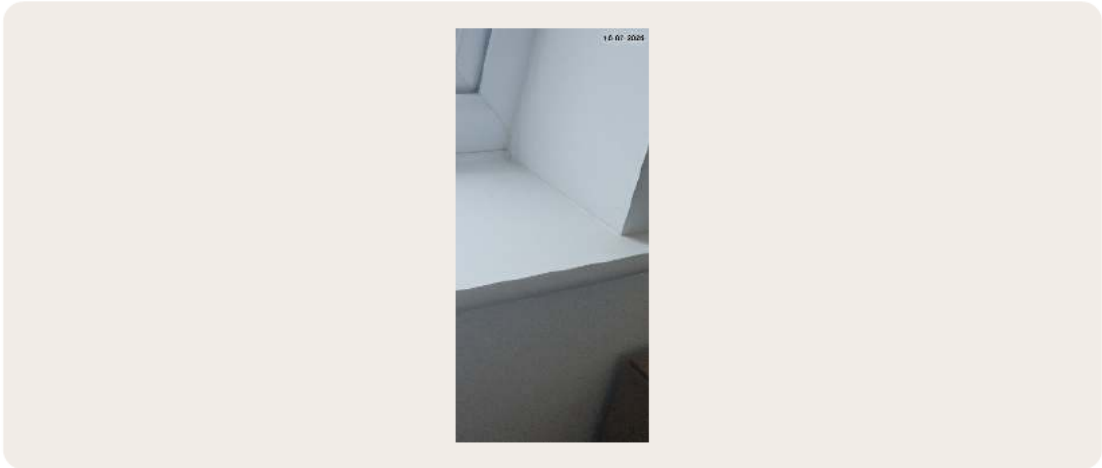
**OBSERVATION**  
A visible shrinkage gap has opened around the bedroom 1 window junction at recorded location 3 of 3.

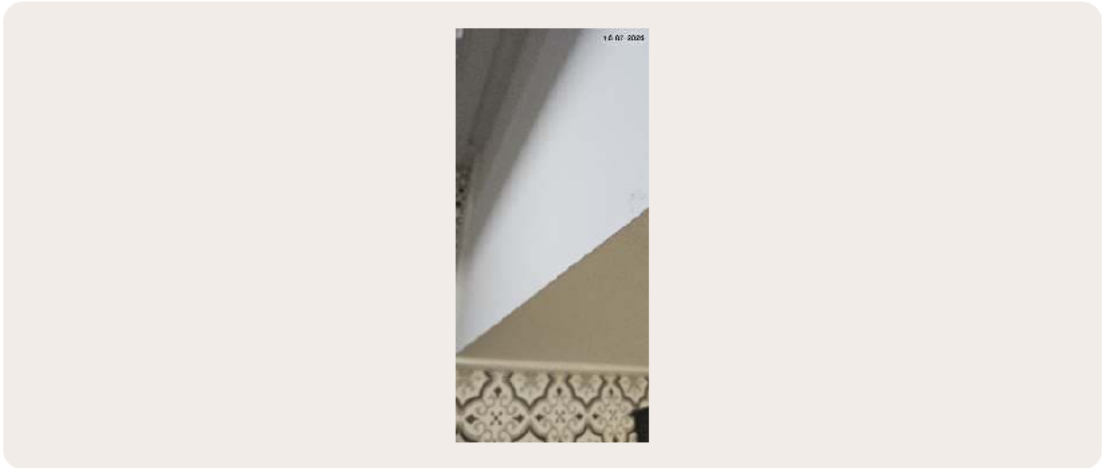
**OBSERVATION**  
The external corner bead is corroding and staining the surrounding finish.
