# Professional Snagging Inspection Report

Pre-completion inspection

**Sample Development - Plot XX**

Development: Sample Development | Plot XX | Developer: Anonymised | Total defects: 95

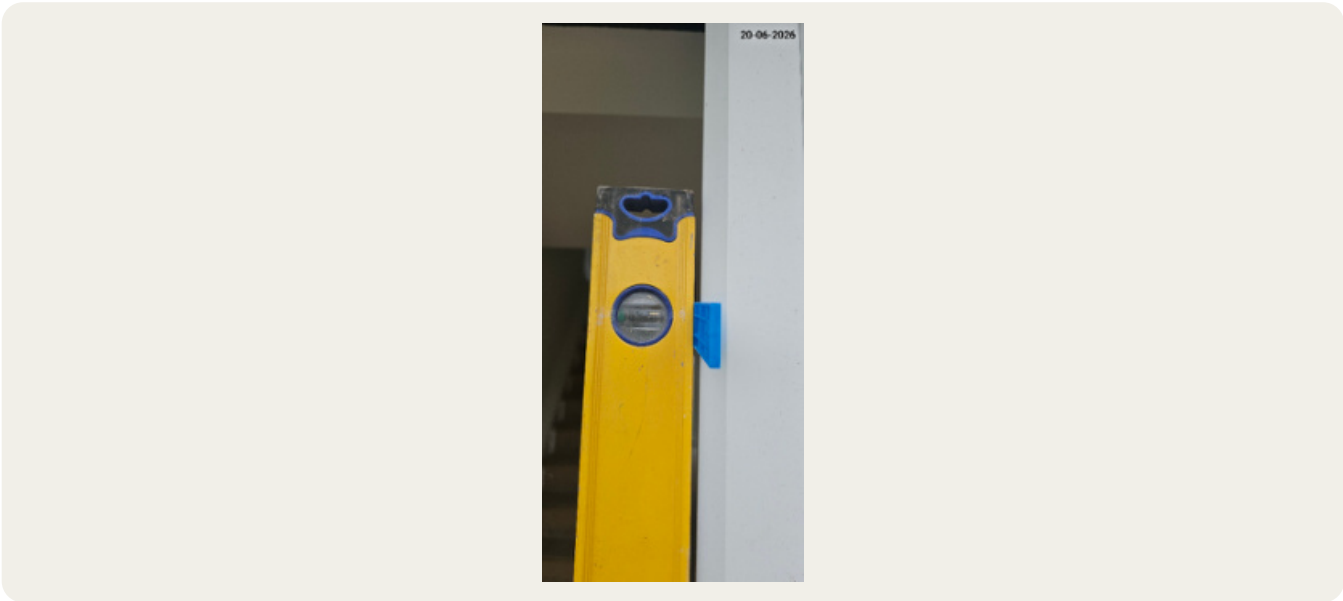
Defect 2

The left-hand side of the front door is more than 5mm out of plumb.

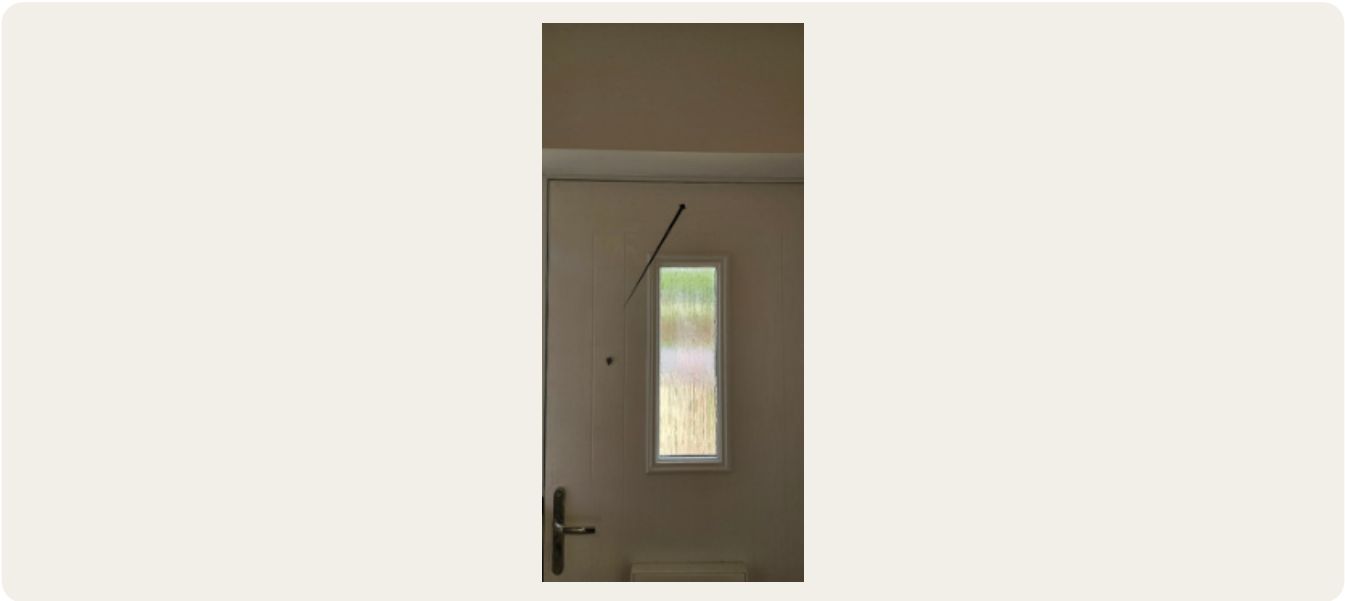
Defect 3

The margin at the head of the door is visibly uneven and reduced.

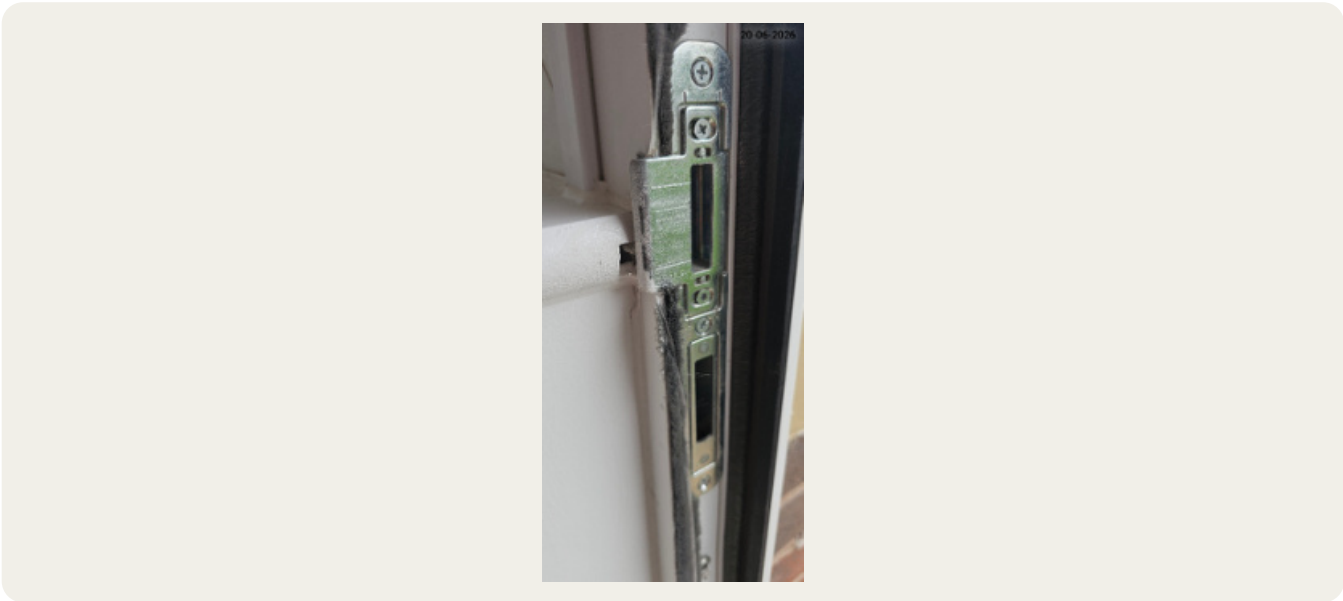
## Defect 4

Paint contamination is present on the front door ironmongery.

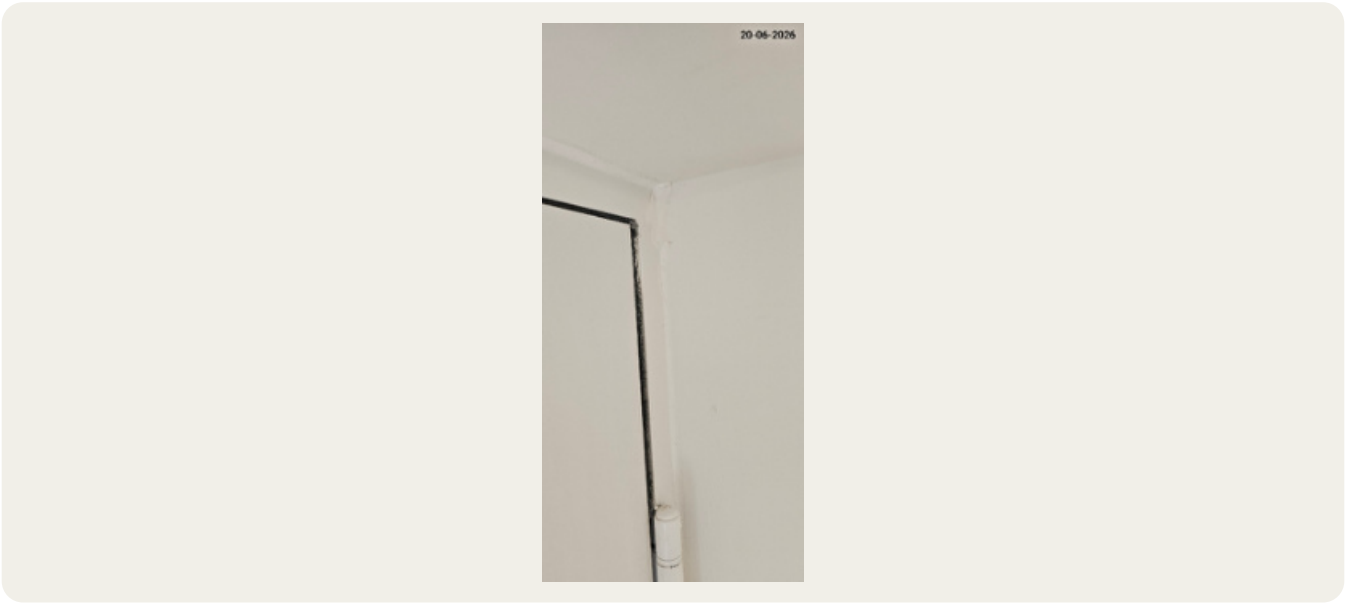
## Defect 5

Sealant has been left with a poor and uneven finish.

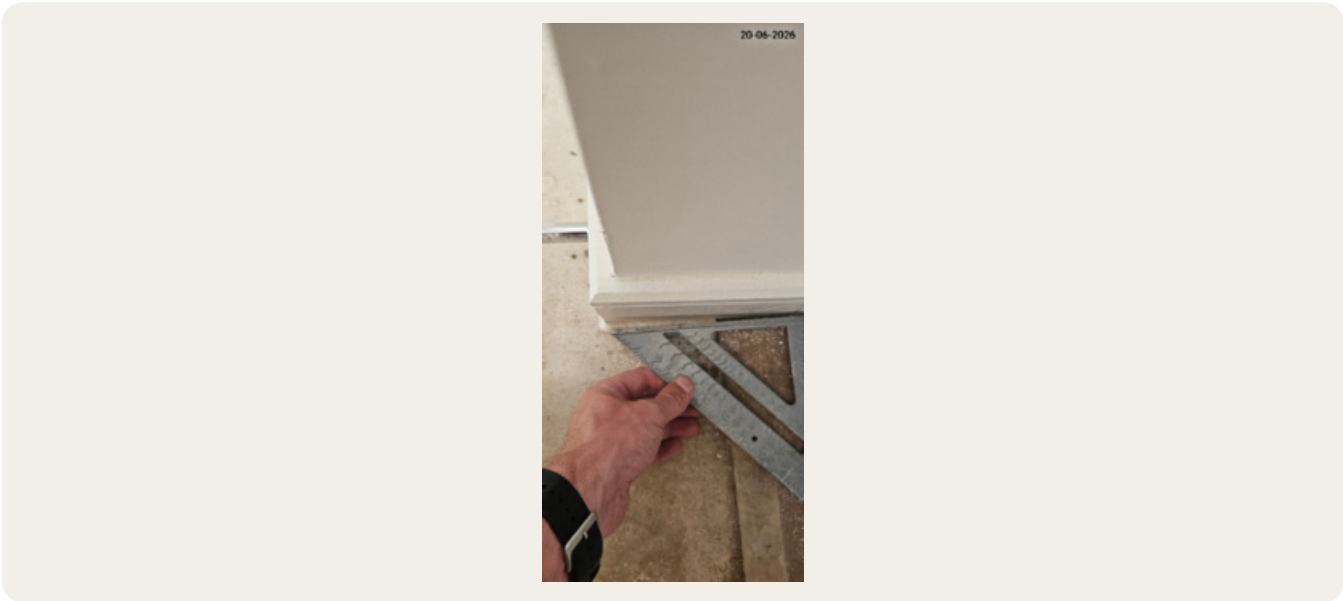
Defect 6

The front door reveal is more than 5mm out of square and the adjacent skirting requires adjustment.

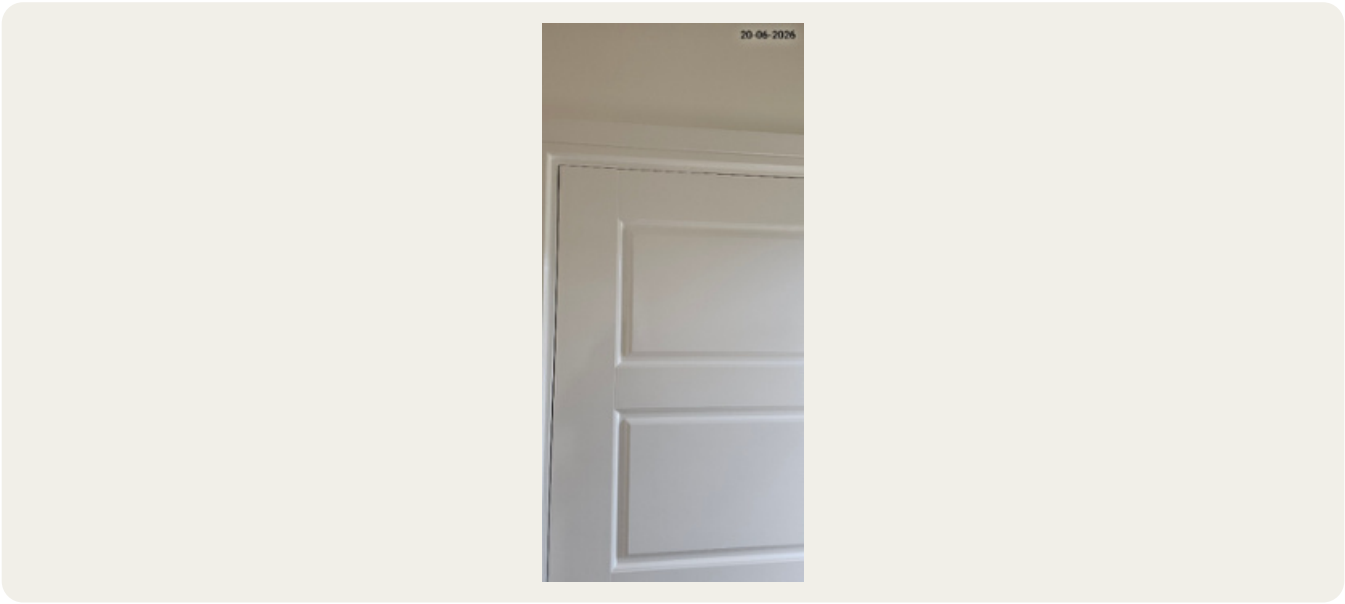
Defect 9

The finish to the hallway cupboard door frame is poor.

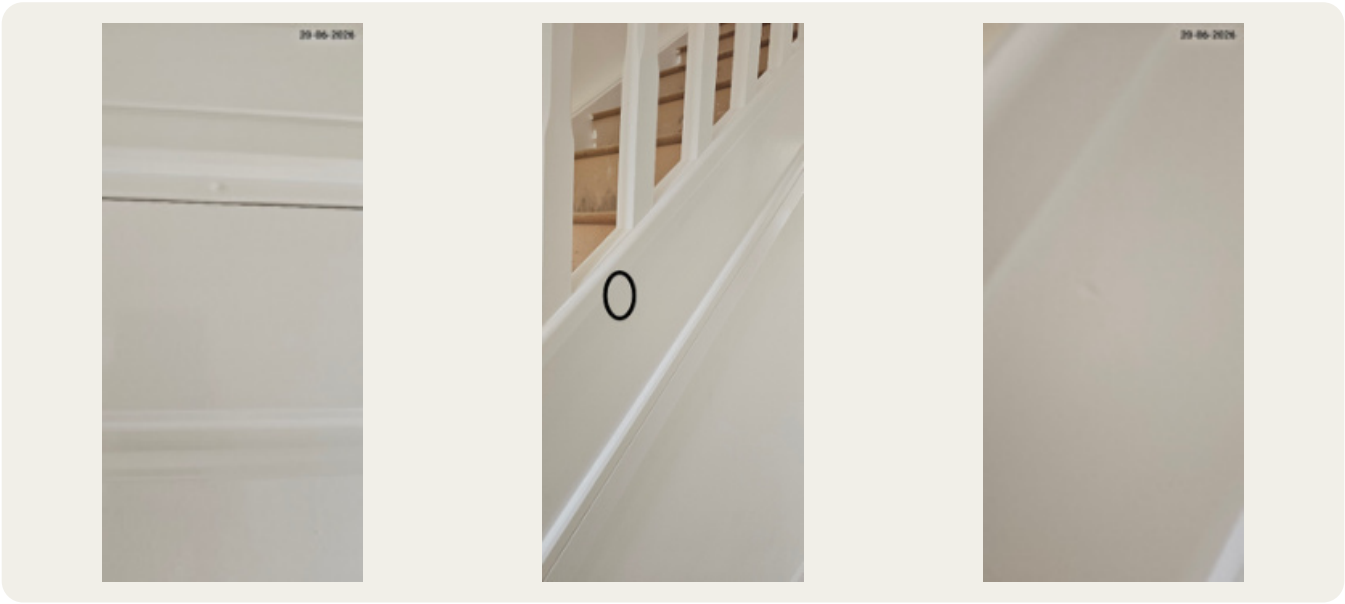
Defect 10

OBSERVATION  
The stair string finish is incomplete and requires making good.

RECOMMENDED ACTION  
The developer should fill, make good and touch up the affected stair string.

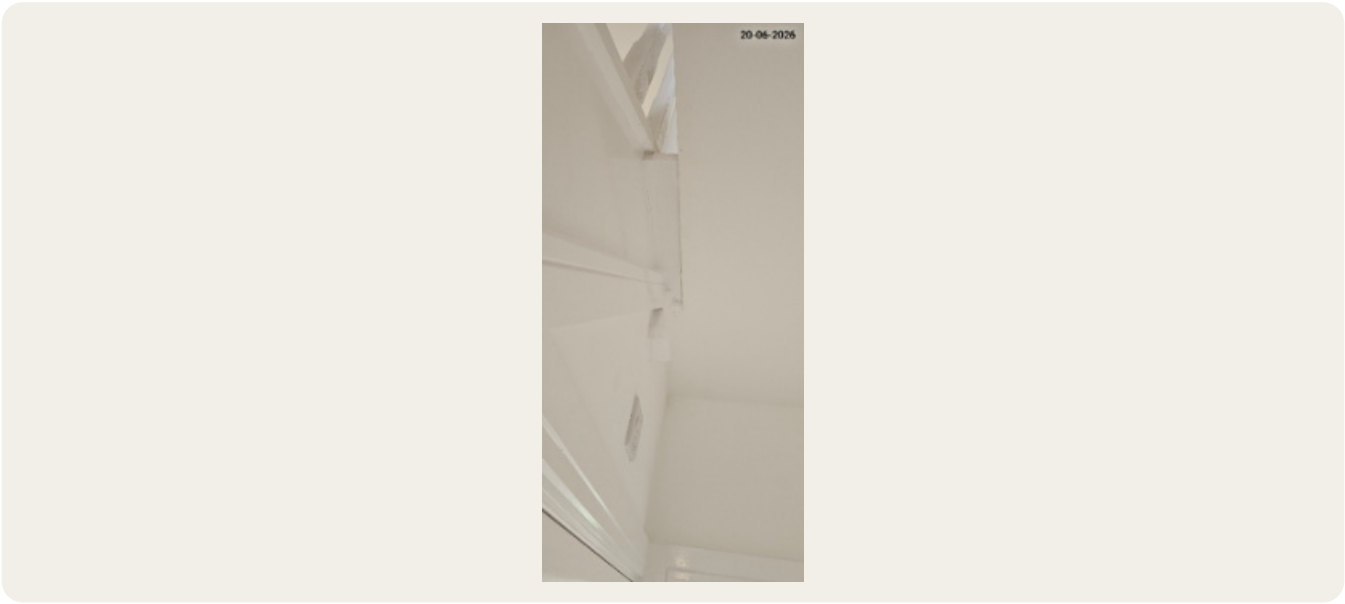
# Defect 11

OBSERVATION  
The decorative finish to the stair woodwork is poor.

RECOMMENDED ACTION  
The developer should redecorate the affected stair woodwork.

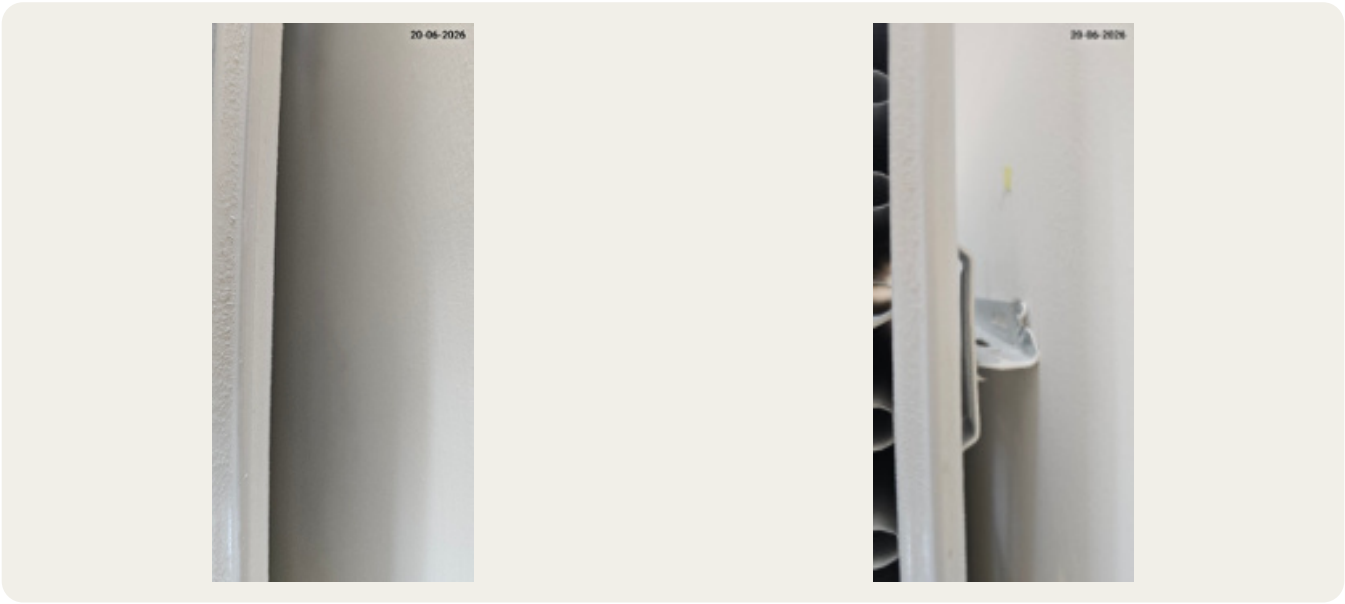
# Defect 12

**OBSERVATION**  
Decoration behind the radiator is incomplete, with pencil marks and paint contamination visible to adjacent brackets.

**RECOMMENDED ACTION**  
The developer should complete decoration behind the radiator, remove pencil marks and clean paint from the radiator brackets.

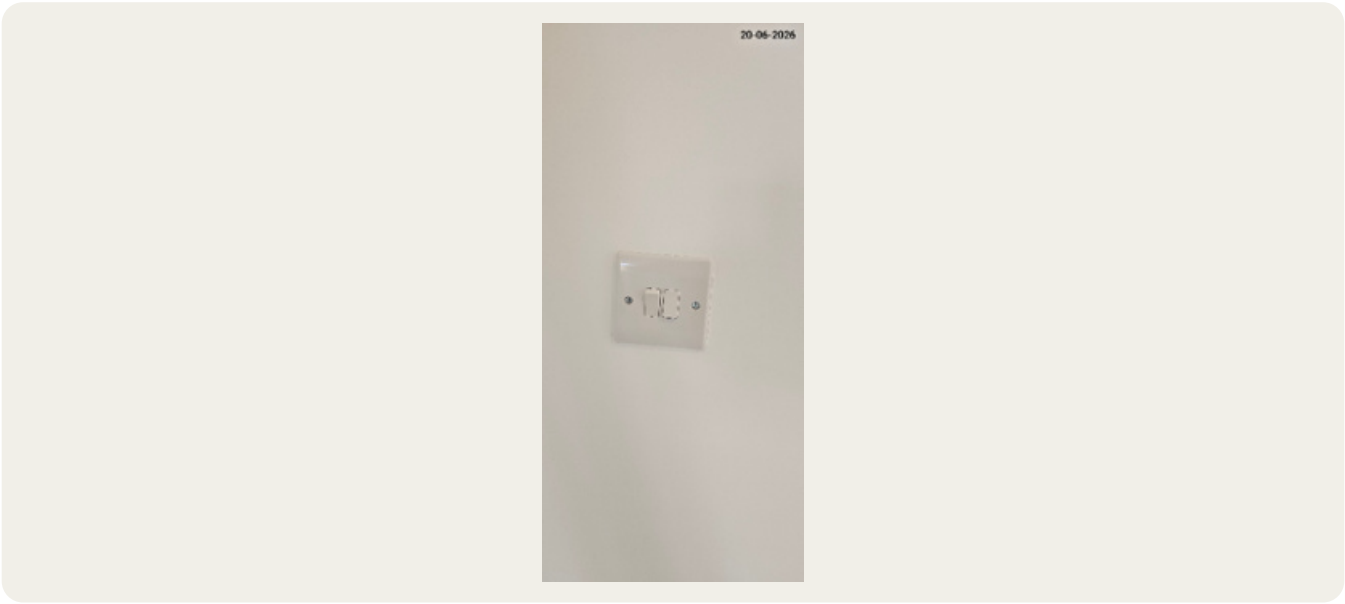
Defect 13

Screw cover caps are missing from the light switch.

The developer should install the missing screw cover caps.

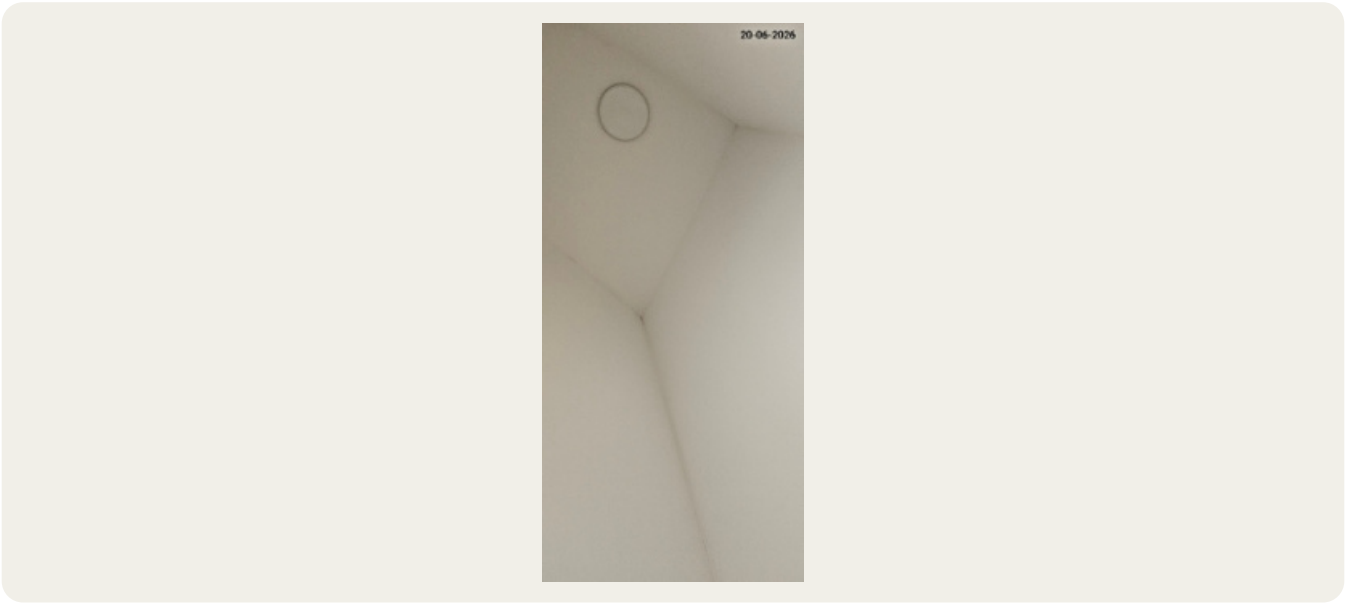
# Defect 14

The ceiling finish is poor and requires making good.

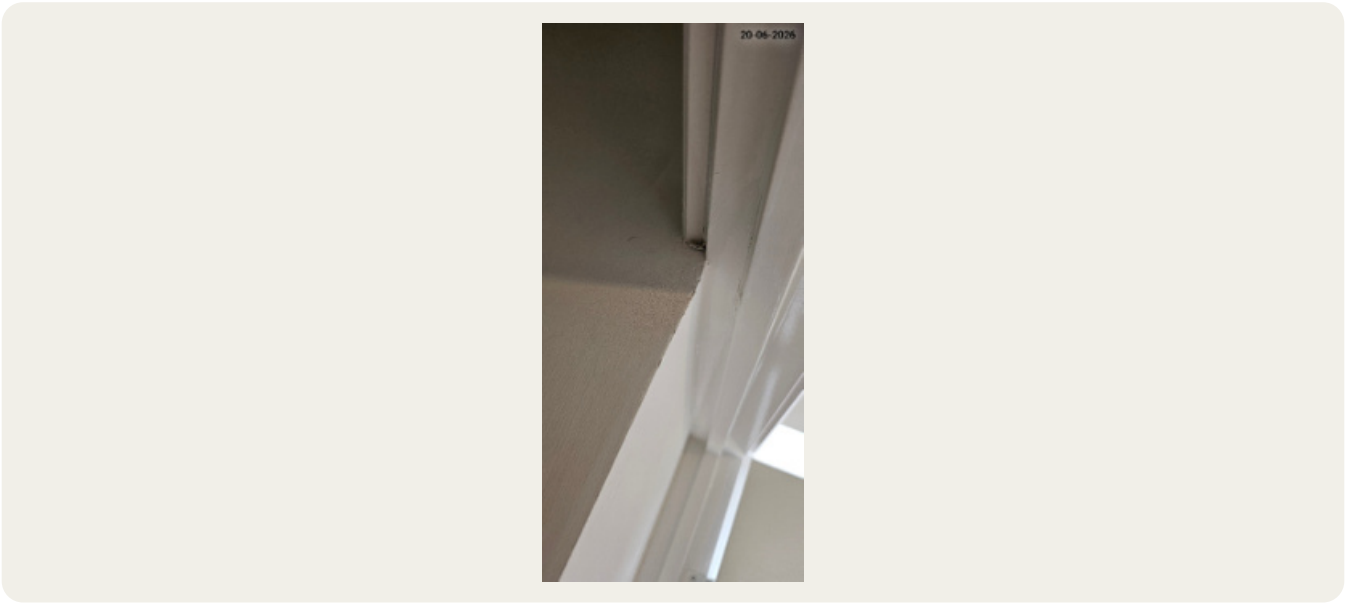
# Defect 16

The finish to the head of the hallway cupboard architrave is poor.

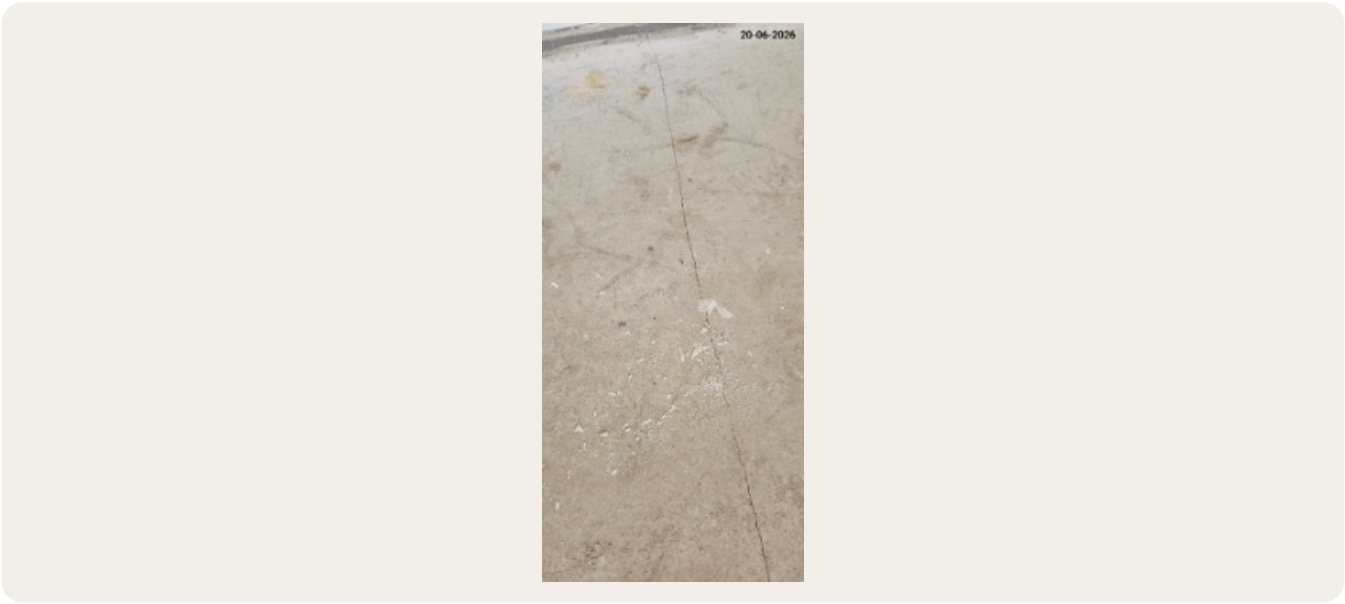
# Defect 17

Issue 17: Lounge - A crack is present to the lounge floor slab.

OBSERVATION  
A crack is present to the lounge floor slab.

WHY THIS MATTERS  
This may affect the suitability of floor finishes, the performance of the completed floor and the homeowner acceptance of the property. Where cracking or significant level change is present, the developer should confirm the cause and appropriate remedial action.

RECOMMENDED ACTION  
The developer should review the concern, complete suitable remedial works and provide written confirmation where engineer or technical review is required.

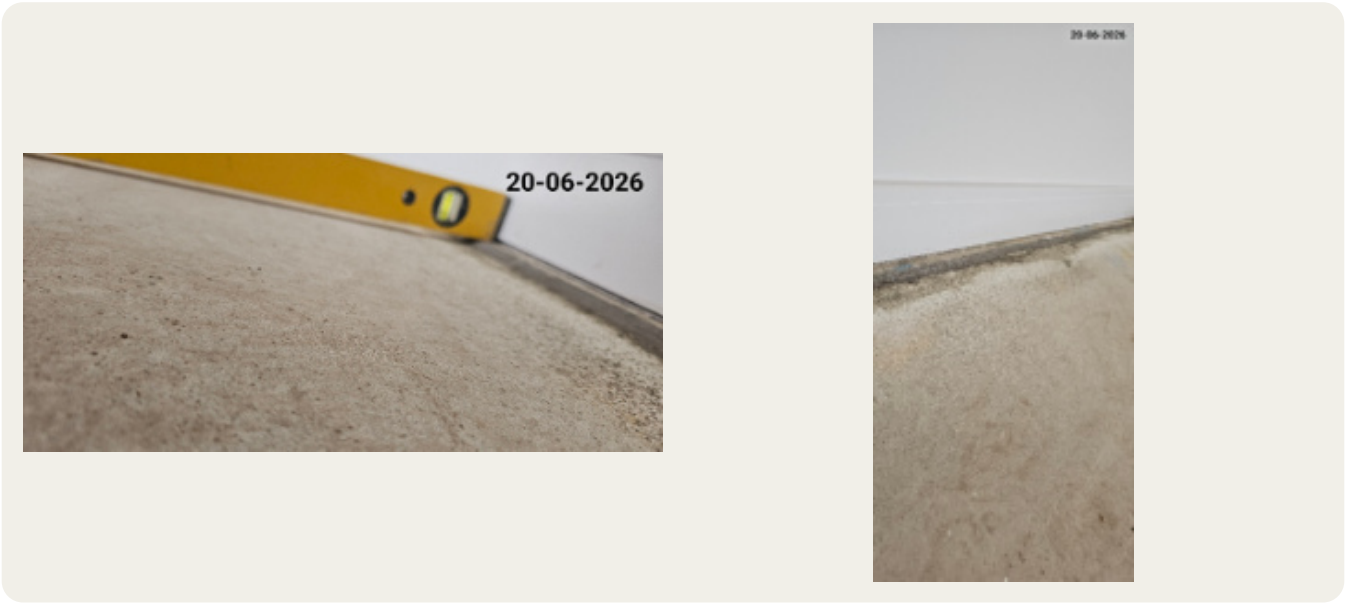
Defect 18

Issue 18: Lounge - Step in floor to rear of lounge beneath skirting. Previous attempts to make good have not achieved an adequate finish.

A step is present in the rear lounge floor beneath the skirting, and previous remedial attempts have not achieved an acceptable finish.

This may affect the suitability of floor finishes, the performance of the completed floor and the homeowner acceptance of the property. Where cracking or significant level change is present, the developer should confirm the cause and appropriate remedial action.

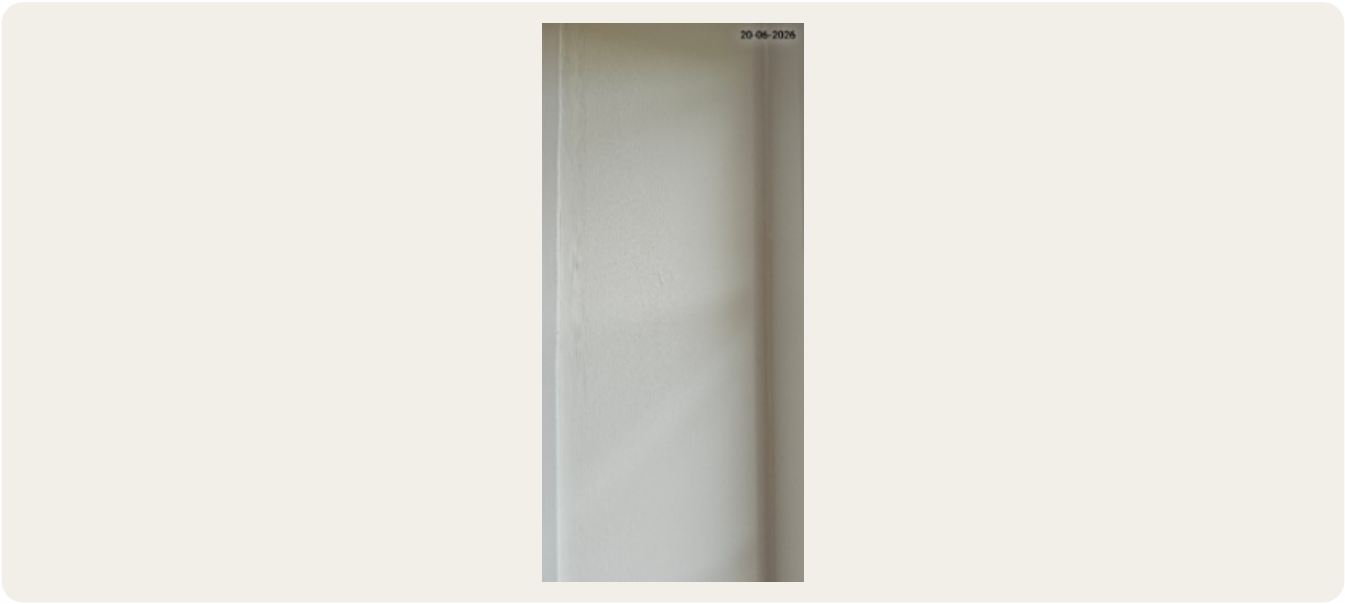
# Defect 19

The finish to the window reveal is poor.

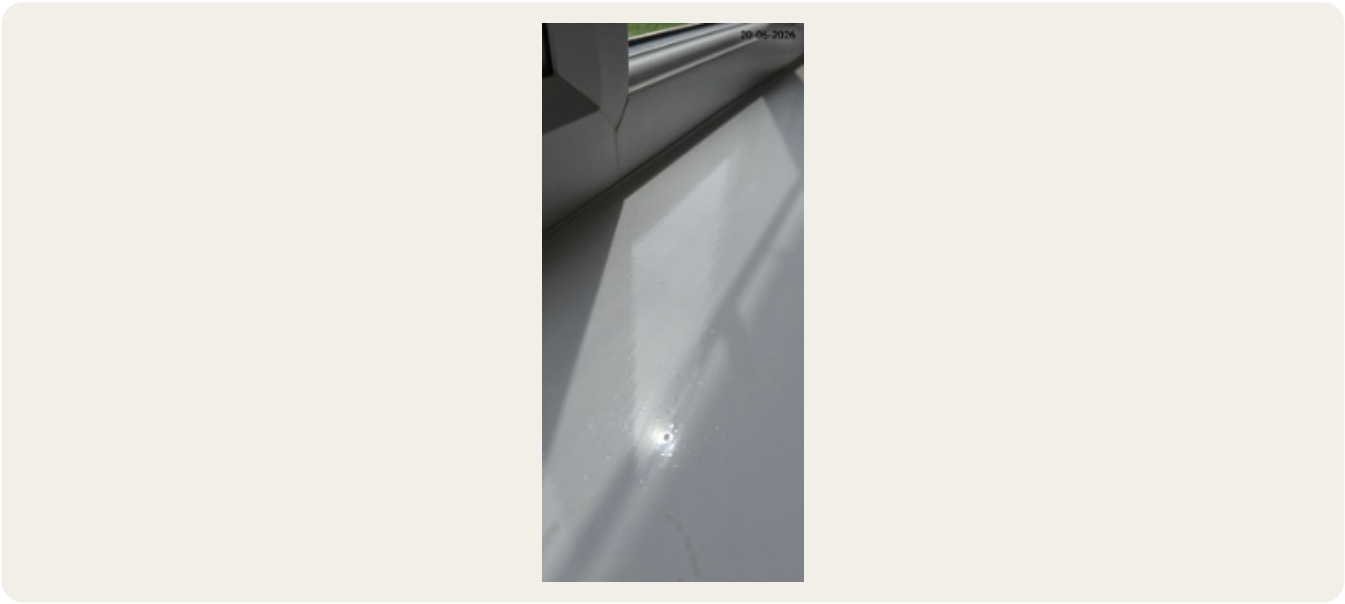
# Defect 20

The window sill paint finish is pitted and requires attention.

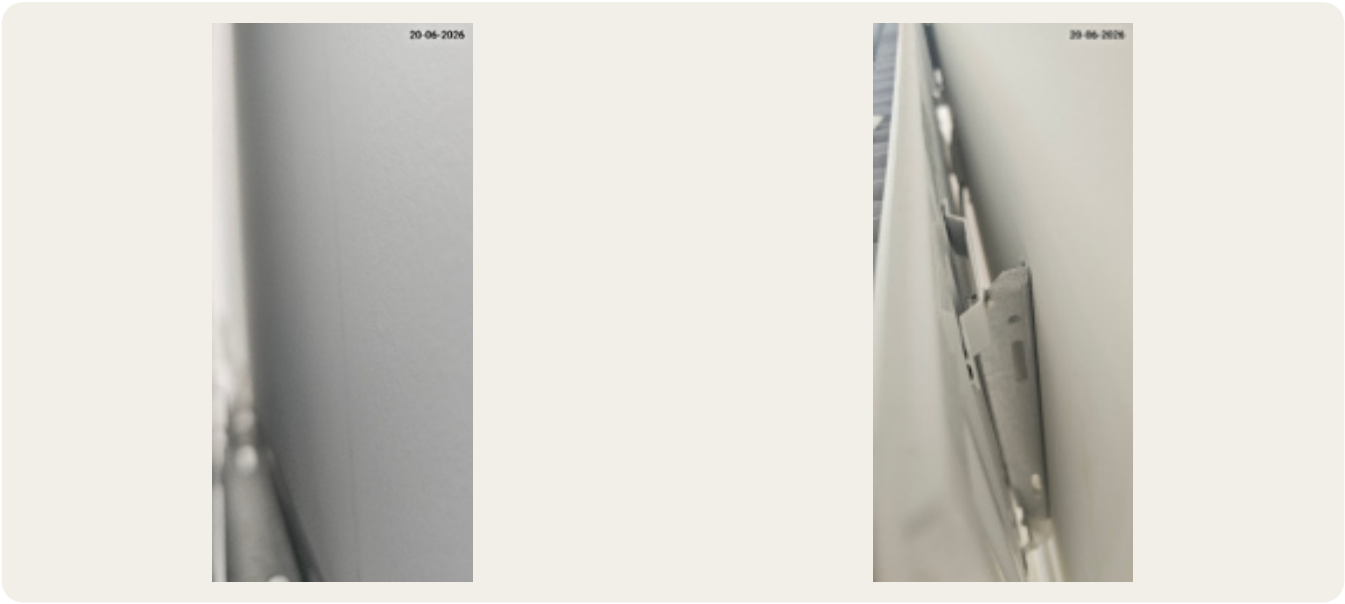
Defect 21

OBSERVATION  
Decoration is incomplete behind the radiator.

RECOMMENDED ACTION  
The developer should complete decoration behind the radiator and remove any pencil marks or paint contamination.

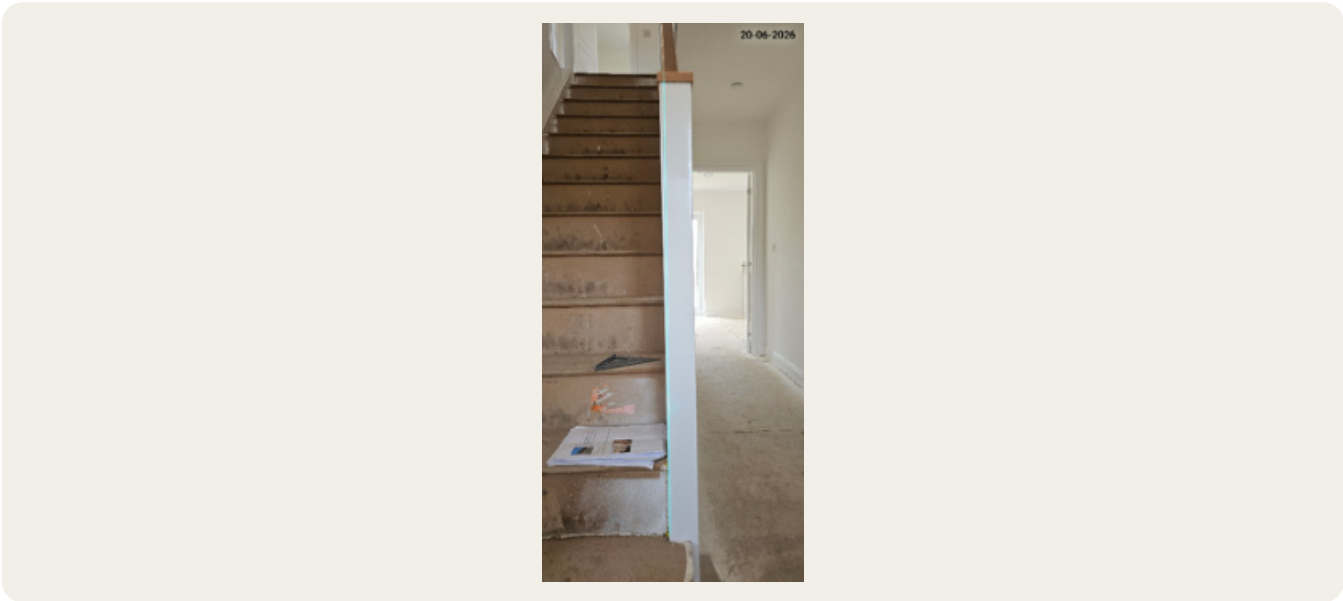
# Defect 22

The newel post at the bottom of the stairs is out of plumb.

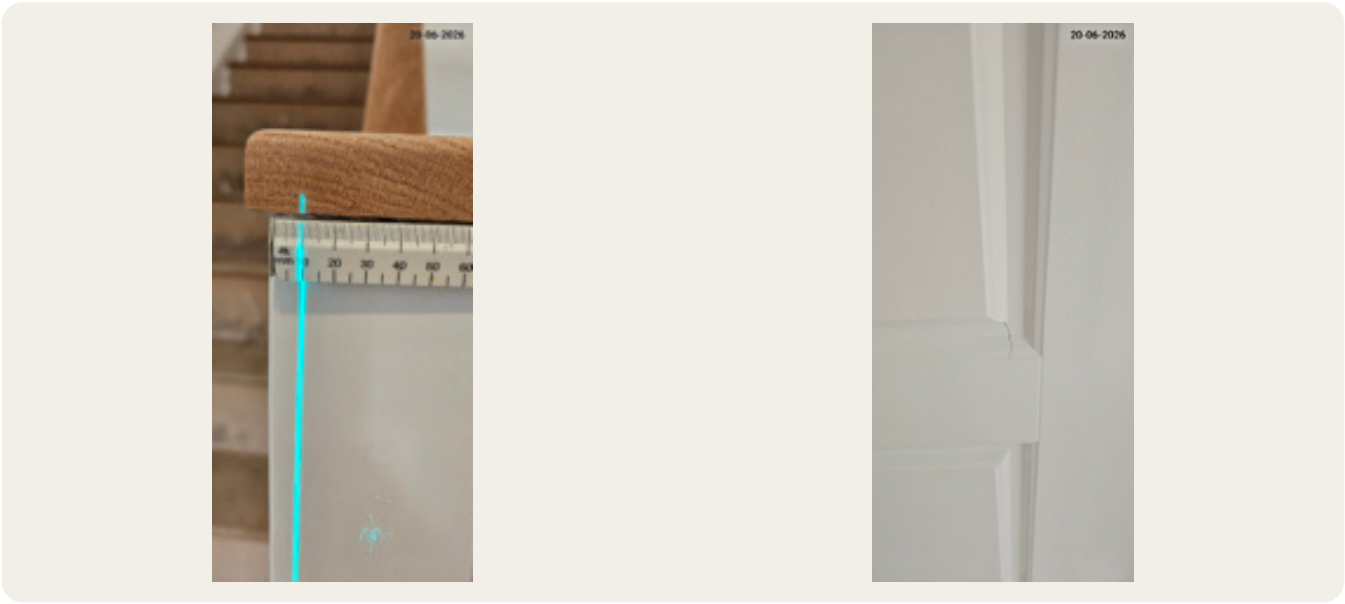
Defect 23

OBSERVATION  
Damage is present to the WC door.

RECOMMENDED ACTION  
The developer should repair the door or replace it if an acceptable finish cannot be achieved.

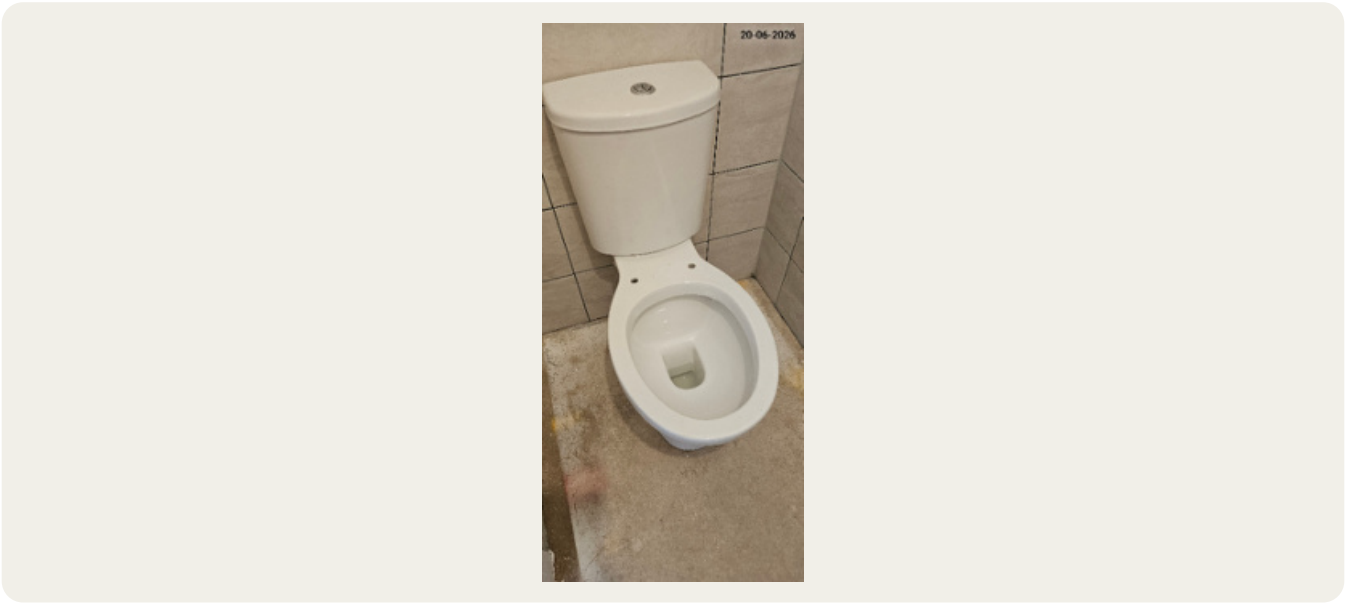
Defect 25

OBSERVATION  
The toilet seat is missing.

RECOMMENDED ACTION  
The developer should install the missing toilet seat.

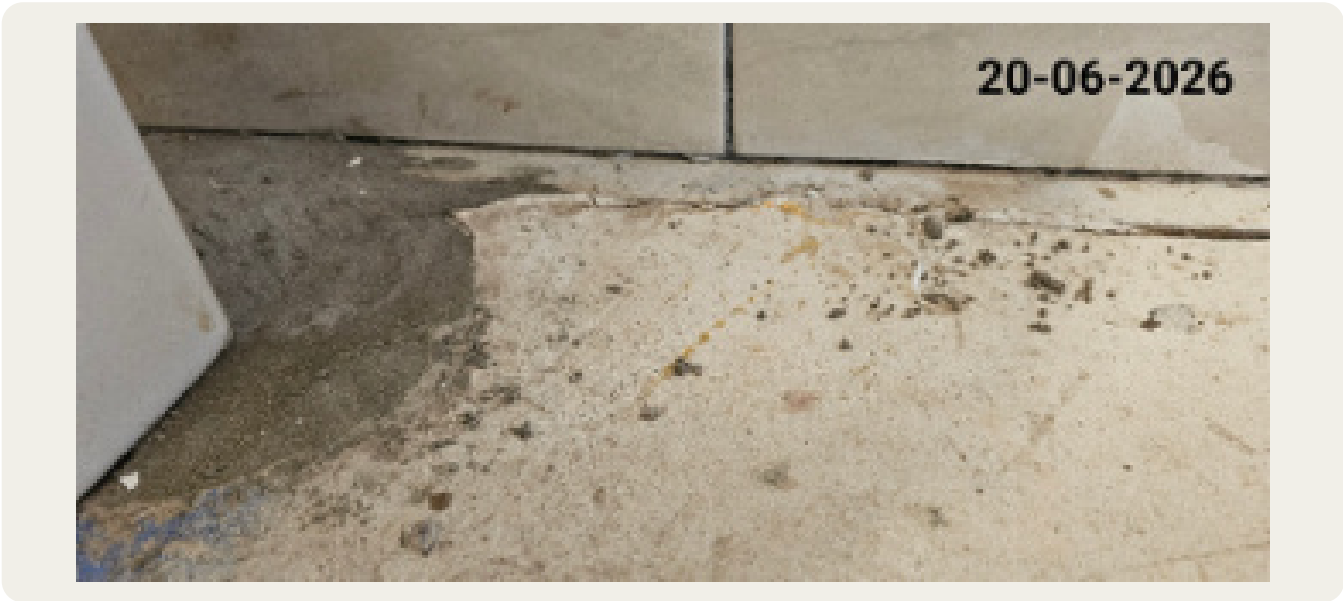
Defect 26

OBSERVATION  
A localised poor floor finish was identified behind the wash hand basin.

RECOMMENDED ACTION  
The developer should prepare, level and make good the affected floor area to achieve a suitable finish.

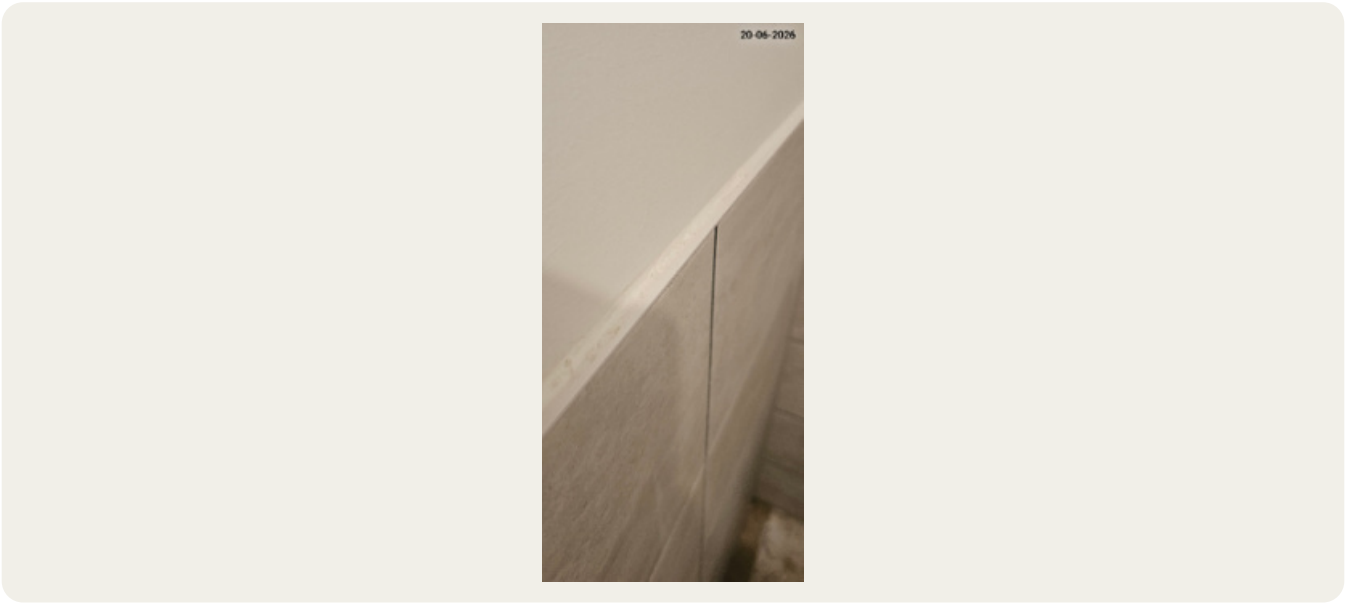
# Defect 27

Sealant above the tile edge has been left with a poor finish.

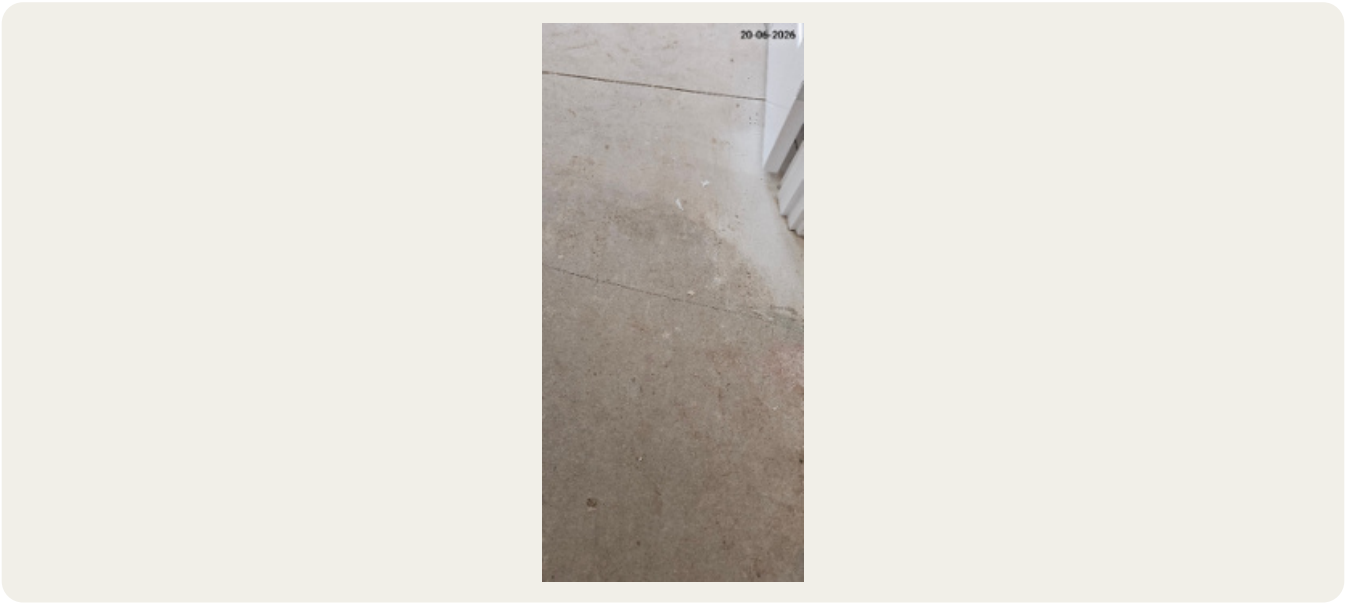
# Defect 28

Issue 28: Hallway - Cracks and floor the hallway

Cracking was identified to the hallway floor.

This may affect the suitability of floor finishes, the performance of the completed floor and the homeowner acceptance of the property. Where cracking or significant level change is present, the developer should confirm the cause and appropriate remedial action.

The developer should review the cracking, complete suitable remedial works and provide written confirmation where technical review is required.

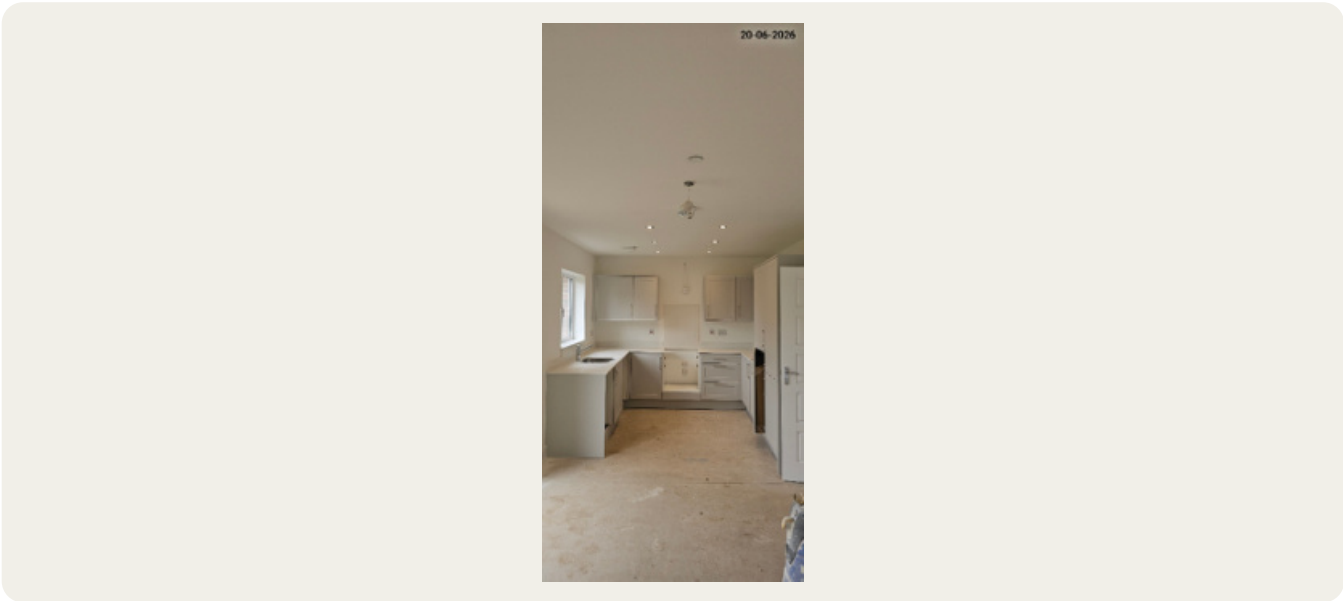
Defect 29

The kitchen was being replaced at the time of inspection and could not be fully inspected.

The developer should complete the kitchen replacement and allow the finished installation to be inspected before handover.

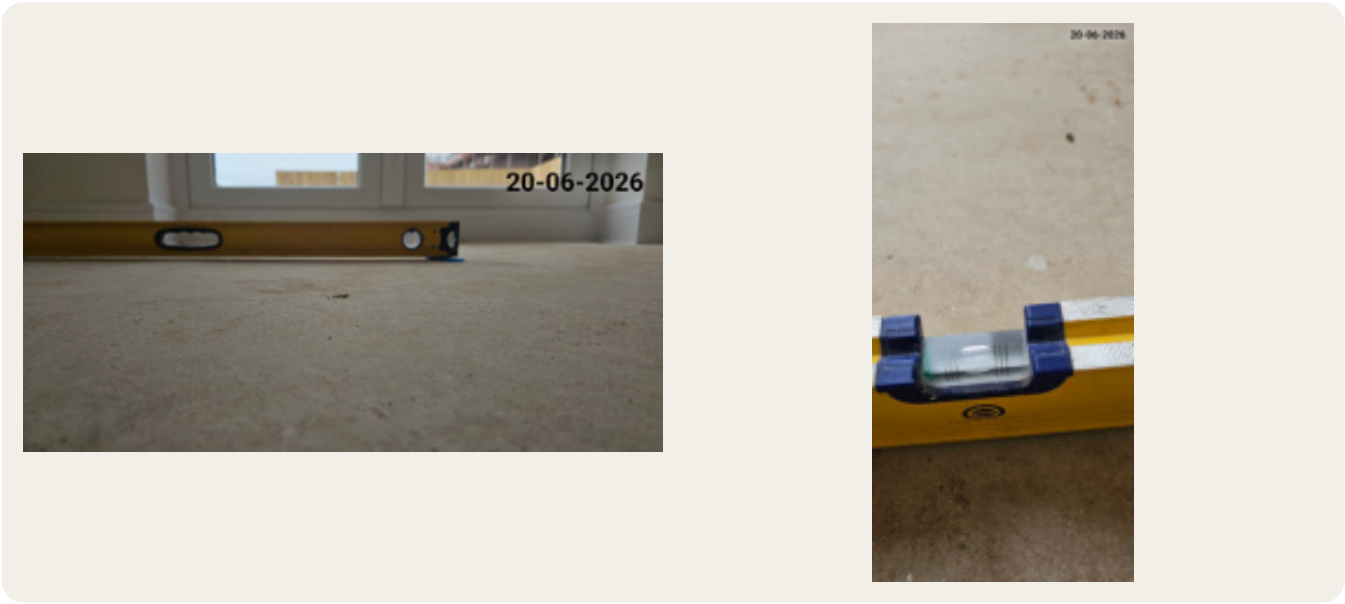
Defect 30

Issue 30: Kitchen - Floor out of level left hand side and right hand side of induced movement joint

The kitchen floor is out of level on both sides of the induced movement joint.

This may affect the suitability of floor finishes, the performance of the completed floor and the homeowner acceptance of the property. Where cracking or significant level change is present, the developer should confirm the cause and appropriate remedial action.

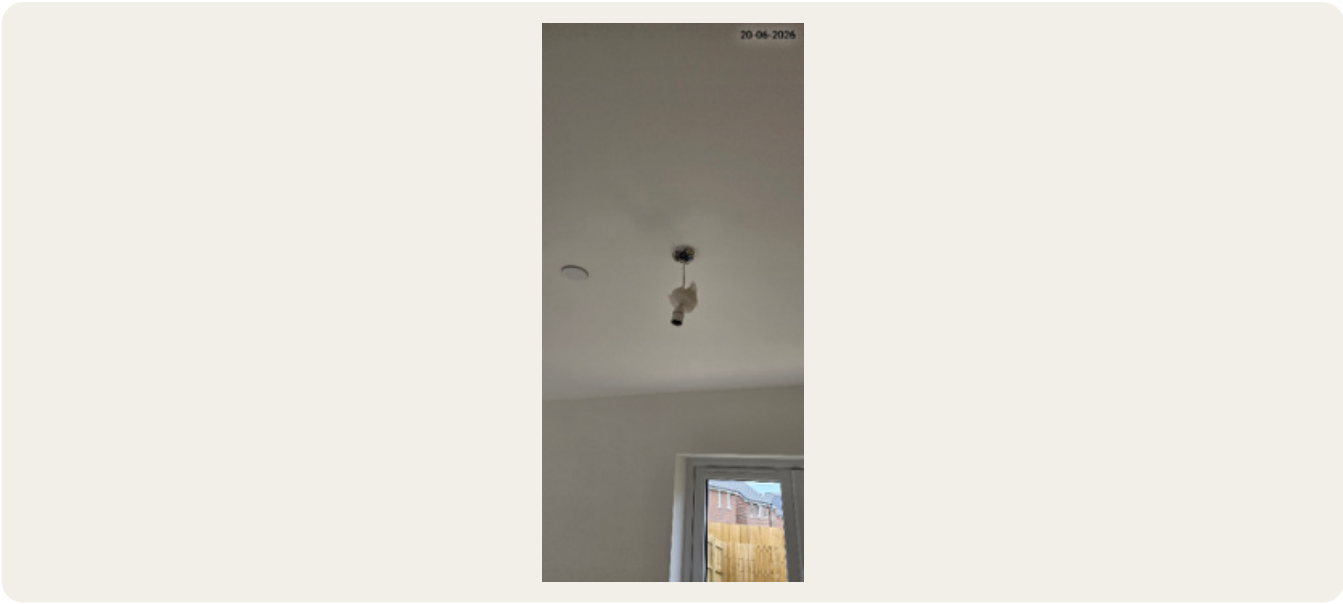
Defect 31

OBSERVATION  
An electrical accessory or fitting issue was identified: Bulbs missing and ceiling roses not fitted.

RECOMMENDED ACTION  
The developer should install bulbs and fit the ceiling roses.
