# Professional Snagging Inspection Report

Pre-completion inspection

**Sample Development - Plot XX**

Development: Sample Development | Plot XX | Developer: Anonymised | Total defects: 95

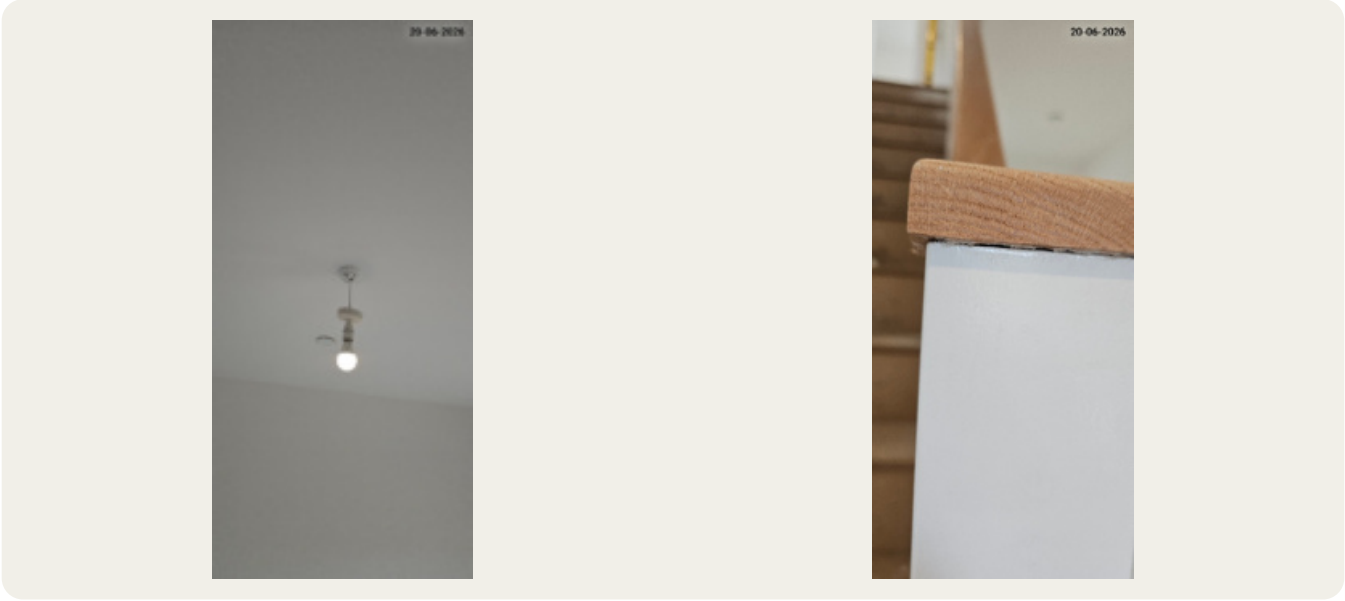
# Defect 32

A poor finish was identified beneath the newel post cap at the bottom of the stairs.

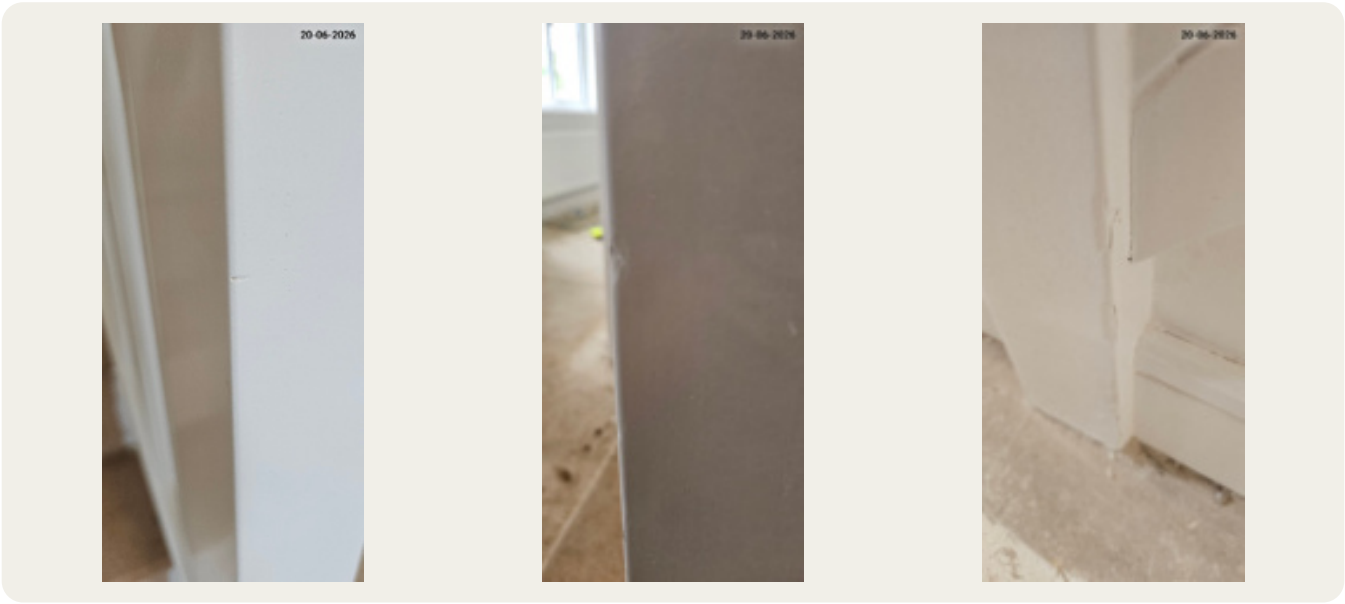
# Defect 34

**OBSERVATION**  
Numerous chips are present to the newel post at the bottom of the stairs.

**RECOMMENDED ACTION**  
The developer should fill, make good and redecorate the chipped areas.

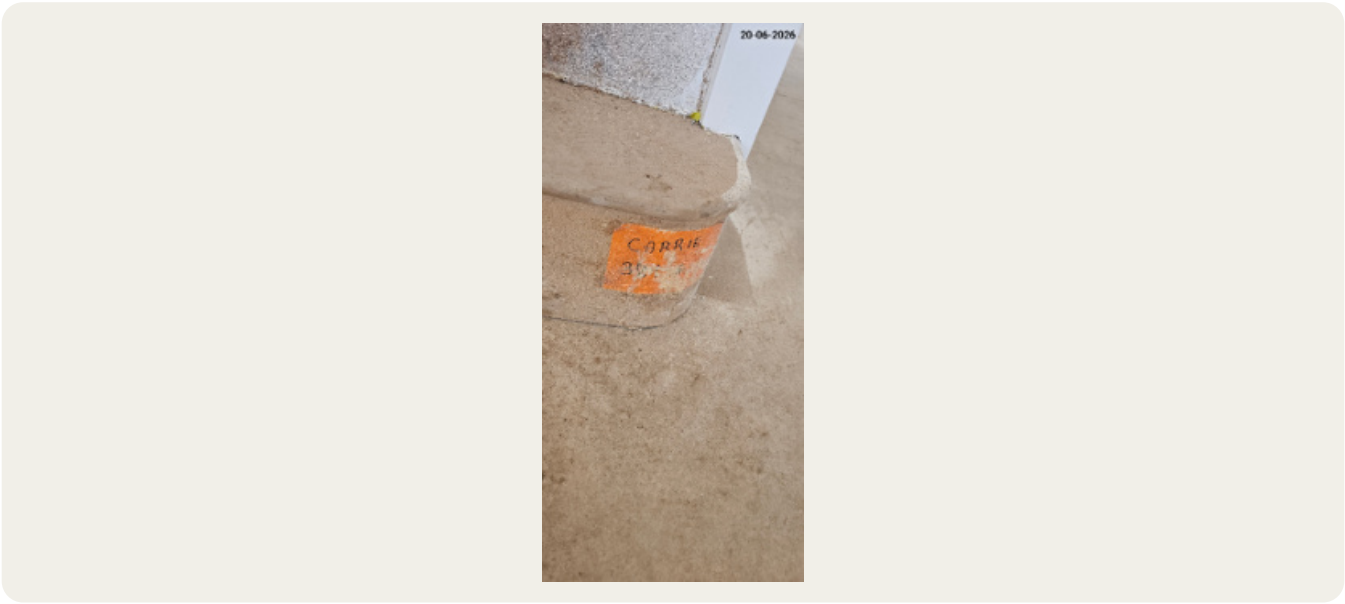
# Defect 35

**OBSERVATION**  
Excess glue is present to the bullnose detail.

**RECOMMENDED ACTION**  
The developer should remove excess glue without damaging the adjacent finish.

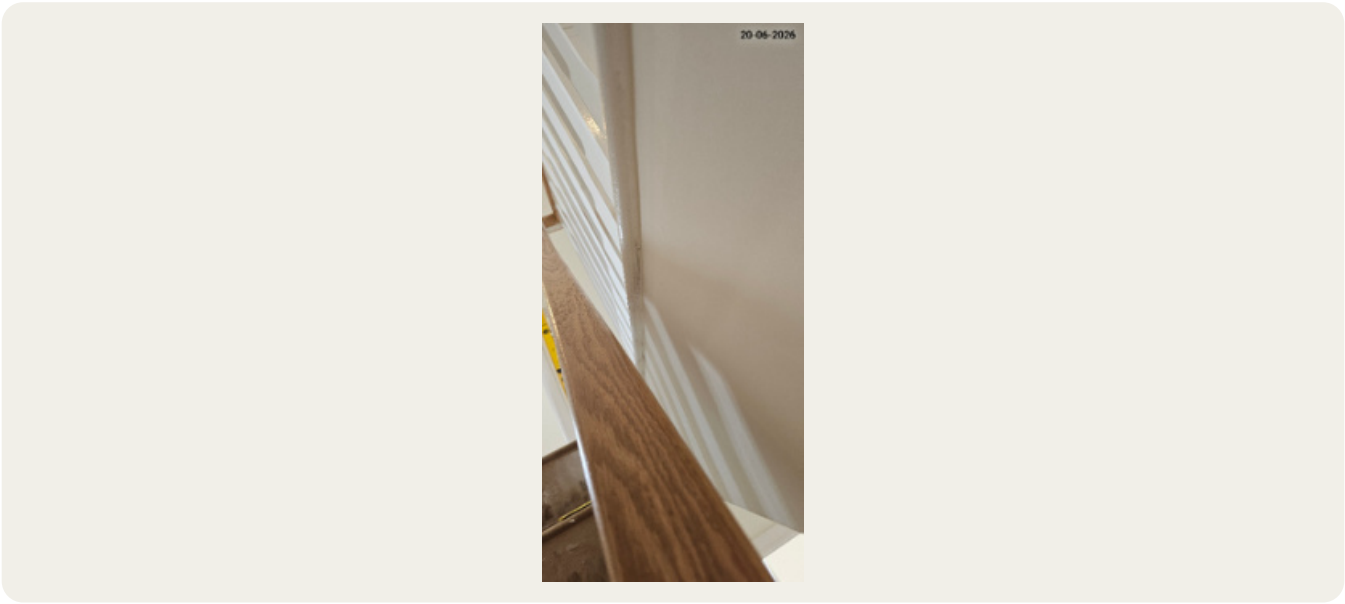
Defect 36

The finish to the stair nosing is poor.

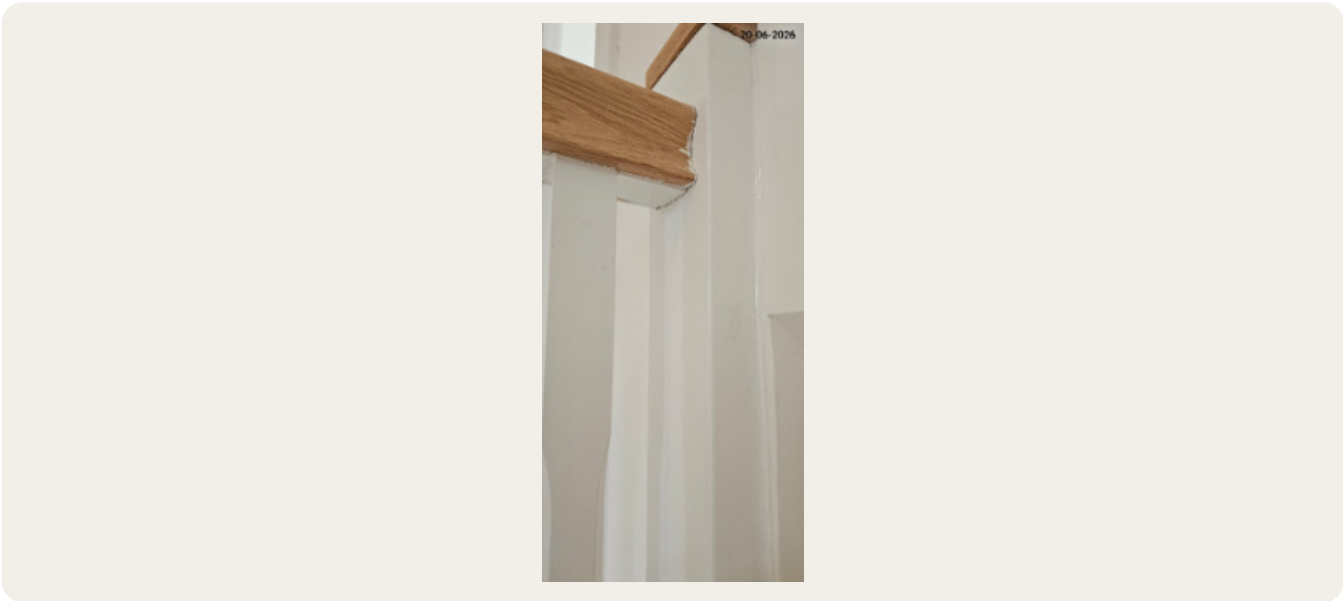
# Defect 37

The finish at the handrail to newel post joint is poor.

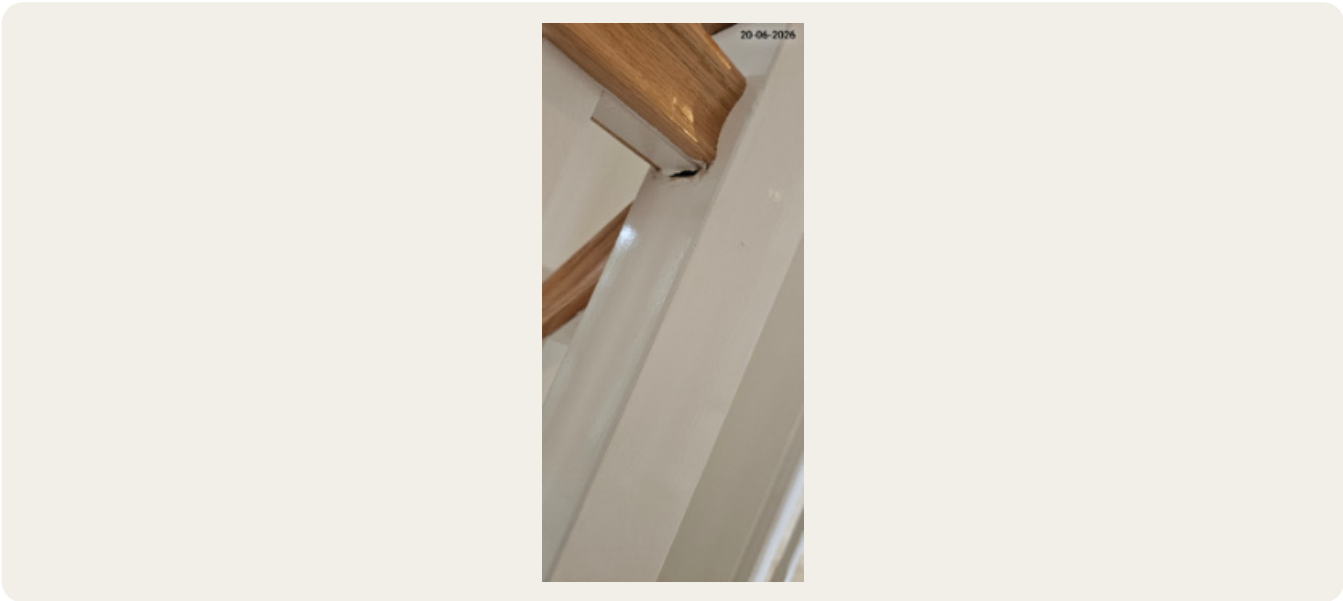
Defect 38

The finish at the handrail to newel post joint is poor.

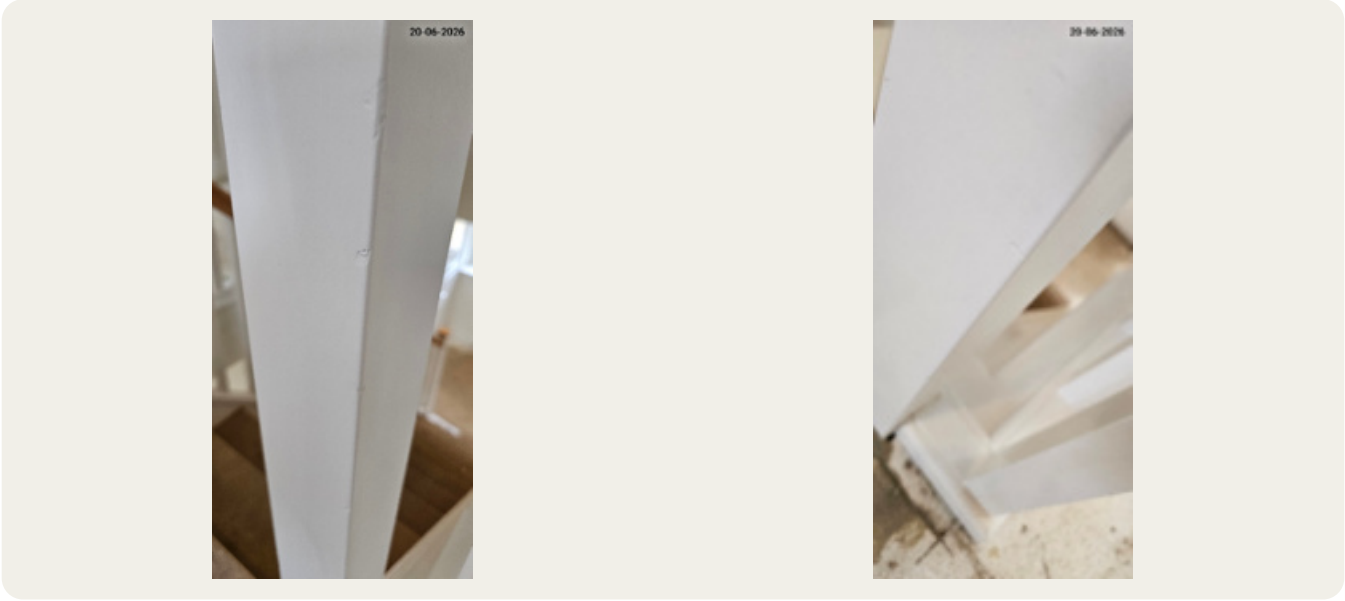
Defect 39

OBSERVATION  
Damage is present to the newel post at the top of the stairs in several locations.

RECOMMENDED ACTION  
The developer should fill, make good and redecorate the damaged areas.

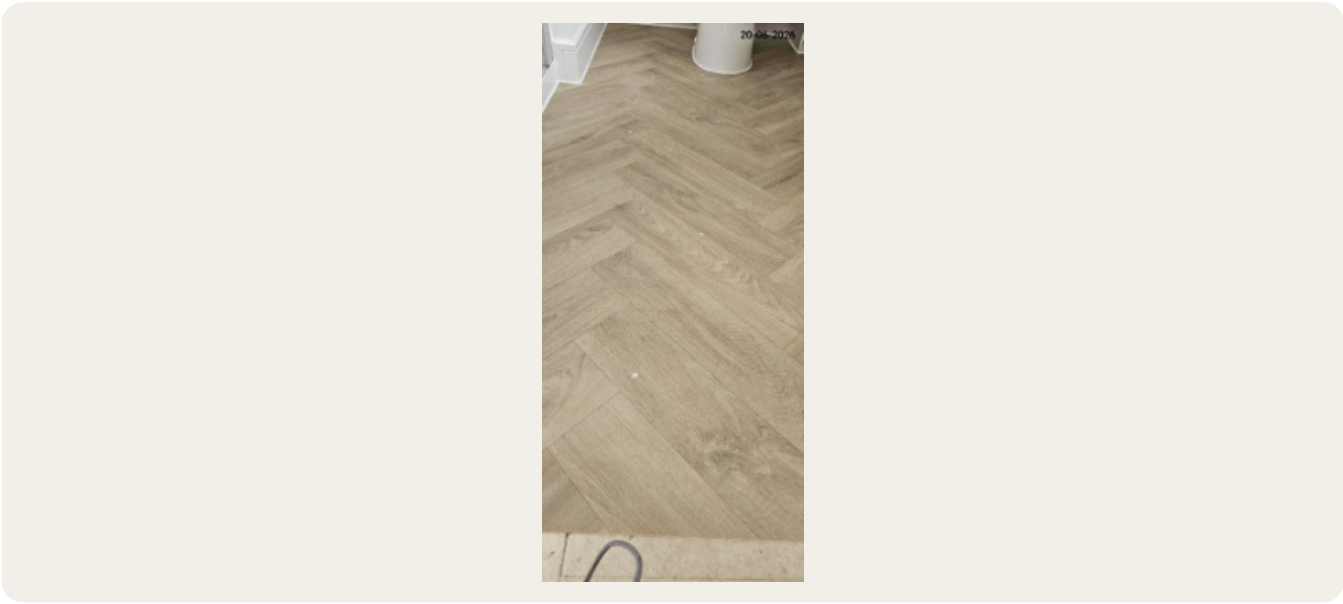
# Defect 40

Paint contamination is present on the vinyl flooring.

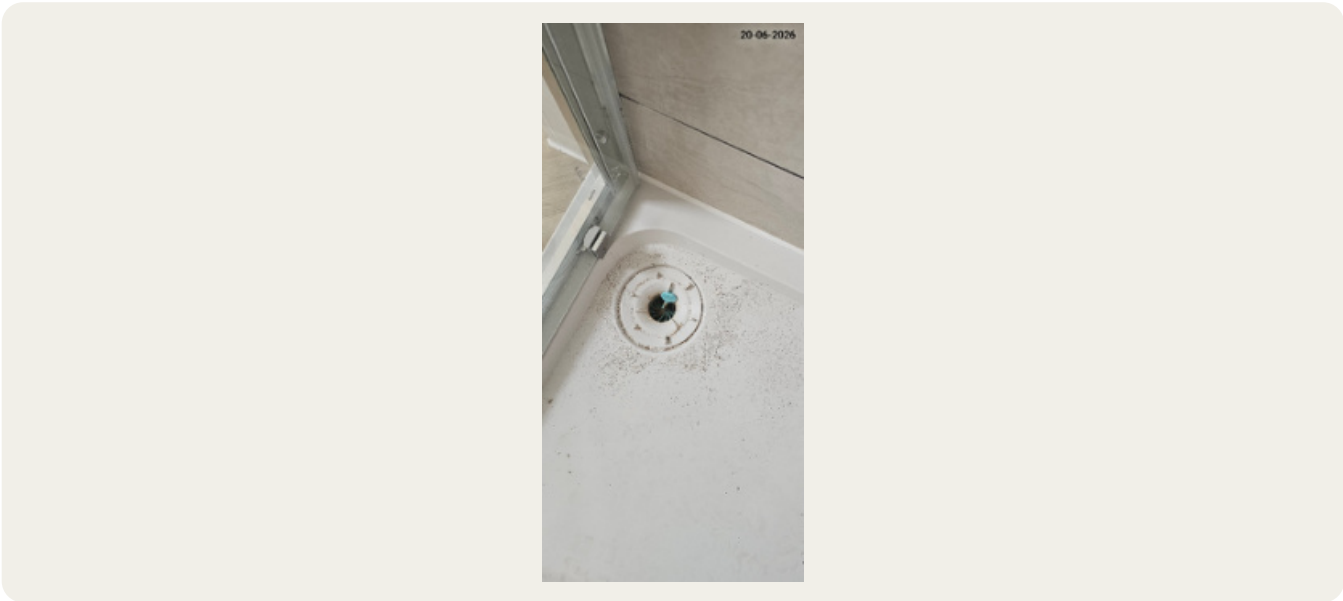
Defect 41

The shower waste cup or cap is missing.

The developer should install the missing shower waste cup or cap.

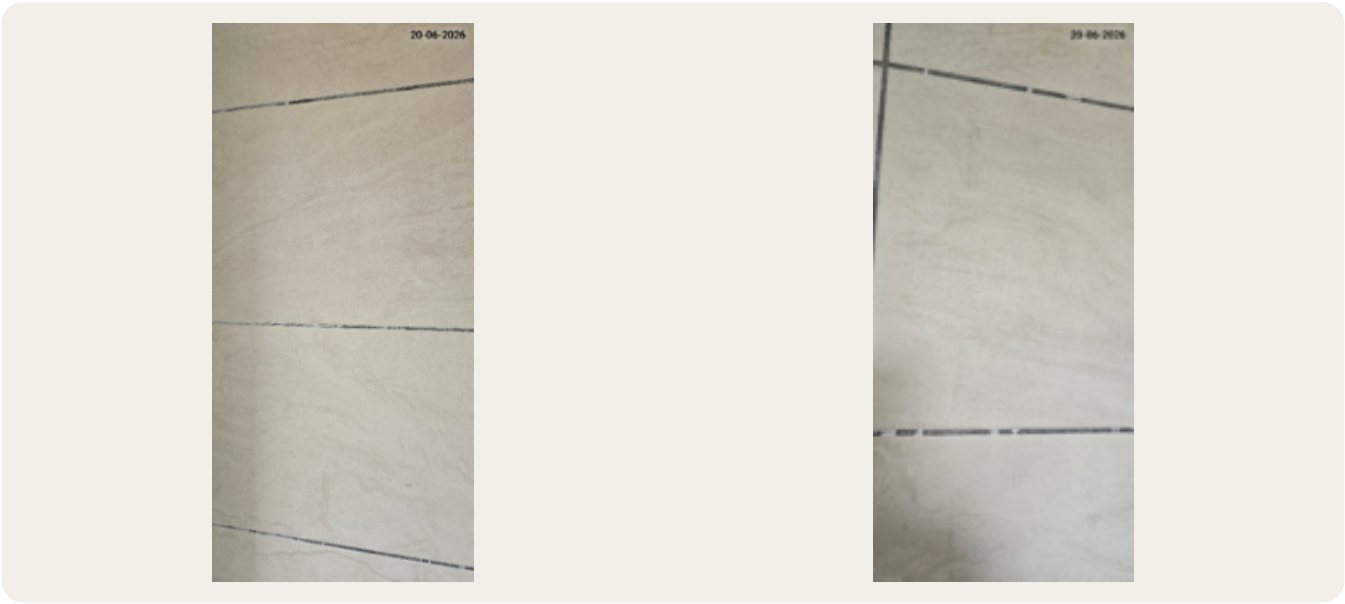
Defect 42

Grout discolouration is present in various areas within the shower.

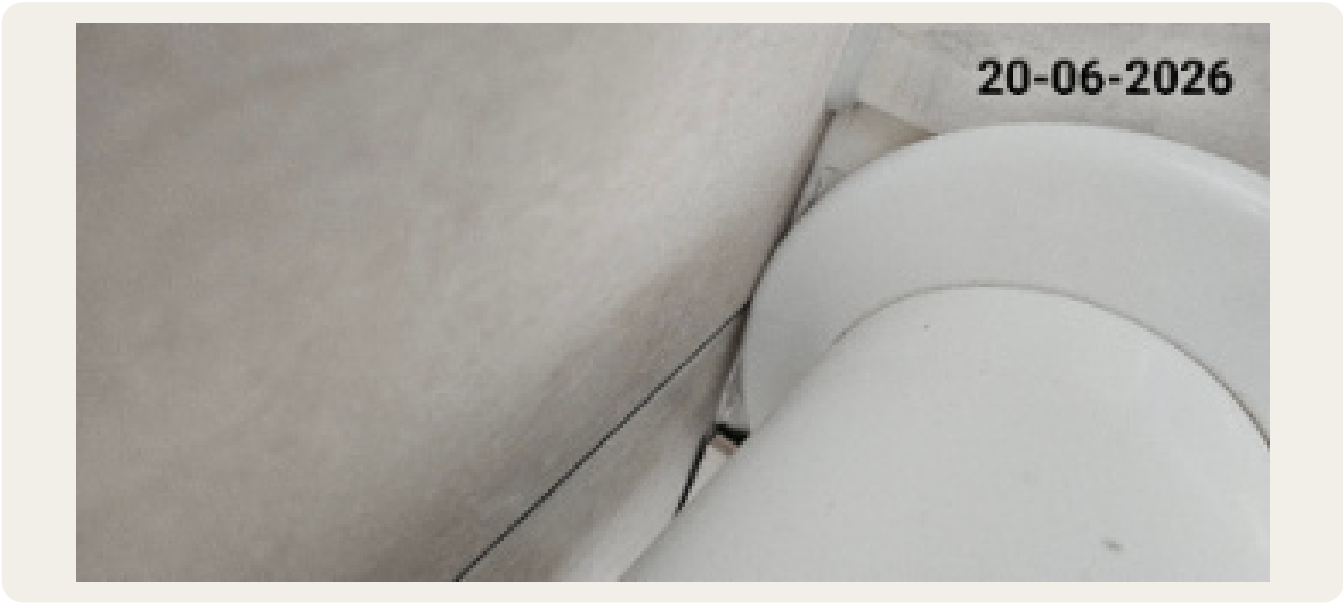
Defect 45

The finish around the toilet waste where it passes through the boxing is poor.

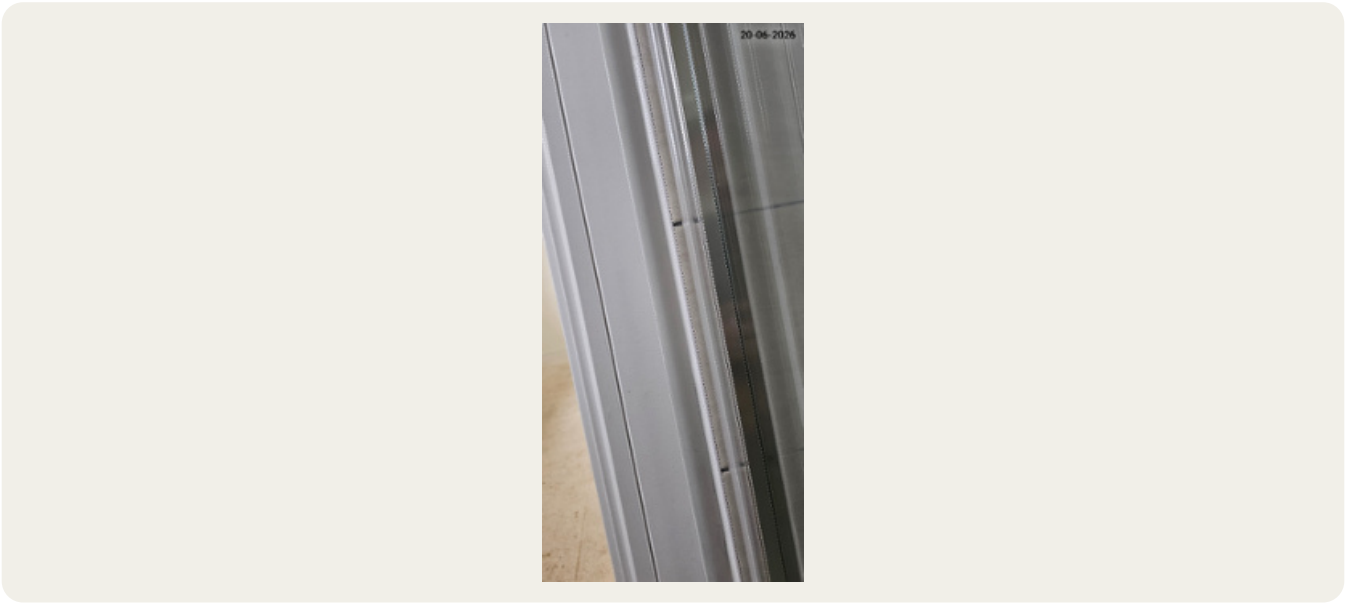
# Defect 46

The wall finish between the architrave and tiling bead is poor.

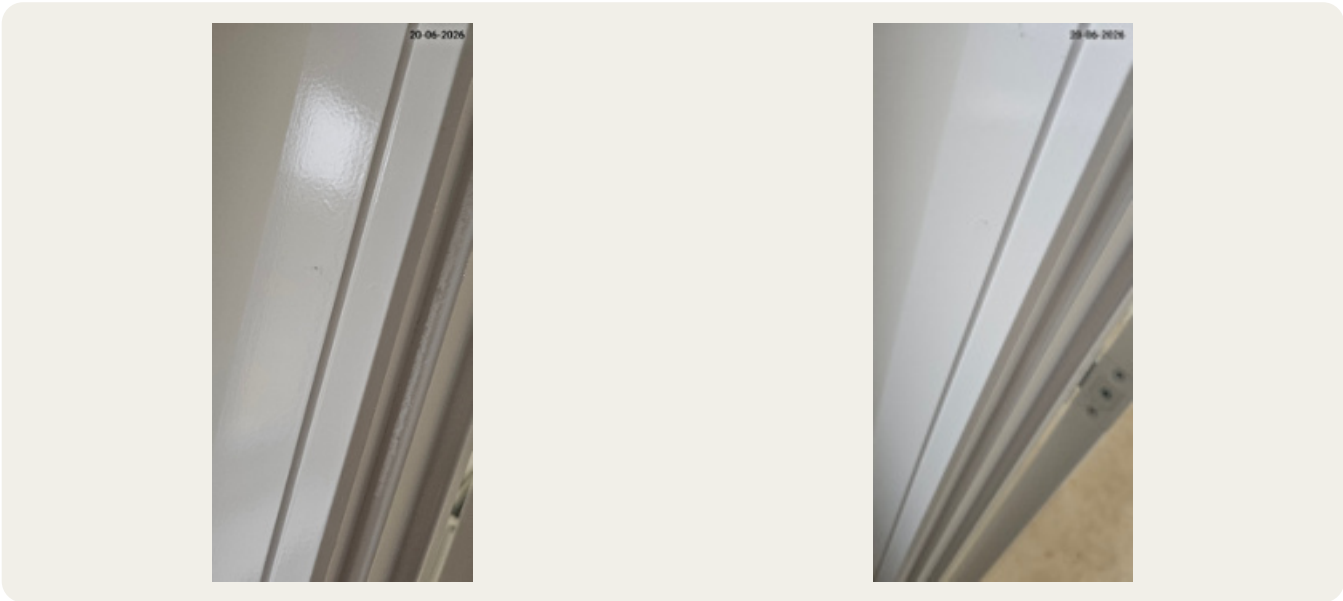
Pin holes are visible to the left-hand architrave.

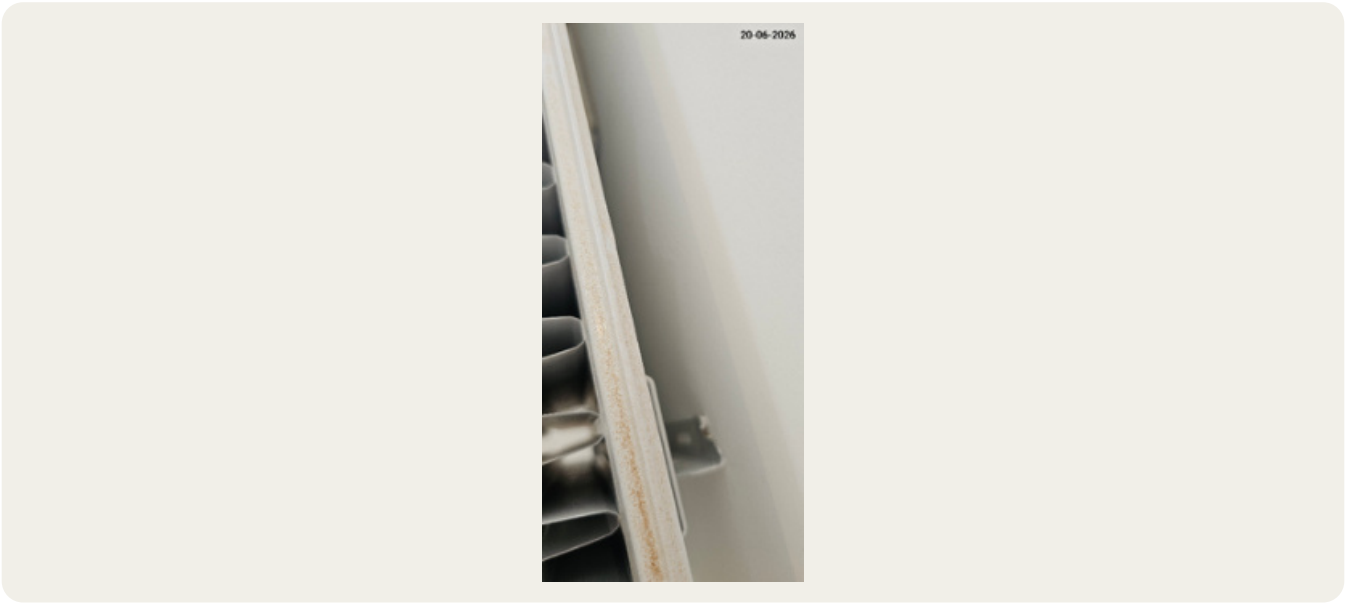
The wall behind the radiator has not been decorated.

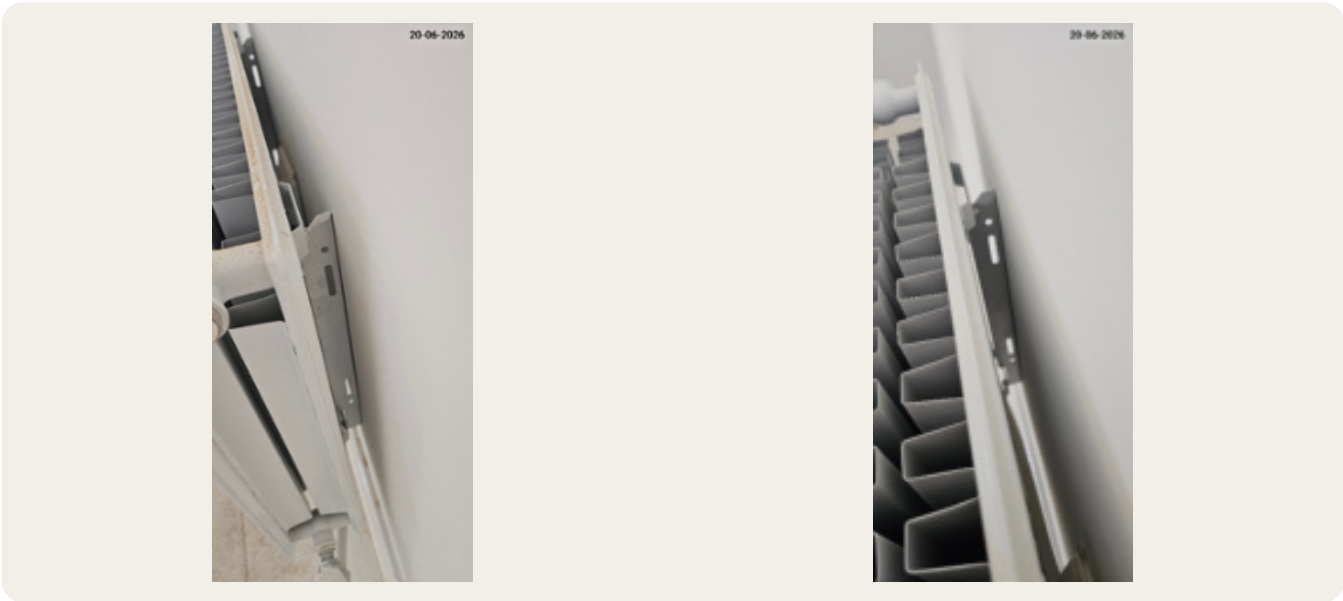
Paint contamination is present on the radiator brackets.

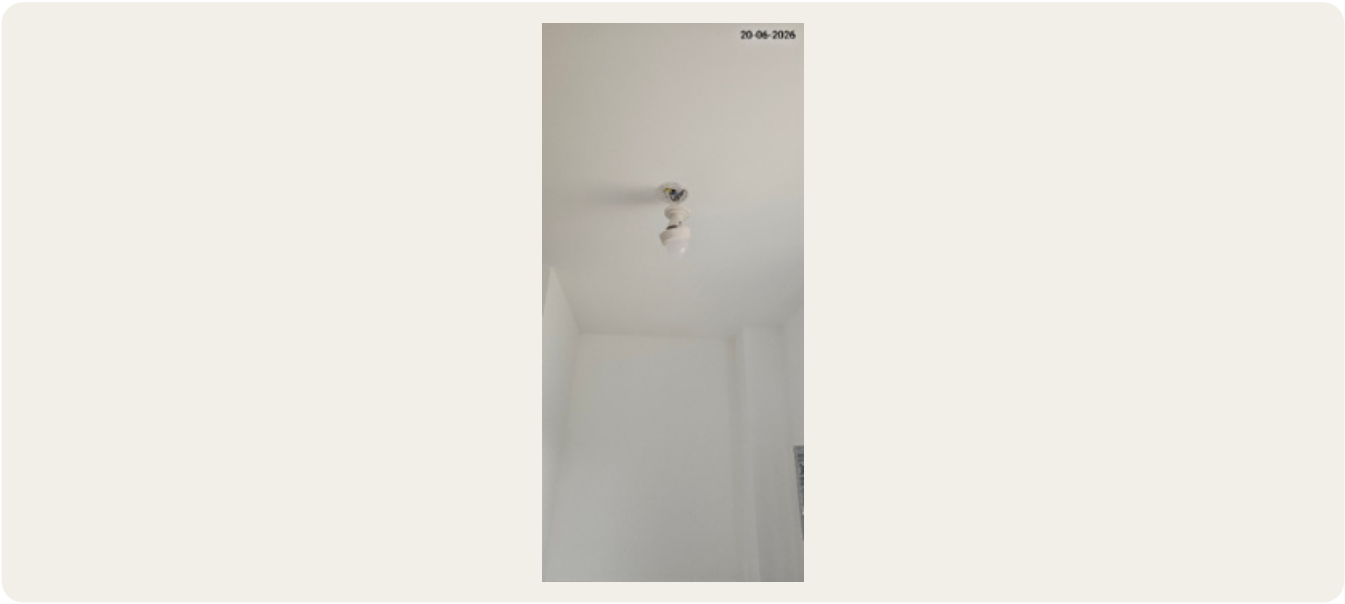
The light fitting has been incorrectly installed.

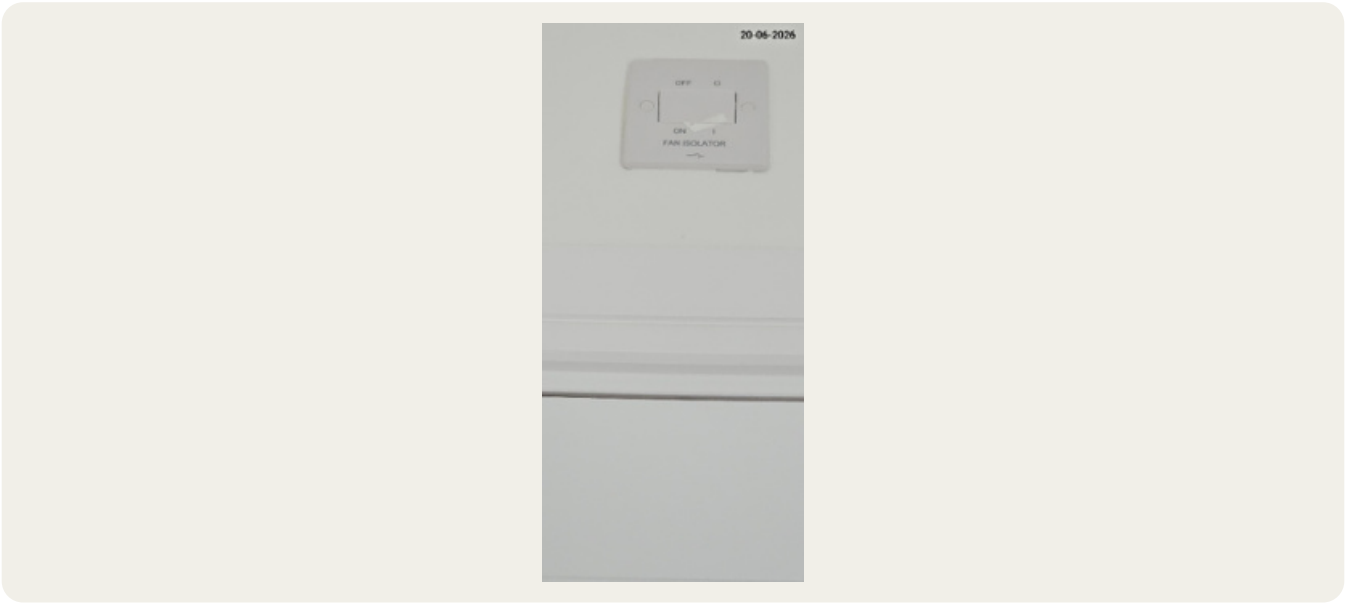
Paint contamination is present on the fan isolator switch.

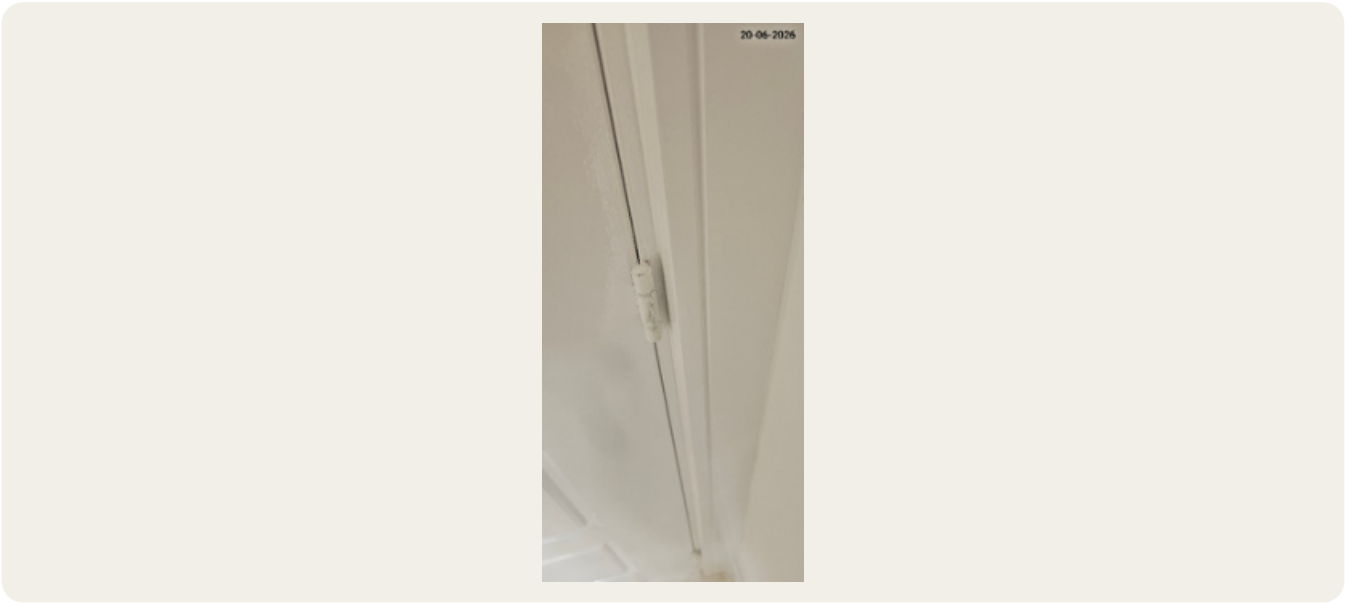
Paint contamination is present on the door hinges.

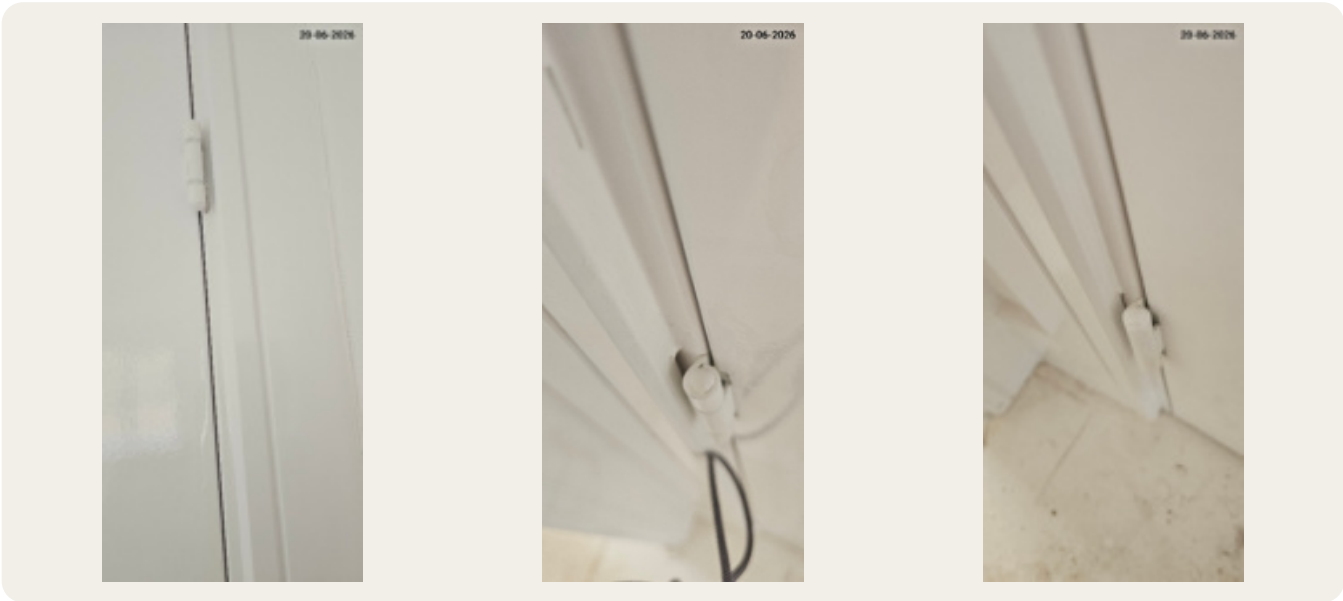
Decoration is incomplete behind the hinges, and paint contamination is present on the hinges.

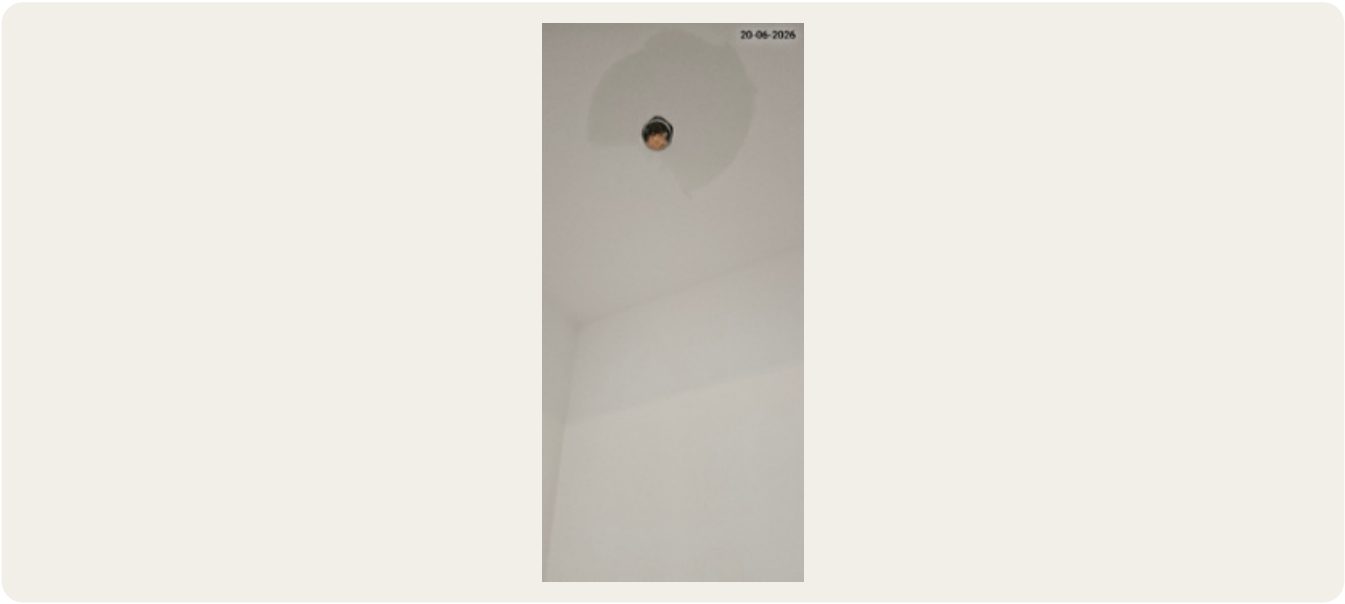
Issue 55: Landing cupboard - Sprinkler head missing and patching not decorated

The sprinkler head is missing and the surrounding patching has not been decorated.

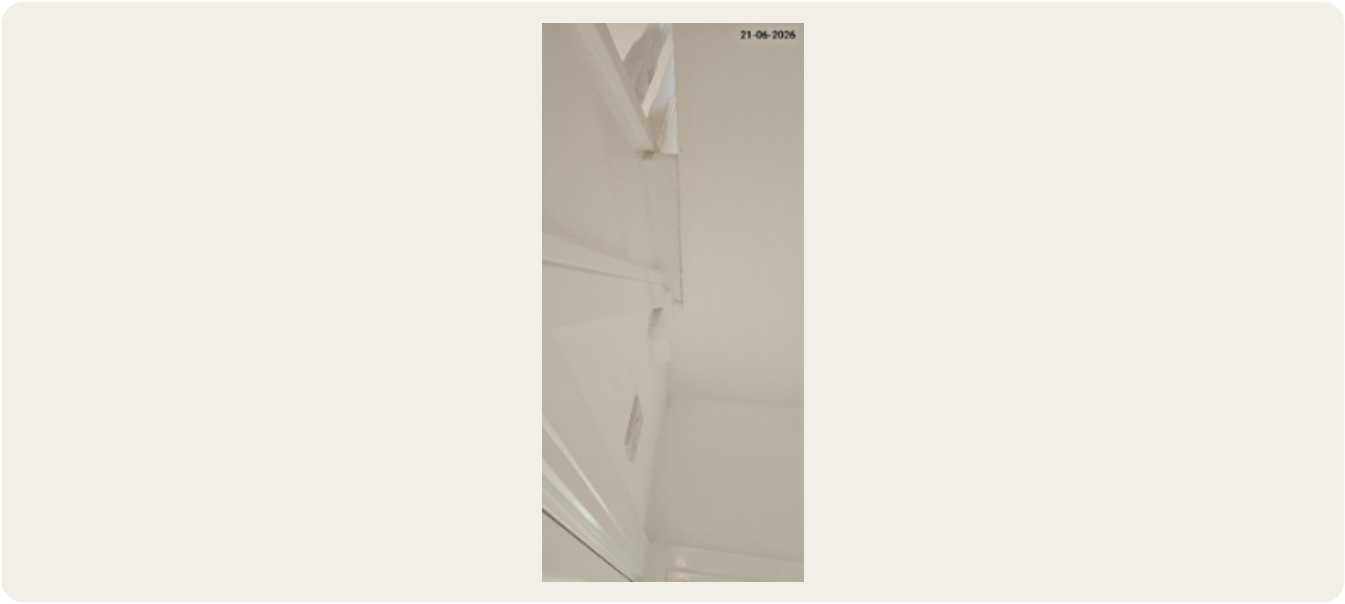
The sides of the architraves have not been decorated.

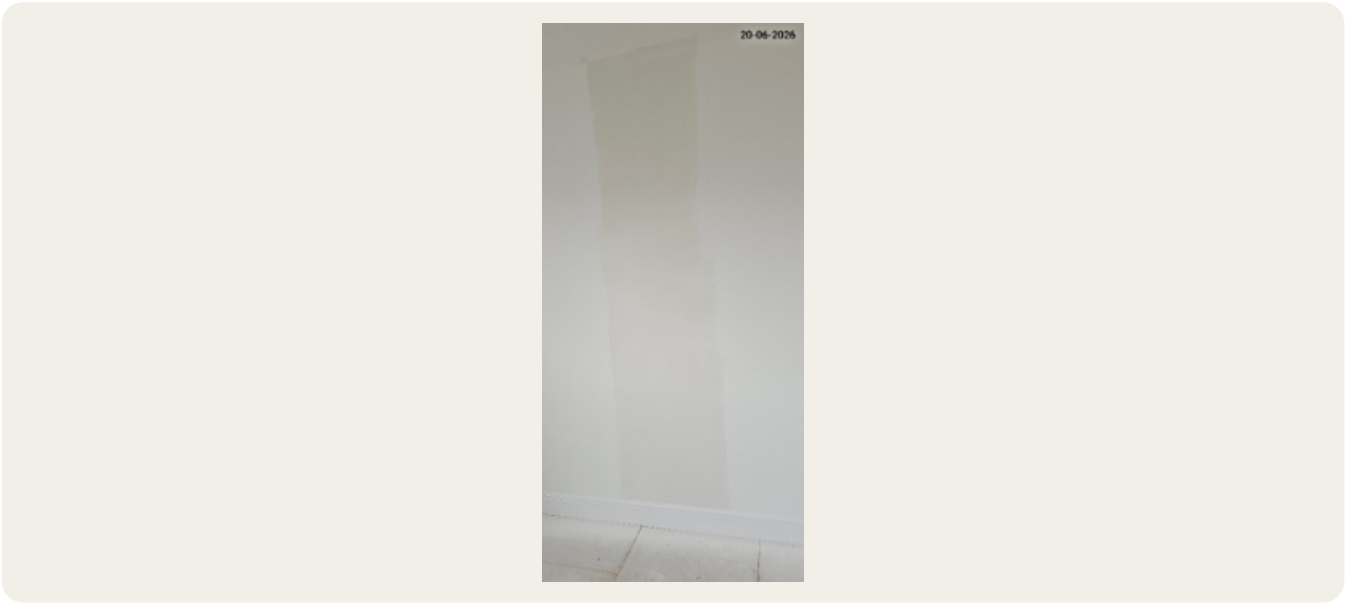
Wall patching has not been decorated.

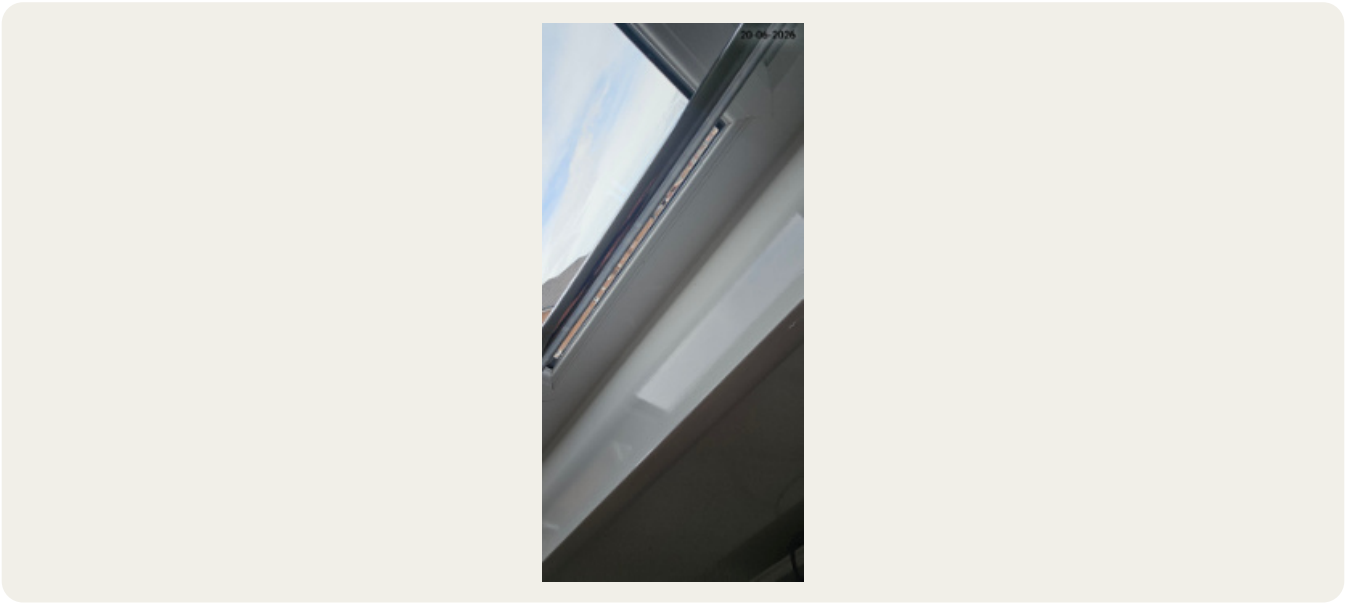
Paint contamination is present on the window frame.

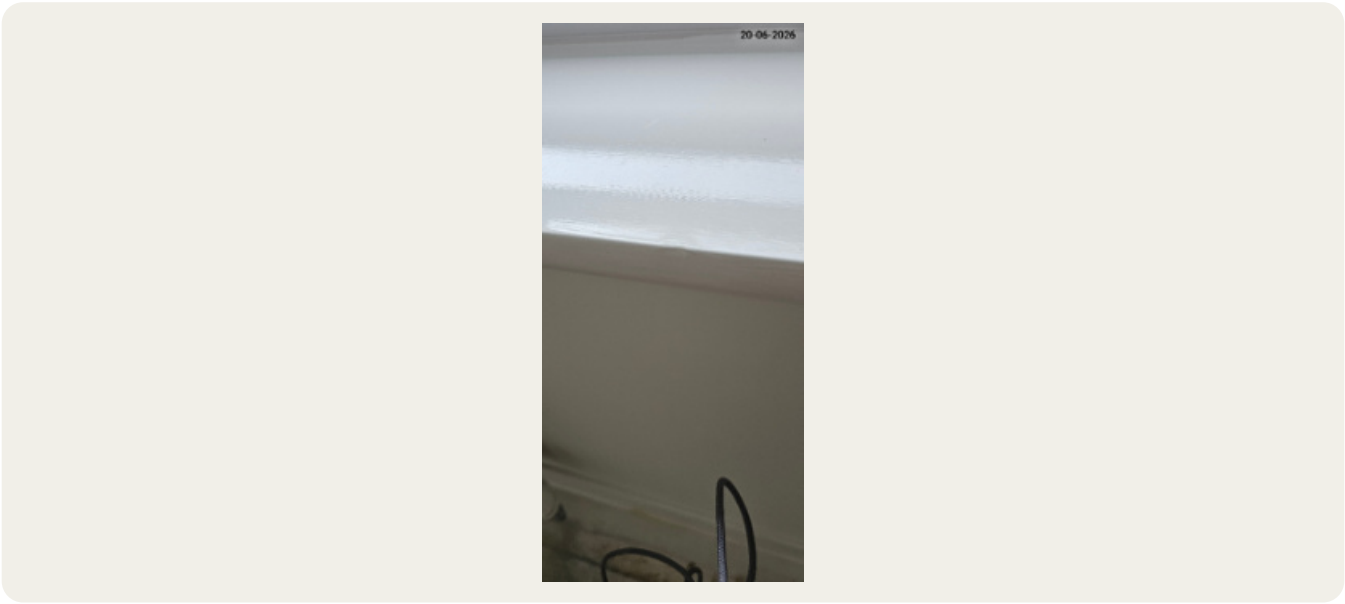
A dent is present to the window sill.

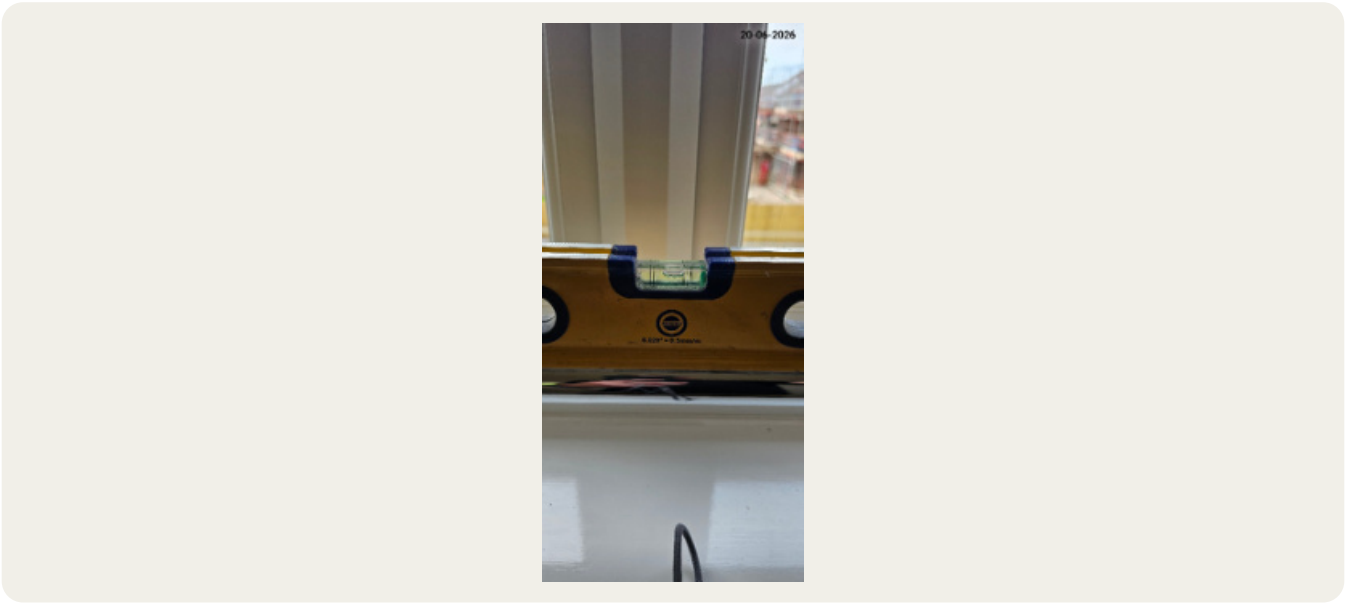
The window safety rail is not level.

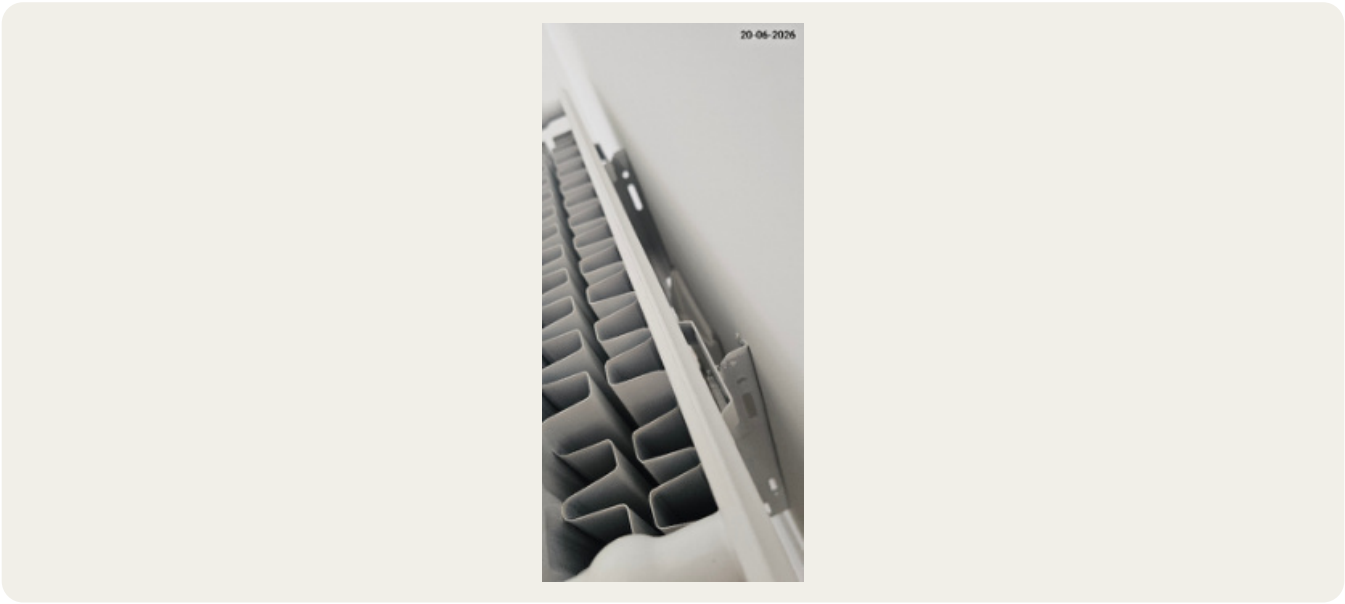
Paint contamination is present on the radiator brackets.

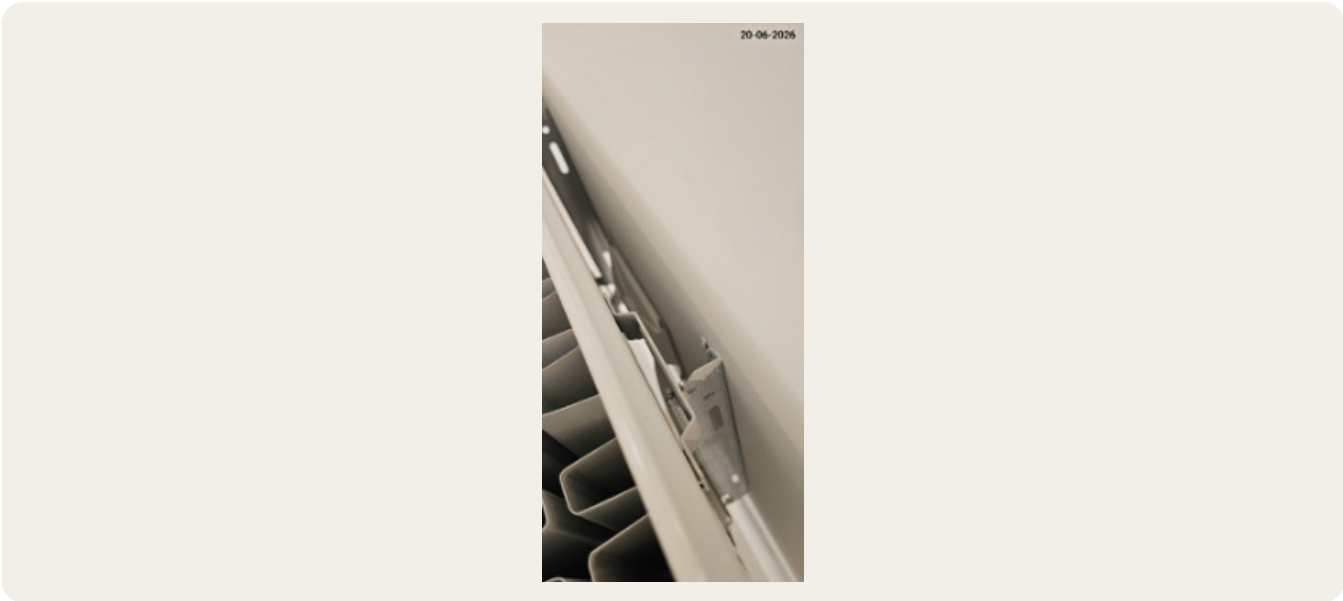
Paint contamination is present on the radiator brackets and pencil lines remain on the wall behind the radiator.

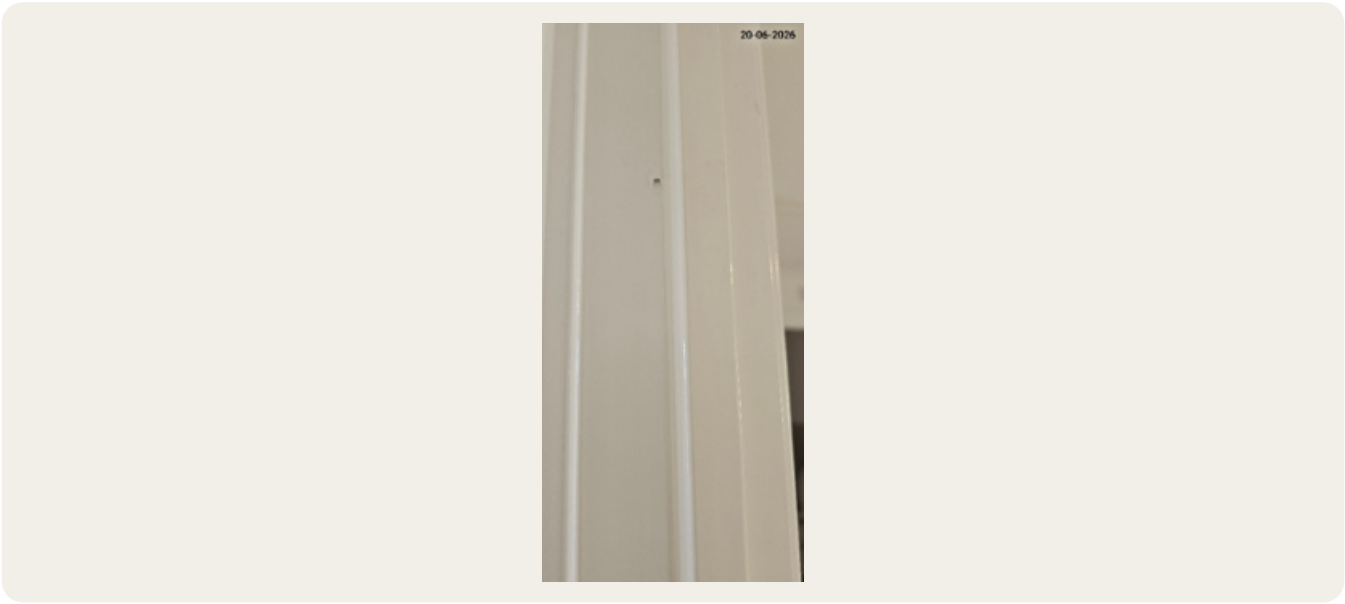
A pin head is visible in the door frame.
