# Professional Snagging Inspection Report

Pre-completion inspection

**Sample Development - Plot XX**

Development: Sample Development | Plot XX | Developer: Anonymised | Total defects: 95

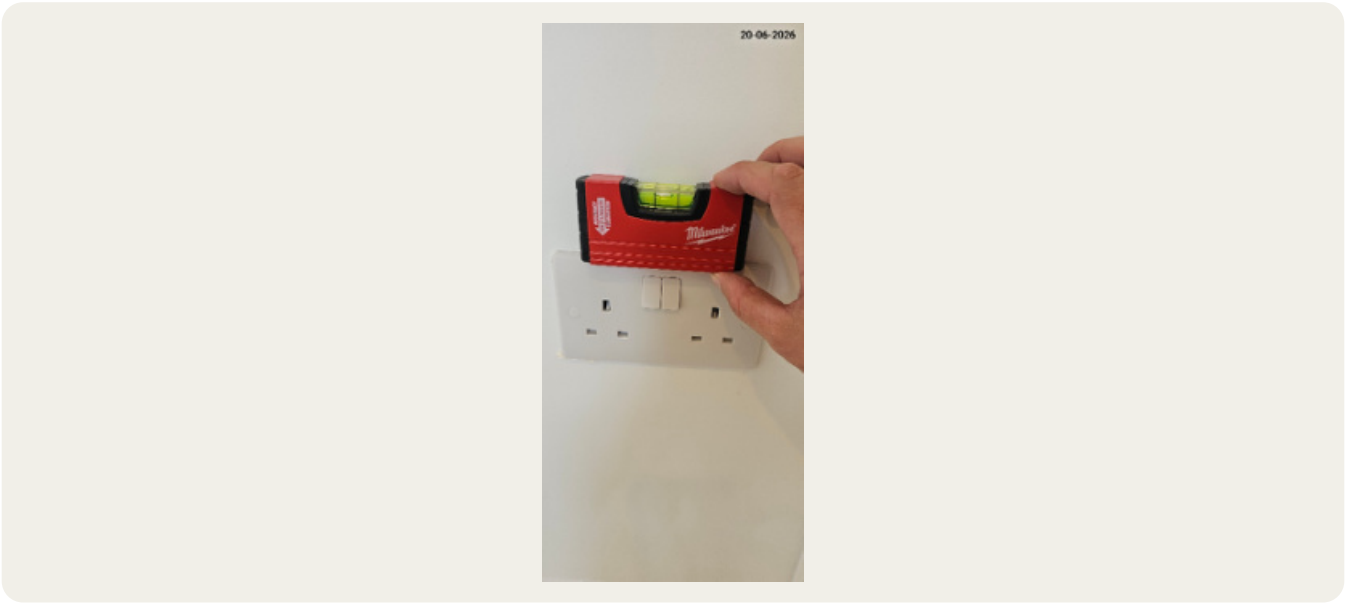
A socket faceplate next to the door is out of level.

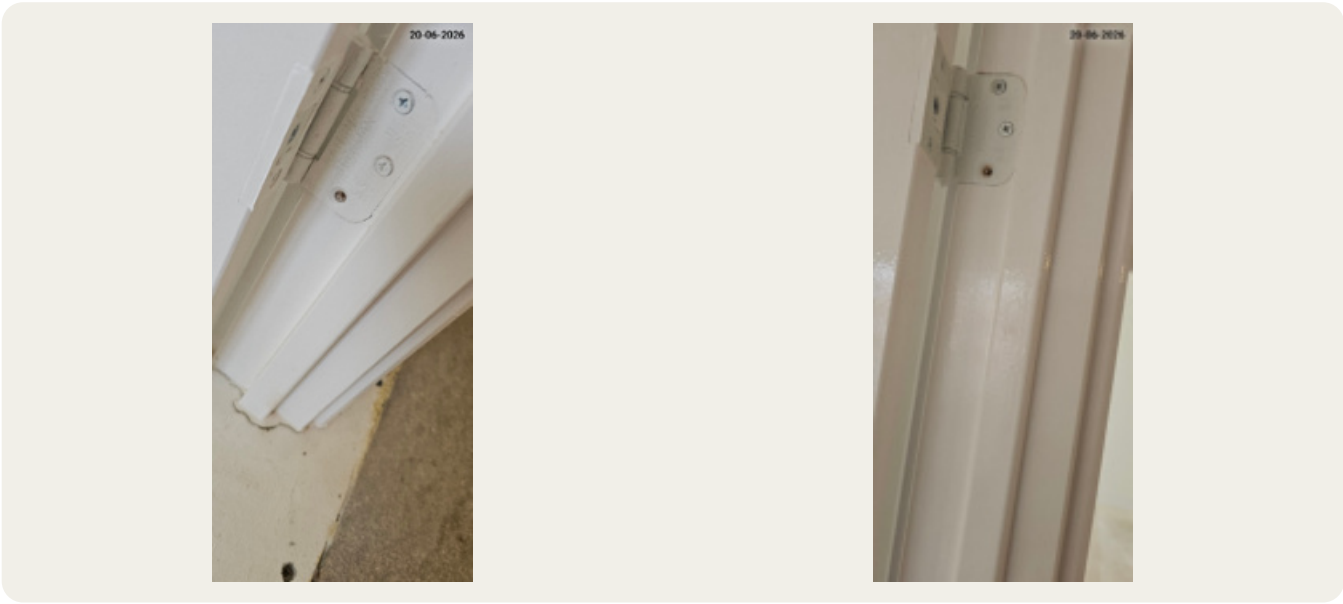
Screws are missing from the door hinges.

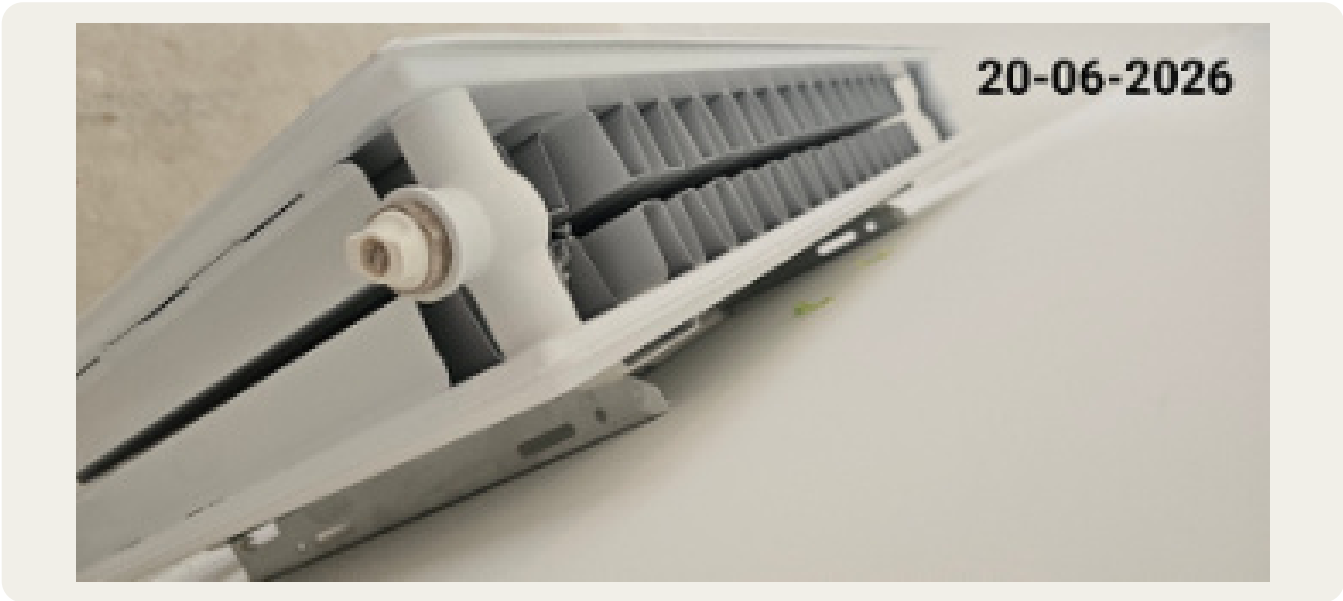
Paint contamination is present on the radiator brackets.

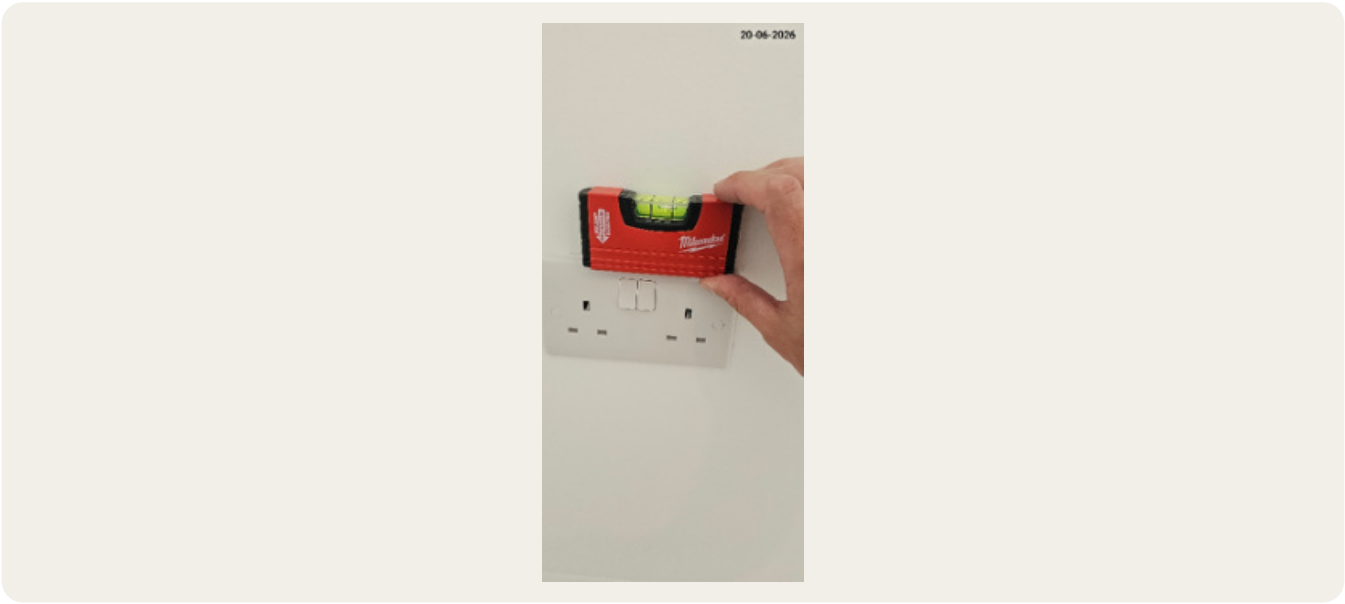
Socket faceplates are out of level.

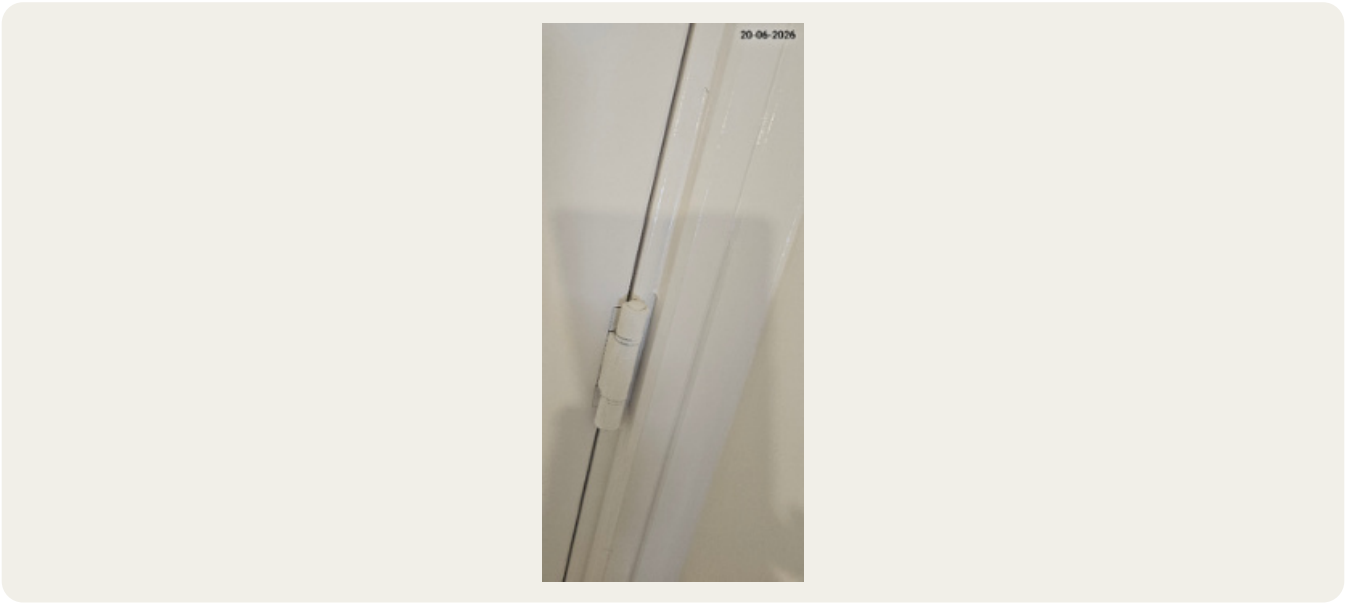
The architrave has not been caulked behind the hinge.

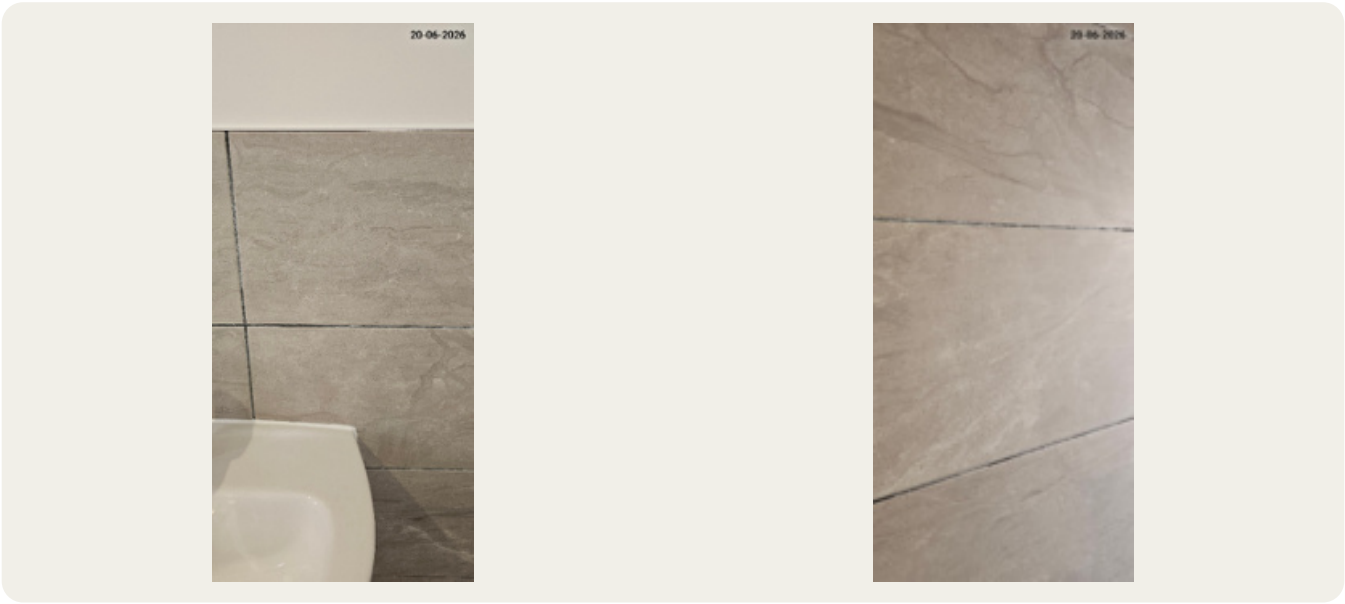
Grout discolouration is present throughout the bathroom.

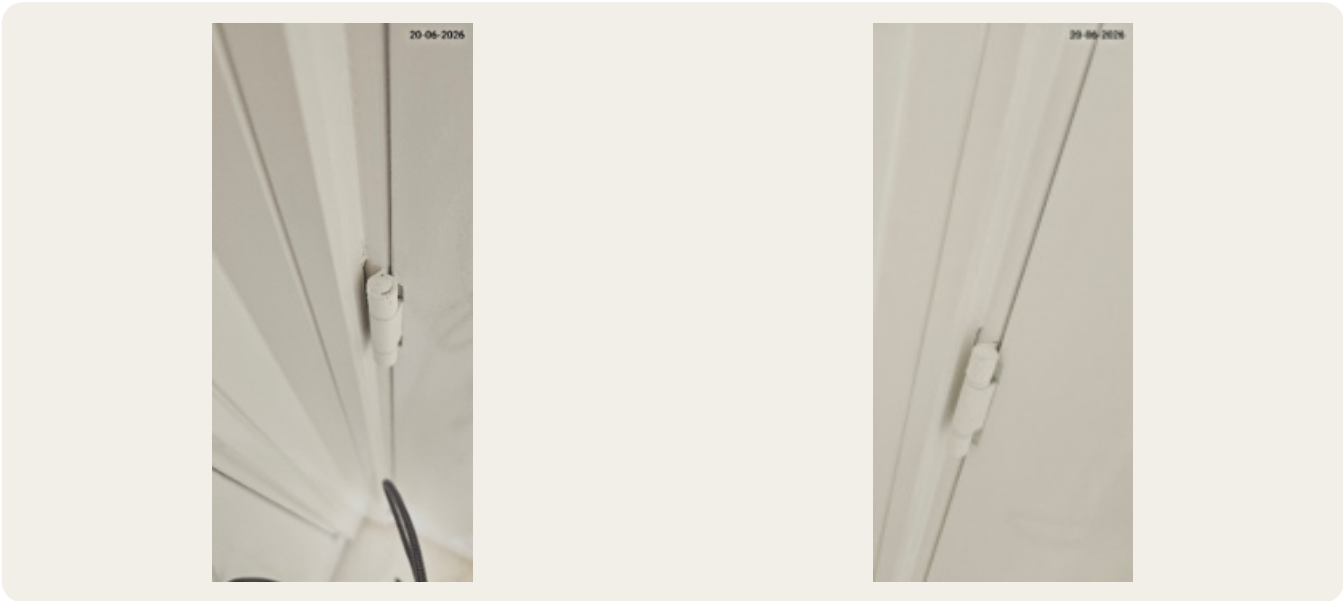
Architraves have not been decorated behind the hinges.

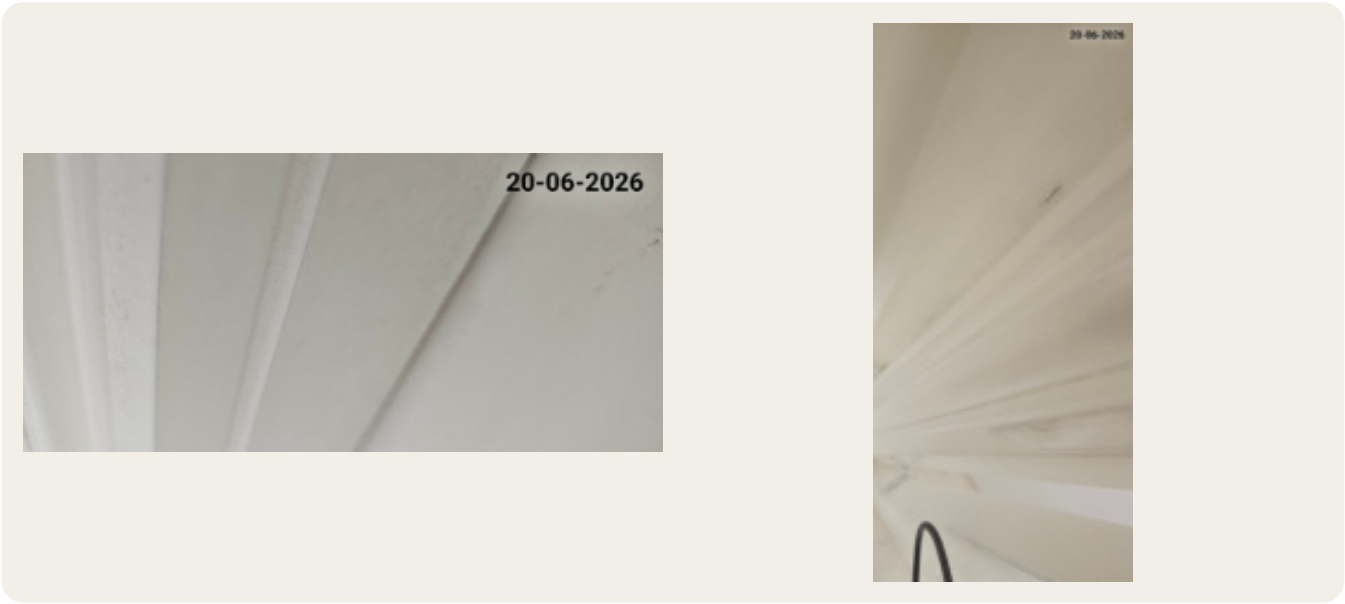
The finish to the walls and architraves between the architrave and bulkhead is poor.

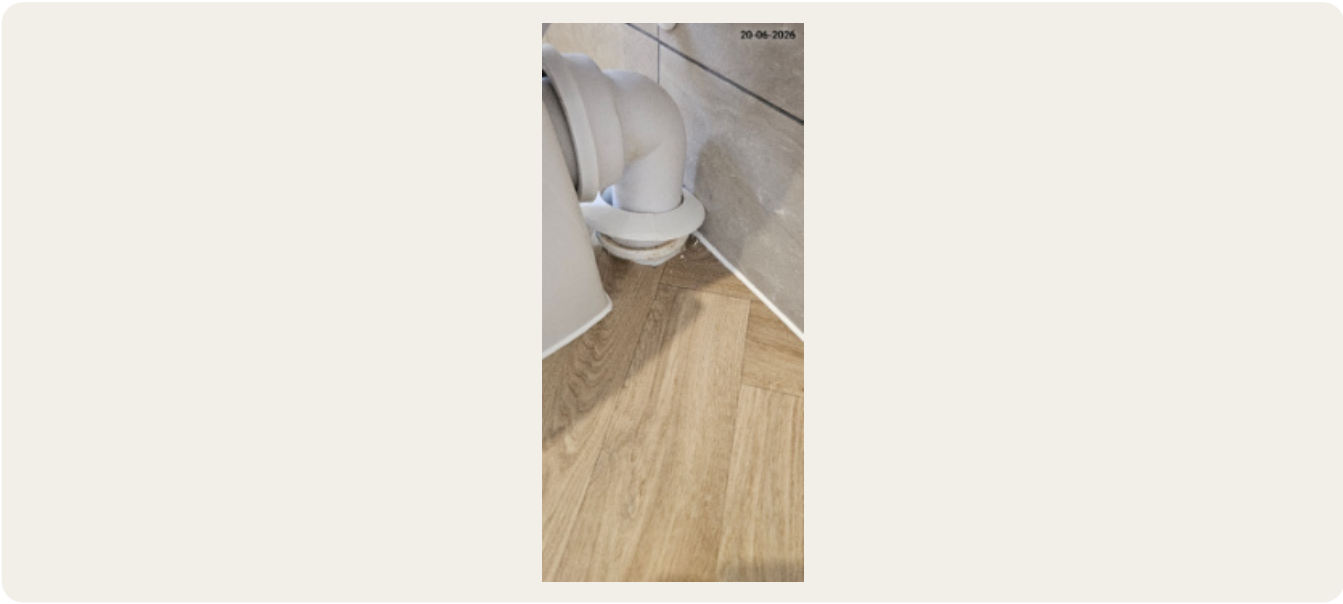
The finish behind the toilet is poor and the pipe collar is not correctly fitted.

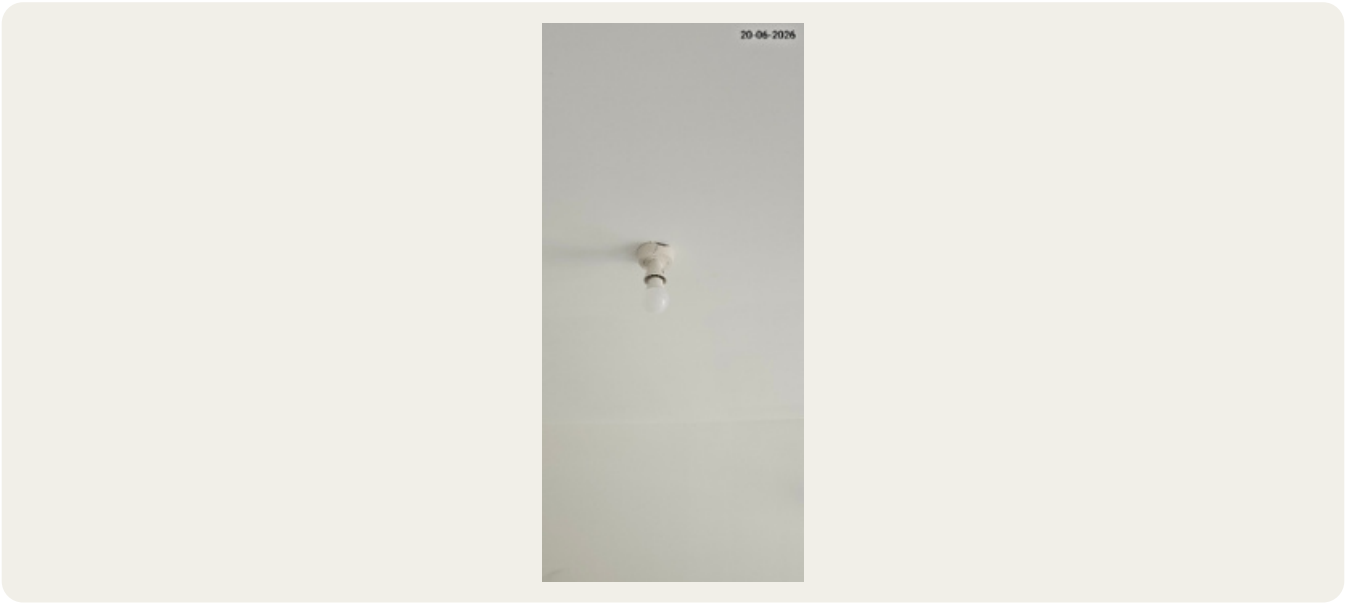
OBSERVATION  
The ceiling rose is damaged.

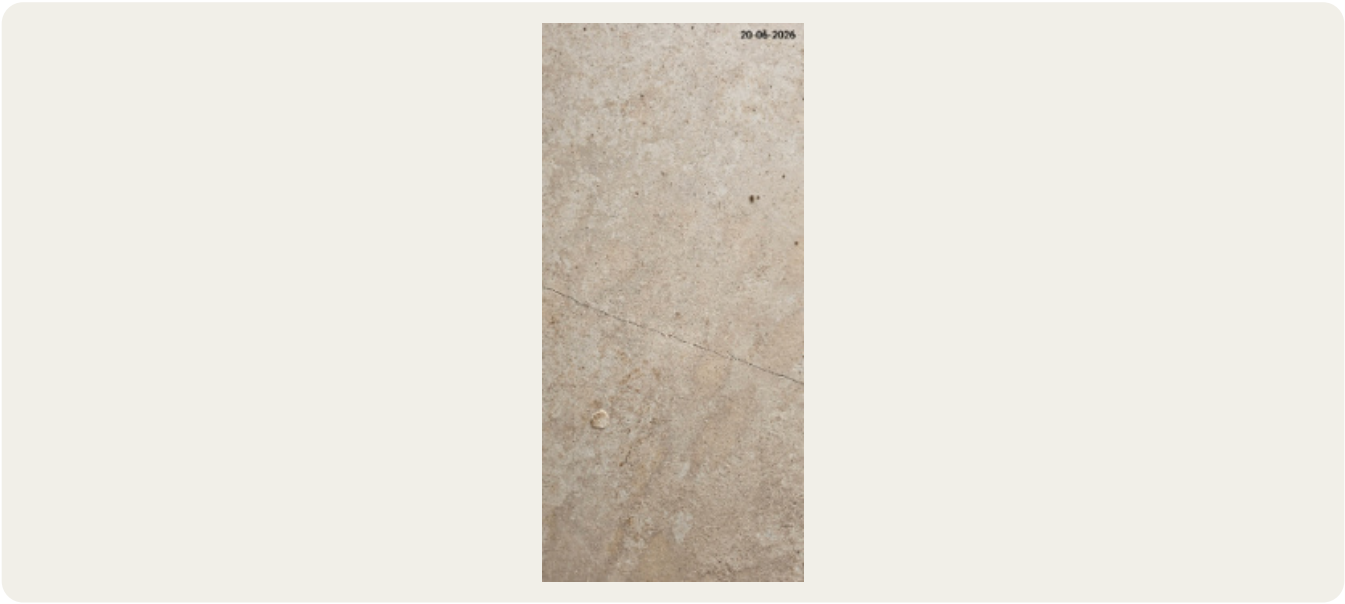
Issue 81: Garage - A crack is present running through the garage slab.

OBSERVATION  
A crack is present running through the garage slab.

WHY THIS MATTERS  
This may affect the suitability of floor finishes, the performance of the completed floor and the homeowner acceptance of the property. Where cracking or significant level change is present, the developer should confirm the cause and appropriate remedial action.

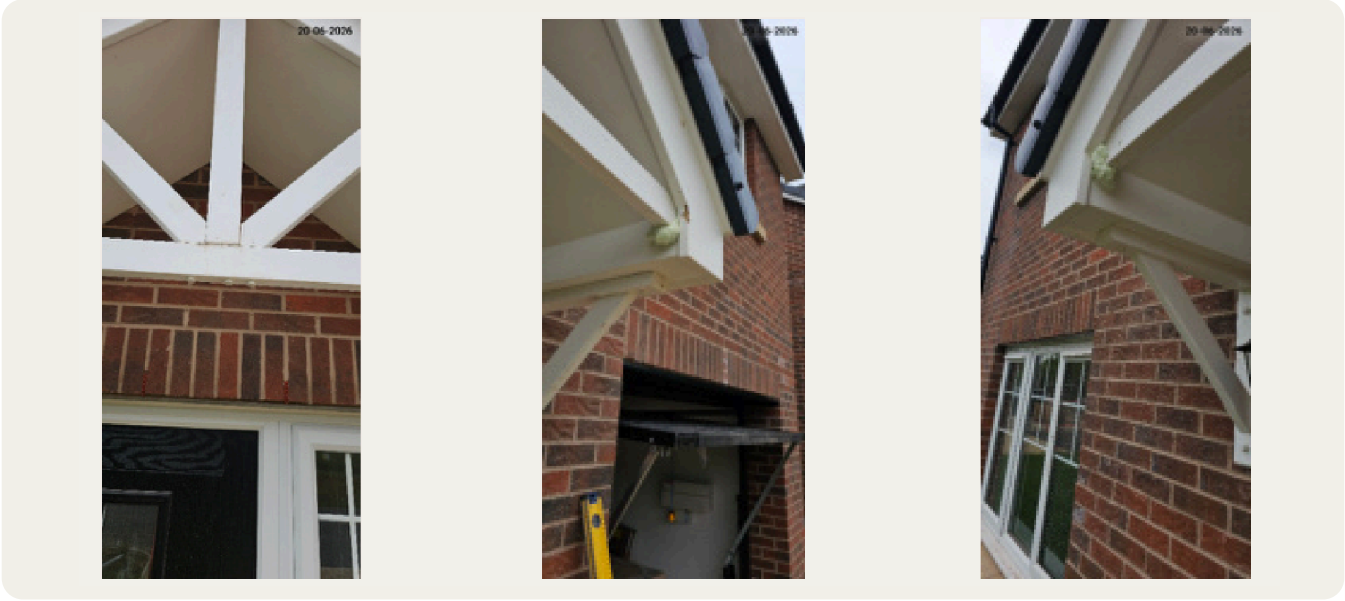
Issue 83: External - Damage to GRP canopy

Damage is present to the GRP canopy.

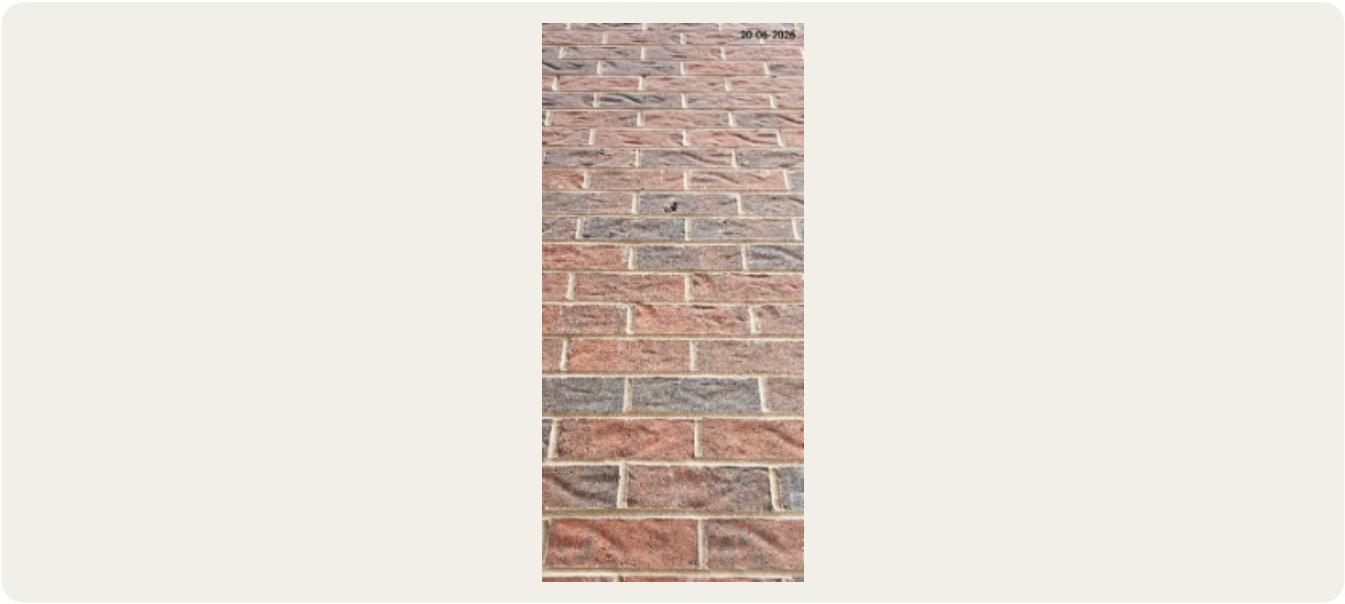
Damage is present to the brickwork at the left-hand end of the wall.

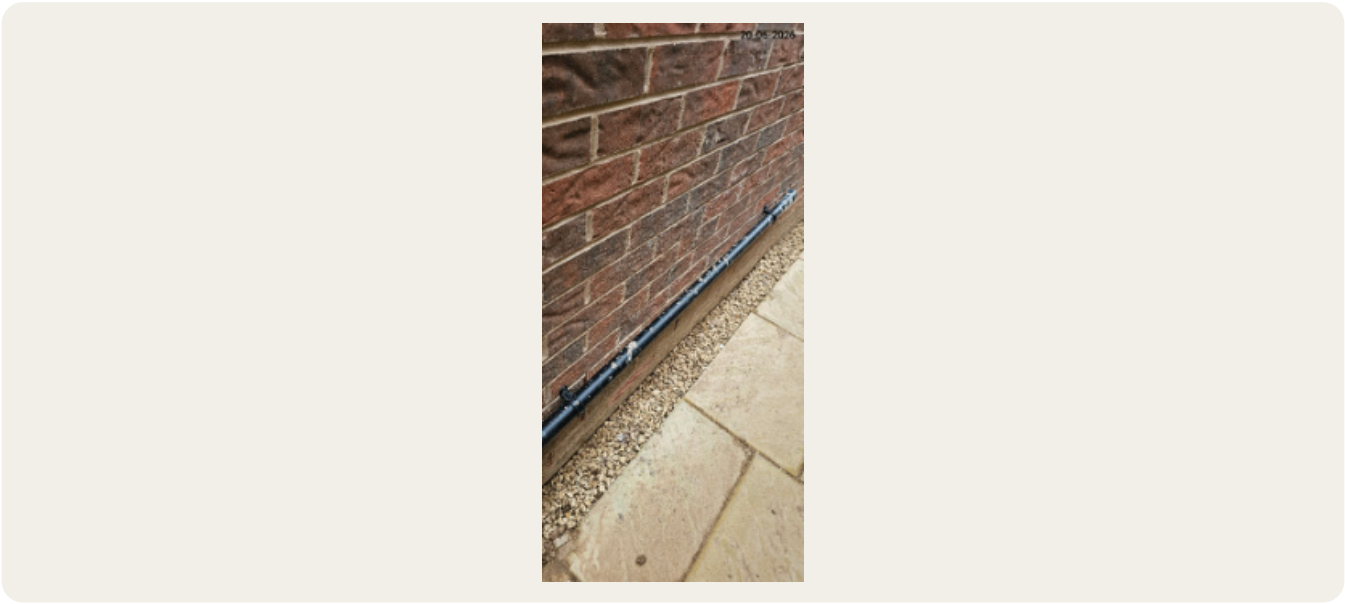
Mortar or construction residue remains on the external waste pipes.

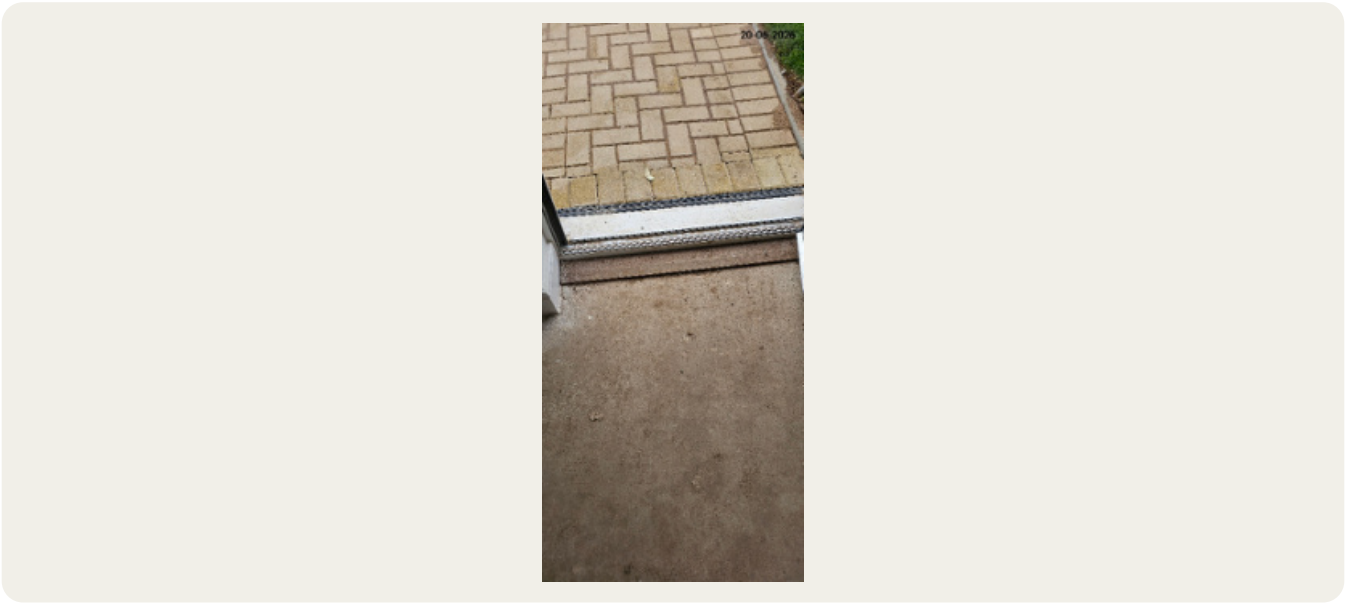
The finish to the front door transition strip is poor.

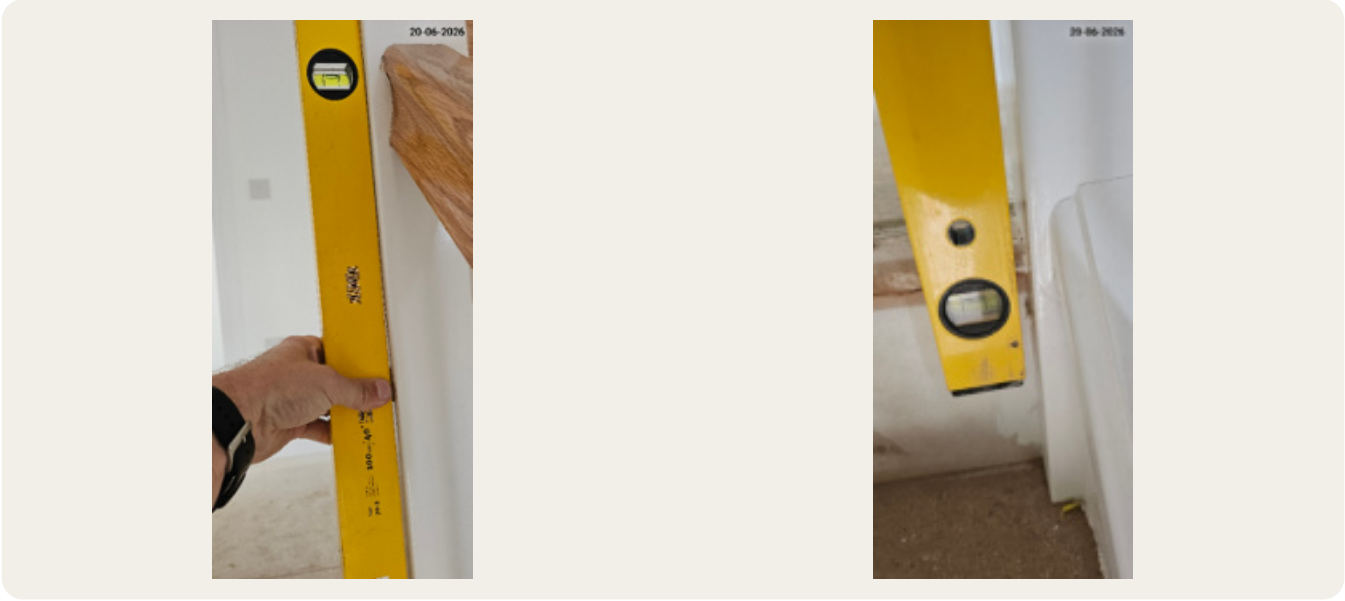
OBSERVATION  
The newel post at the top of the stairs is out of plumb.
