# Professional Snagging Inspection Report

Post-completion inspection

Inspection date: 18 July 2026

South Wales Snagging Co was instructed to undertake a visual, non-destructive post-completion snagging inspection of an anonymised new-build property in South Wales. This report records visible defects, incomplete items and areas requiring developer or aftercare attention based on the condition observed on 18 July 2026.

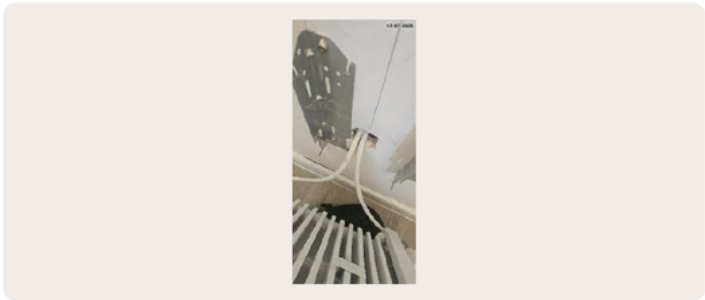
# Defect 13

Required fitting: radiator pipe guide and seal

The radiator pipe guide and seal is missing, leaving an unfinished opening behind the radiator.

Openings around radiator pipework should be properly sealed and finished. The missing radiator pipe guide and seal leaves an unfinished penetration and may allow draughts around the service route.

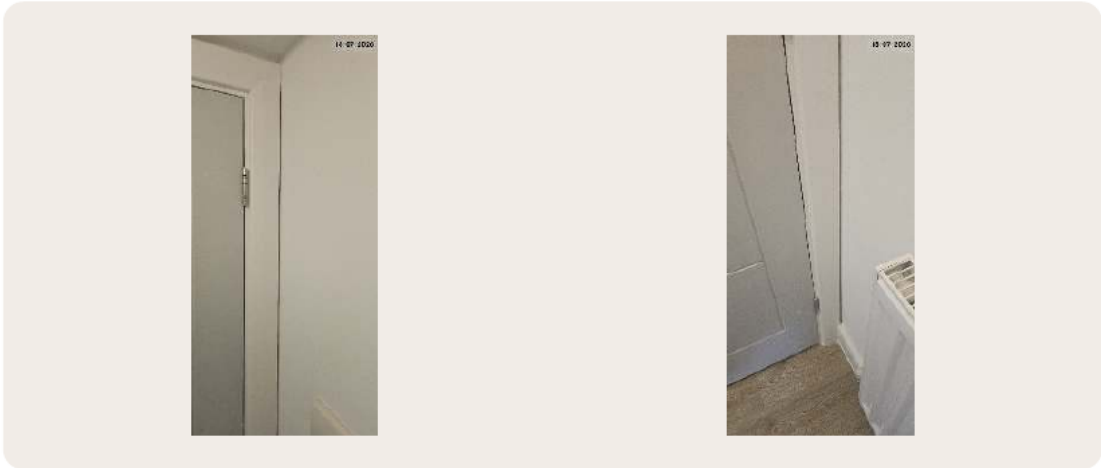
# Defect 15

**OBSERVATION**  
The junction beside the right-hand cloakroom door architrave is uneven and contains a visible shadow gap.

**WHY THIS MATTERS**  
The junction should be neatly closed and decorated so that the completed finish is continuous and visually acceptable.

**RECOMMENDED ACTION**  
Prepare the junction, fill the shadow gap or open decorative joint with suitable decorator's caulk, smooth the caulk neatly and redecorate to match the surrounding finish.

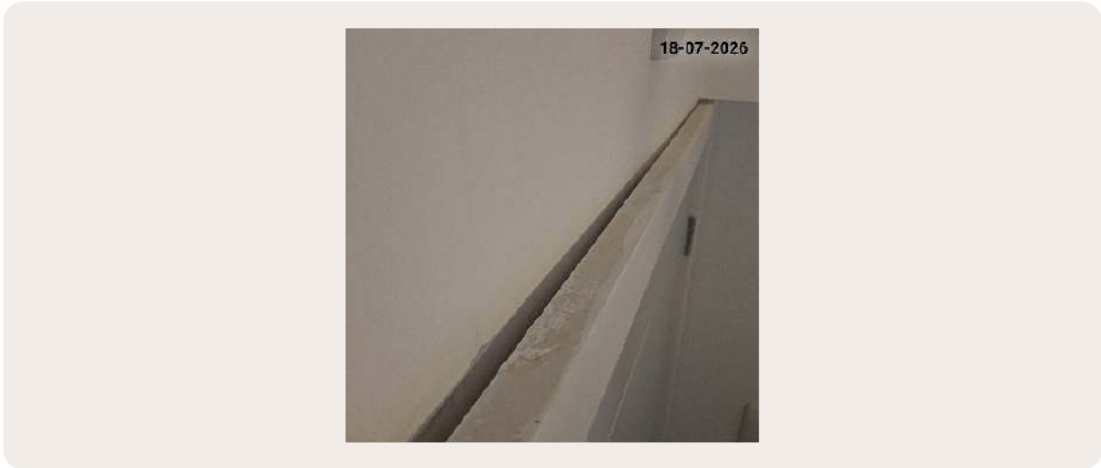
# Defect 16

The architrave head has not been fully decorated, leaving an incomplete and visually inconsistent finish.

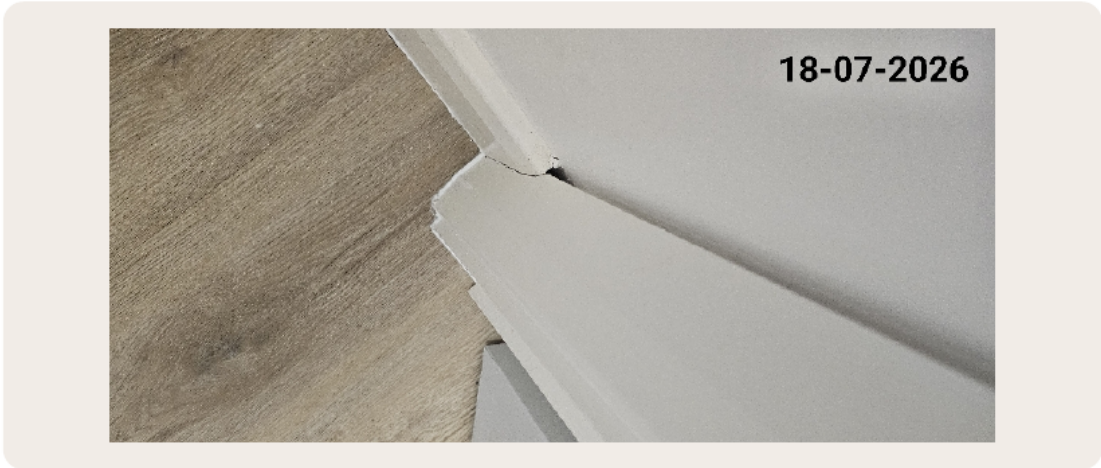
The skirting board finish is uneven and does not provide a neat, consistent appearance.

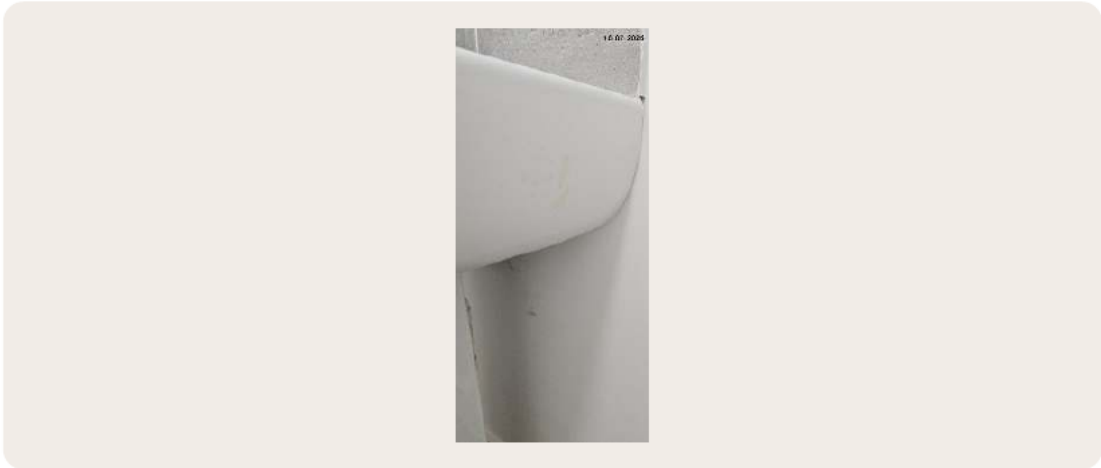
Adhesive residue remains on the wash-hand basin.

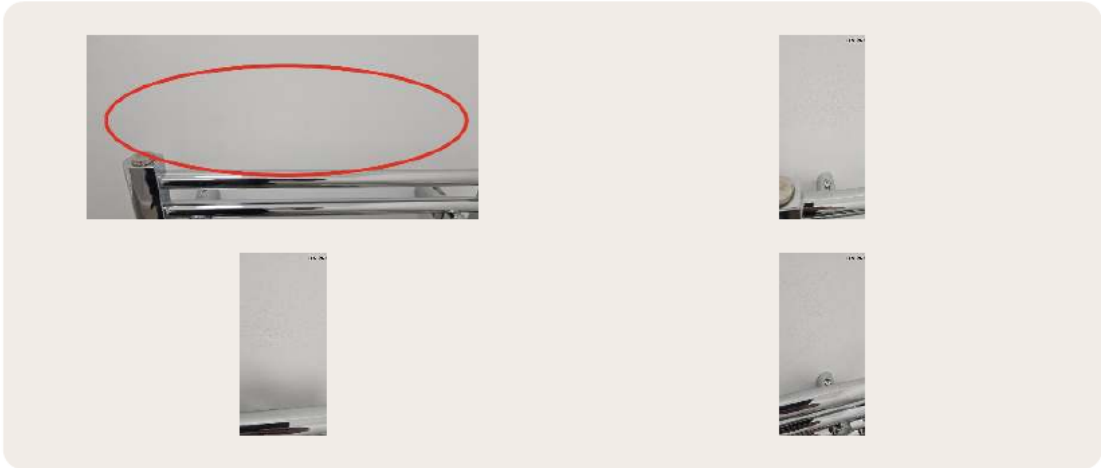
**OBSERVATION**  
Pencil lines and screw holes remain from previous fixings.

**WHY THIS MATTERS**  
Visible decorative finishes should be complete, smooth and consistent at handover. Shrinkage, exposed fixings, marks, insufficient paint coverage and incomplete preparation reduce the quality of finish.

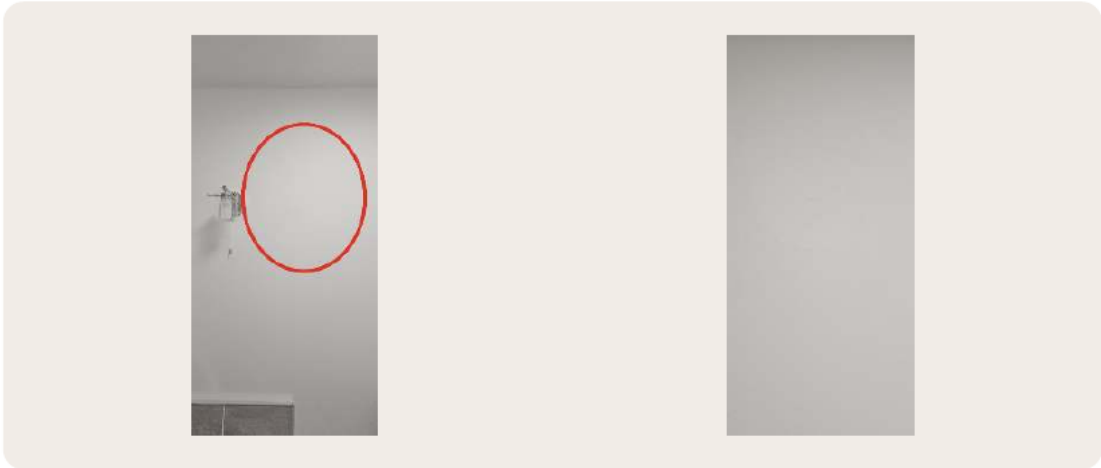
Circular jointing or sanding marks remain visible on the wall to the right-hand side of the wall light.

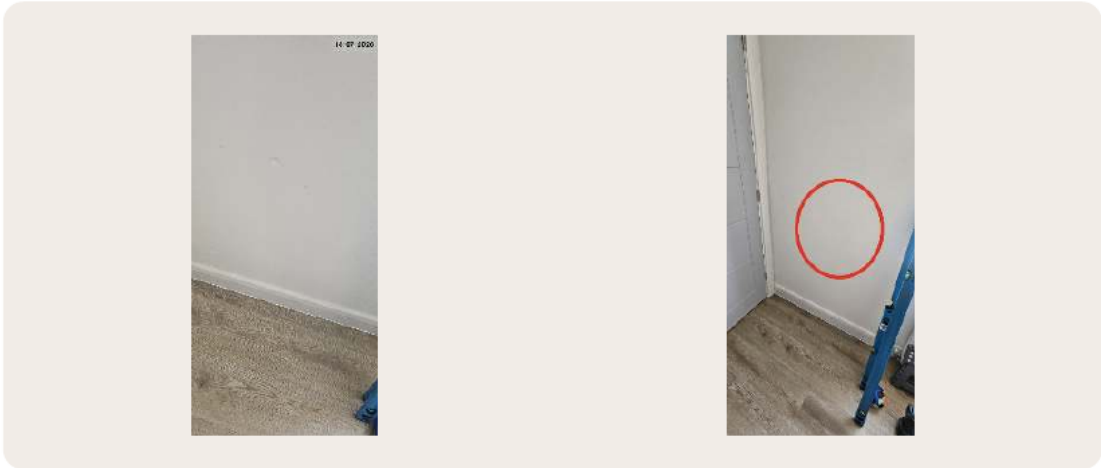
**OBSERVATION**  
Localised indentations are visible in the wall finish behind the door.

**WHY THIS MATTERS**  
Visible decorative finishes should be complete, smooth and consistent at handover. Shrinkage, exposed fixings, marks, insufficient paint coverage and incomplete preparation reduce the quality of finish.

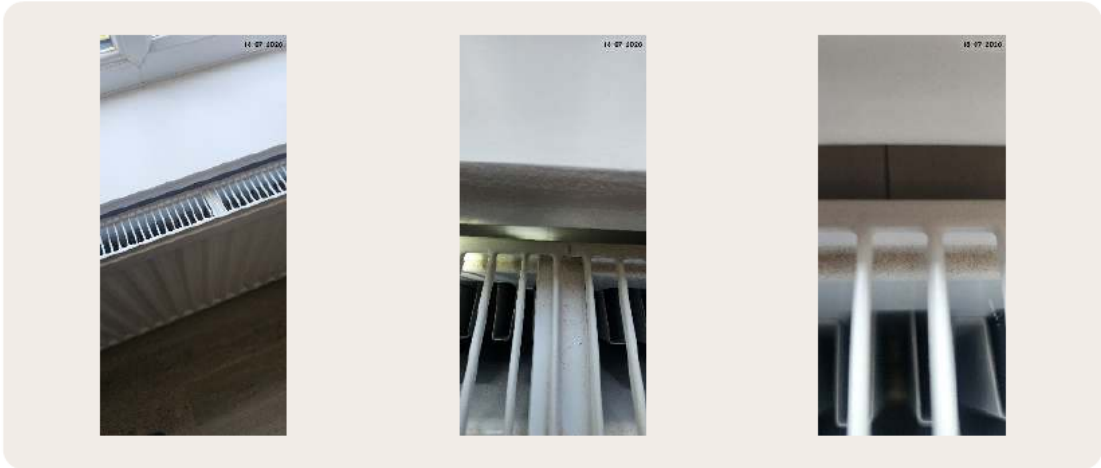
The wall behind the radiator has not been decorated.

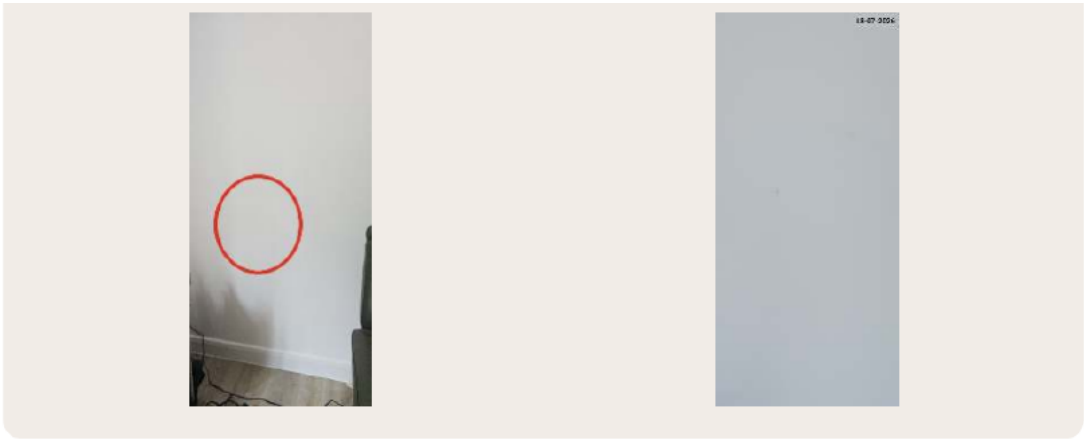
**OBSERVATION**  
A localised indentation is visible in the wall finish to the left-hand side of the sofa.

**WHY THIS MATTERS**  
Plasterboard linings, joints, tapes and reveals should be securely formed, straight and finished without visible distortion or failed jointing materials.

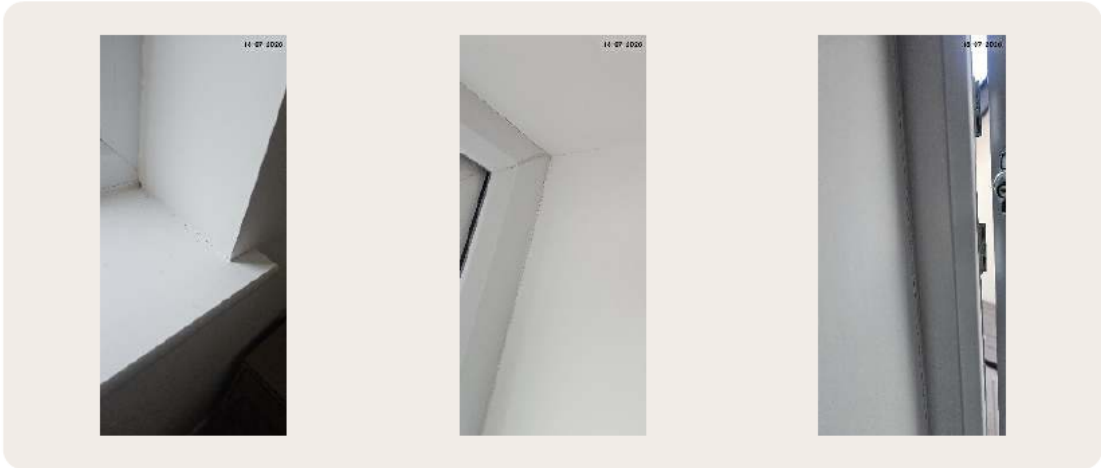
A visible shrinkage gap has opened around the gable-end window junction.

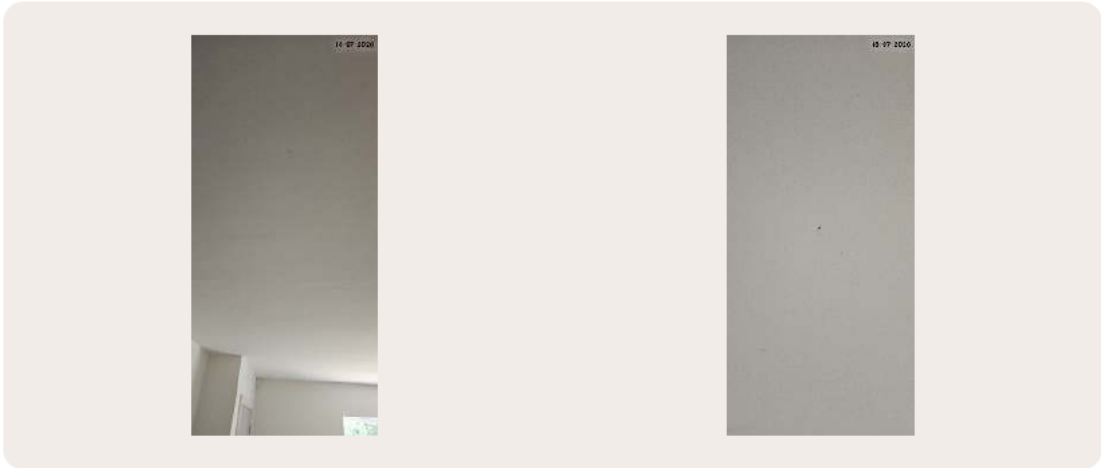
A plasterboard fixing head remains visible through the lounge ceiling finish.

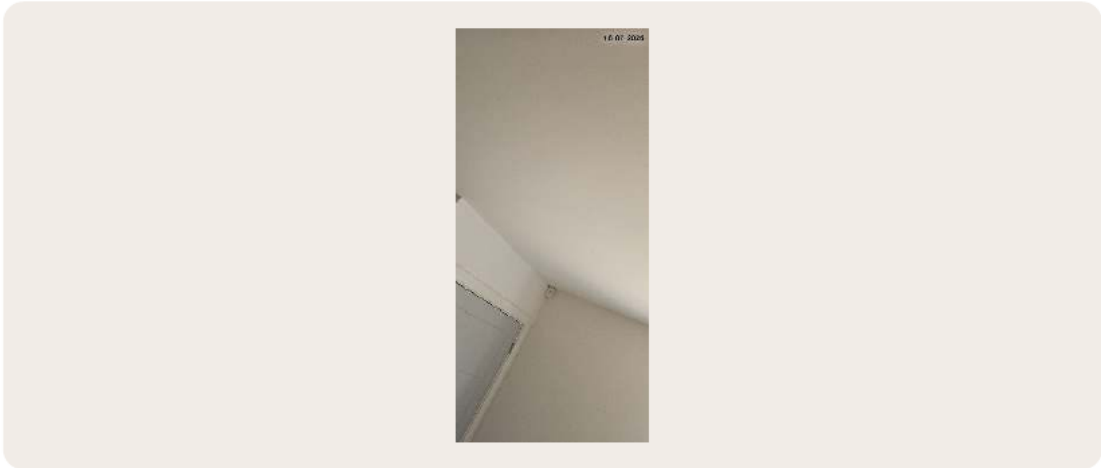
Extensive sanding marks remain visible across the lounge ceiling surface.

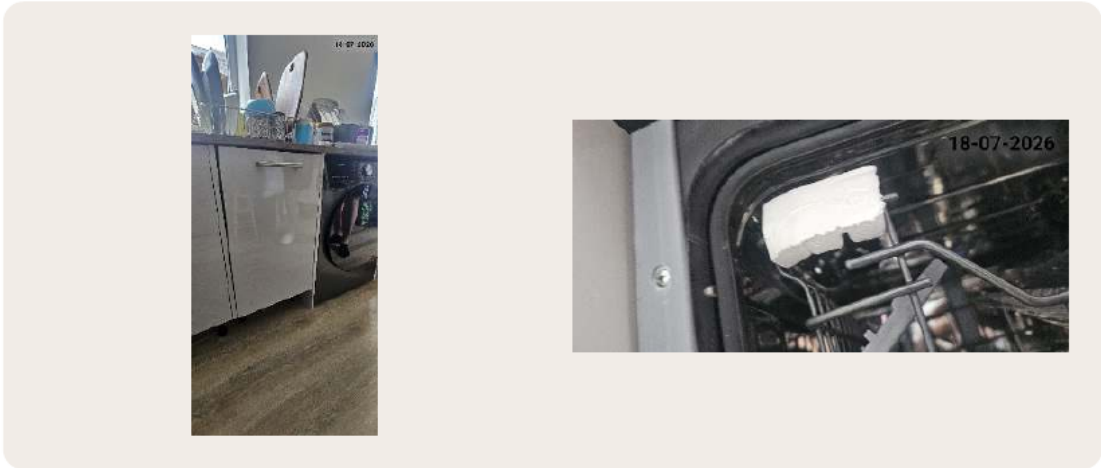
The dishwasher is not securely fixed.

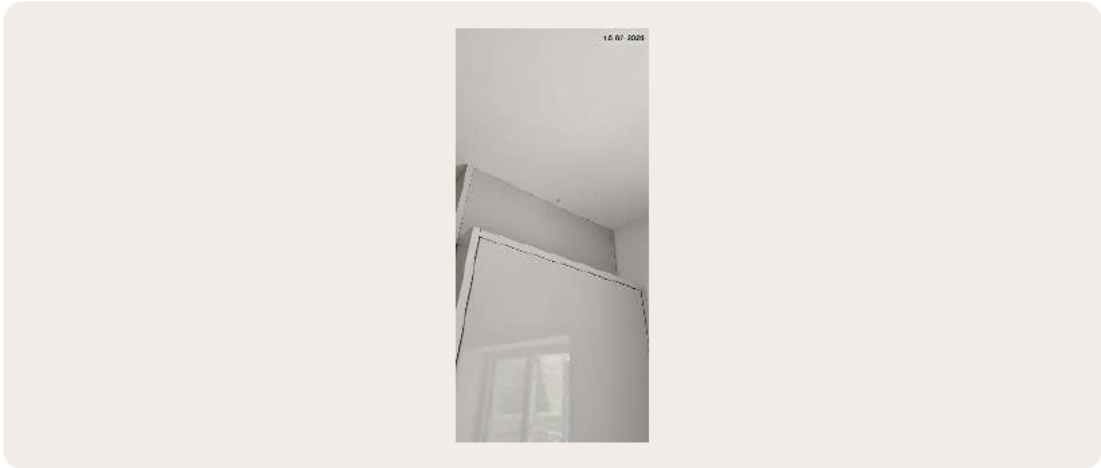
The ceiling finish above the boiler housing is uneven and visually inconsistent.

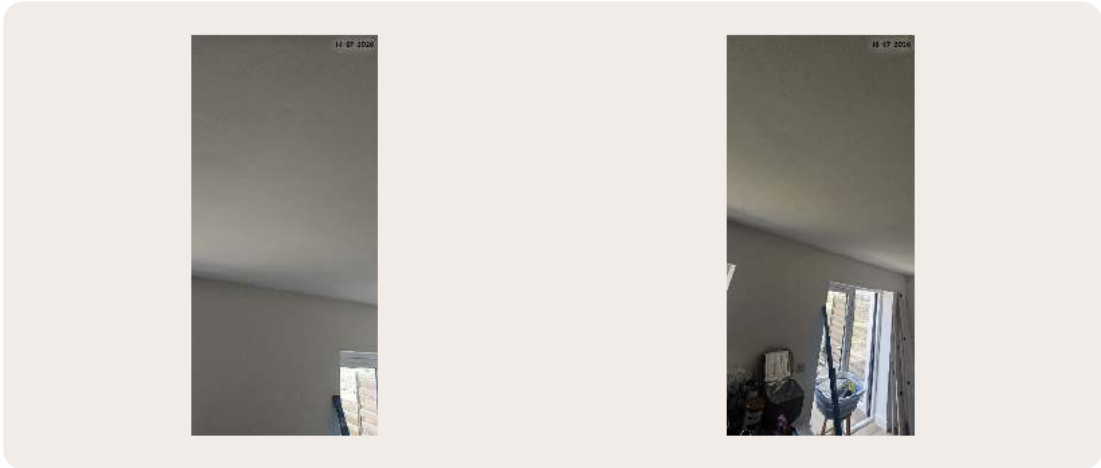
**OBSERVATION**  
The kitchen ceiling board joints remain visible through the finished surface.

**WHY THIS MATTERS**  
Plasterboard linings, joints, tapes and reveals should be securely formed, straight and finished without visible distortion or failed jointing materials.

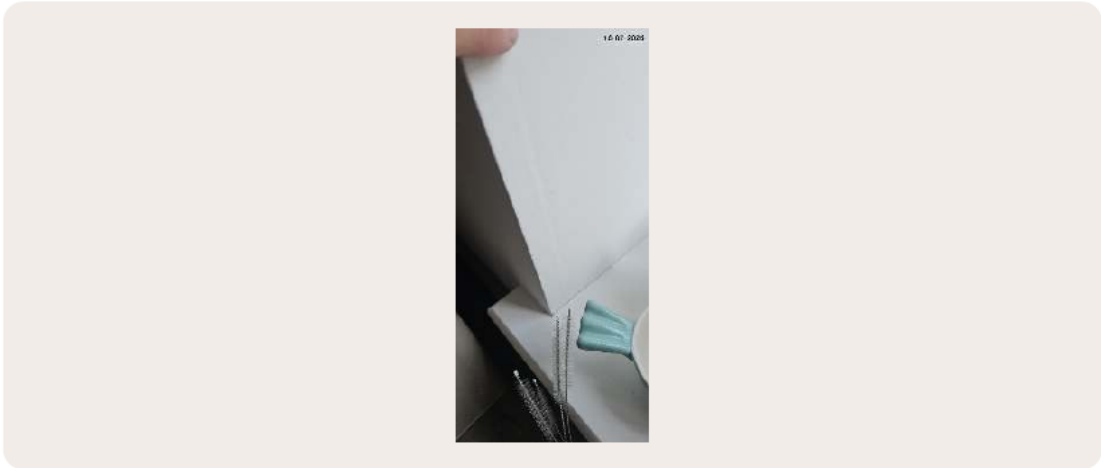
**OBSERVATION**  
The corner tape to the left-hand kitchen window reveal is uneven and remains visible through the finish.

**WHY THIS MATTERS**  
Plasterboard linings, joints, tapes and reveals should be securely formed, straight and finished without visible distortion or failed jointing materials.

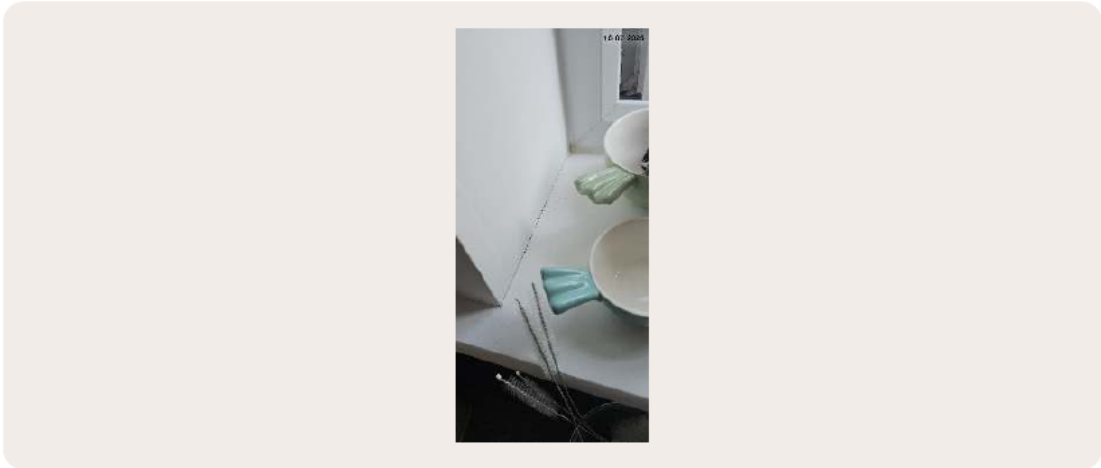
**OBSERVATION**  
A visible shrinkage gap has opened around the kitchen window junction at recorded location 1 of 2.

**WHY THIS MATTERS**  
Visible decorative finishes should be complete, smooth and consistent at handover. Shrinkage, exposed fixings, marks, insufficient paint coverage and incomplete preparation reduce the quality of finish.

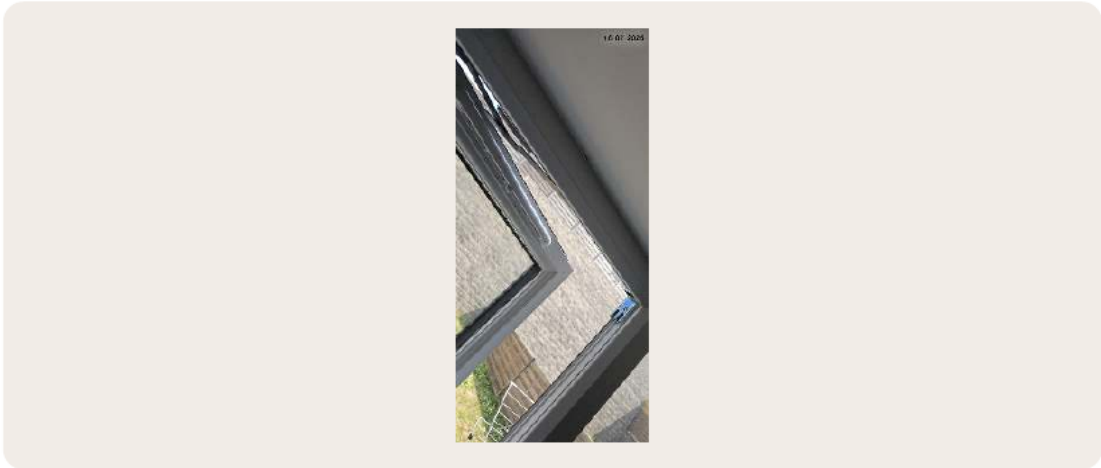
**OBSERVATION**  
A visible shrinkage gap has opened around the kitchen window junction at recorded location 2 of 2.

**WHY THIS MATTERS**  
Visible decorative finishes should be complete, smooth and consistent at handover. Shrinkage, exposed fixings, marks, insufficient paint coverage and incomplete preparation reduce the quality of finish.

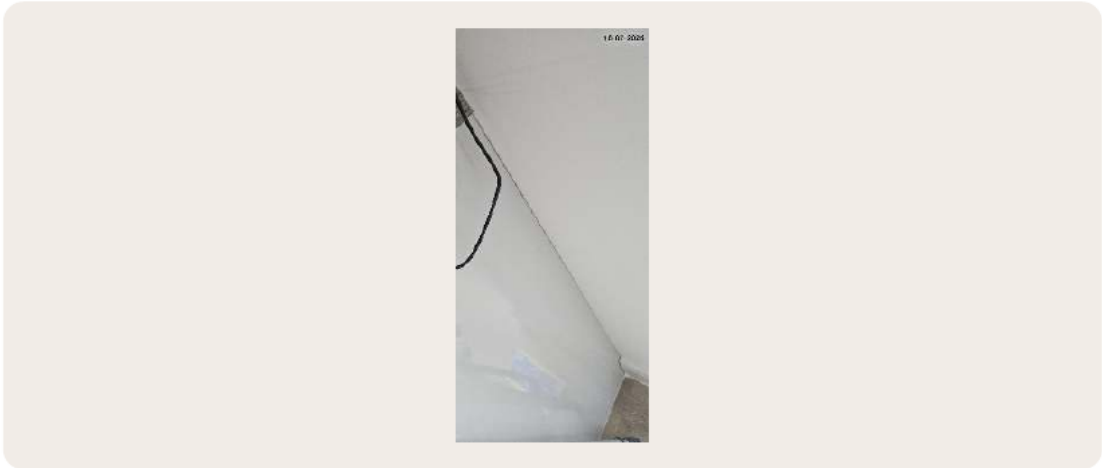
The kitchen end panel has not been sealed to the wall.

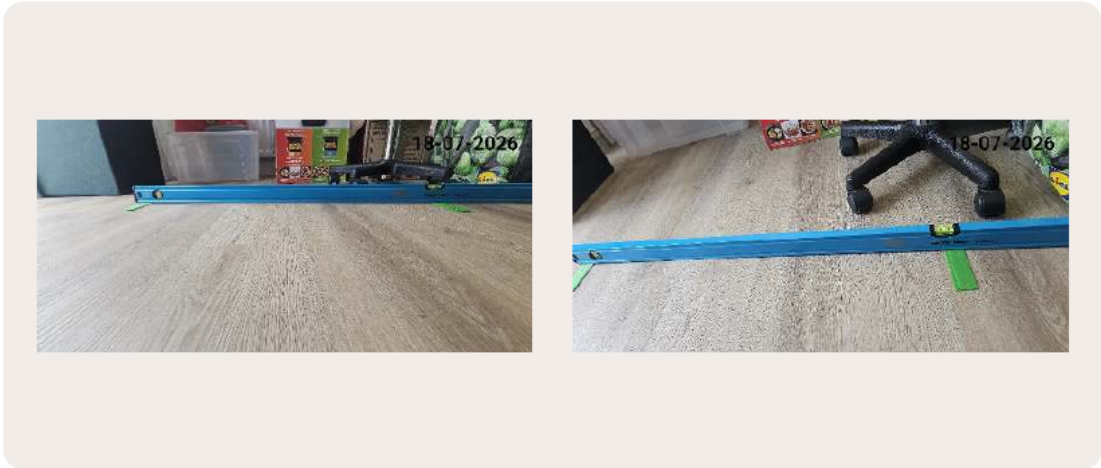
**OBSERVATION**  
There is excessive deviation in the lounge floor levels.

**WHY THIS MATTERS**  
Floors, paving, drainage features and access routes should be stable, reasonably level and suitable for normal use.

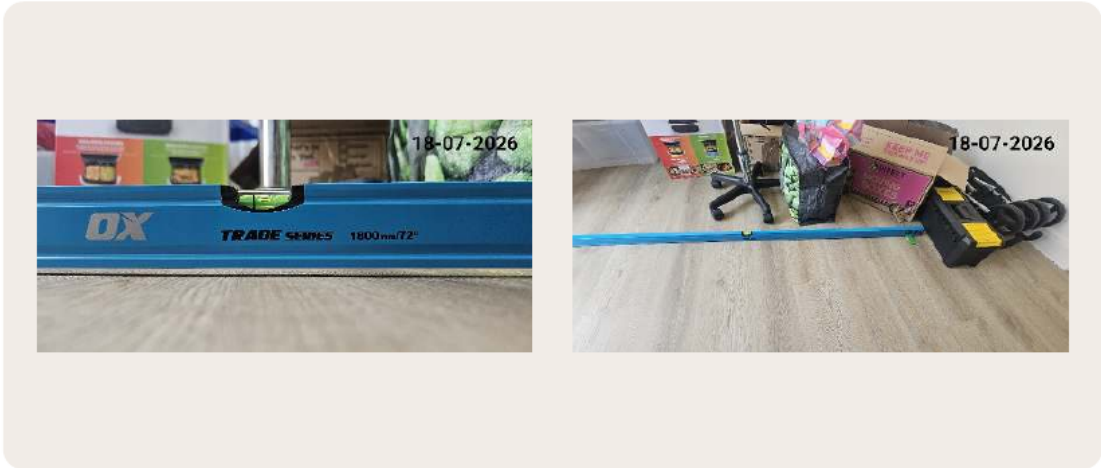
**OBSERVATION**  
The kitchen floor is out of level.

**WHY THIS MATTERS**  
Floors, paving, drainage features and access routes should be stable, reasonably level and suitable for normal use.

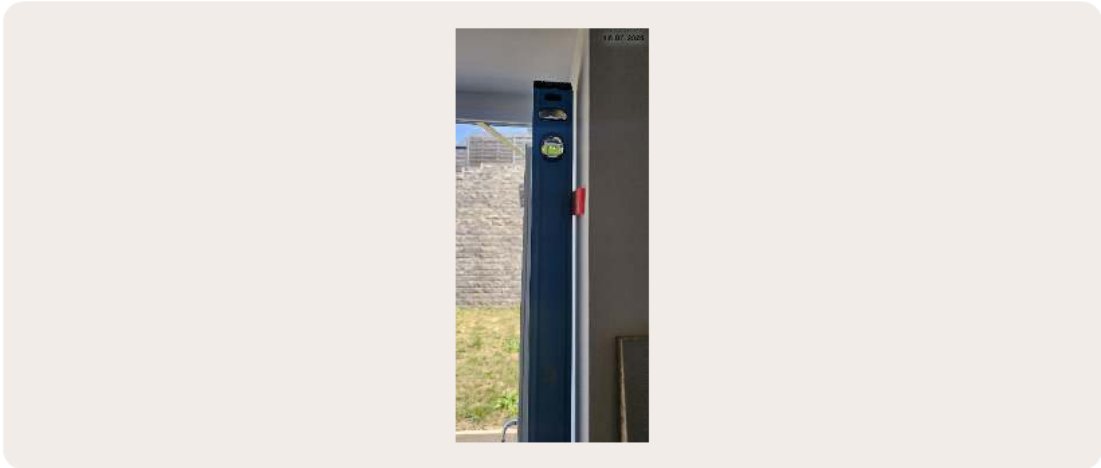
**OBSERVATION**  
The right-hand door reveal is 6mm out of plumb.

**WHY THIS MATTERS**  
Plasterboard linings, joints, tapes and reveals should be securely formed, straight and finished without visible distortion or failed jointing materials.

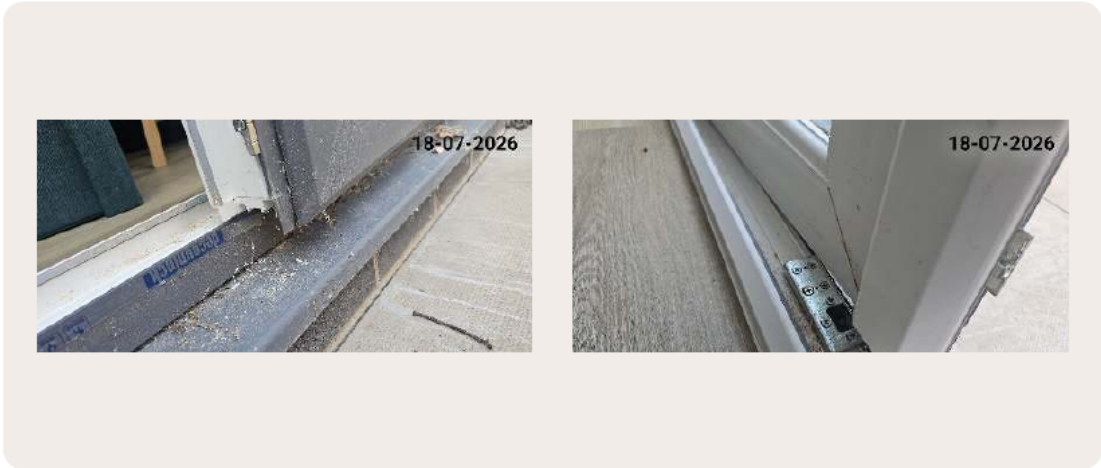
**OBSERVATION**  
The French doors have dropped and require adjustment. The issue does not appear to be solely heat related.

**WHY THIS MATTERS**  
External doors should be correctly installed, aligned and capable of operating smoothly while maintaining effective weather sealing and security.

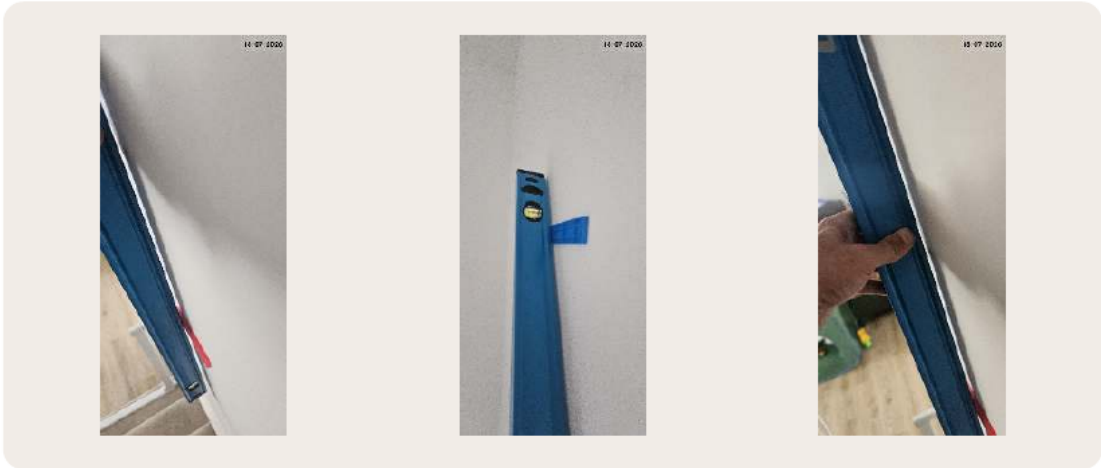
There is excessive deviation to the stairwell wall.

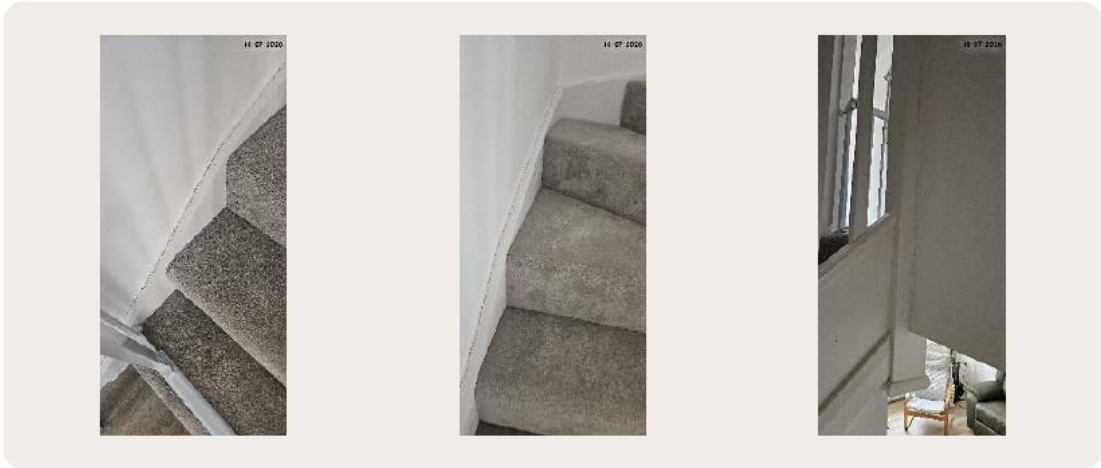
**OBSERVATION**  
An excessive shrinkage gap has opened at the junction between the stair string and newel post.

**WHY THIS MATTERS**  
Visible decorative finishes should be complete, smooth and consistent at handover. Shrinkage, exposed fixings, marks, insufficient paint coverage and incomplete preparation reduce the quality of finish.

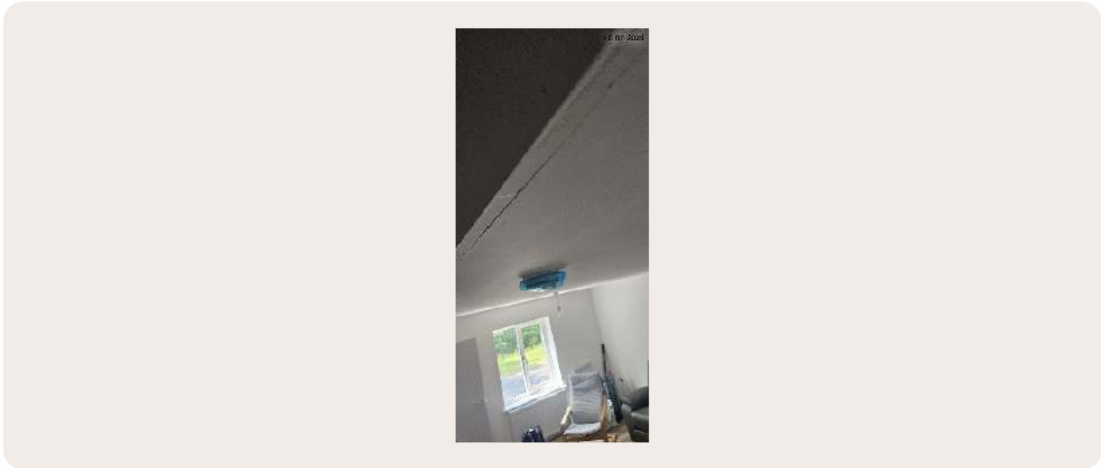
**OBSERVATION**  
The external corner tape has debonded and is visibly raised from the finished surface.

**WHY THIS MATTERS**  
Plasterboard linings, joints, tapes and reveals should be securely formed, straight and finished without visible distortion or failed jointing materials.

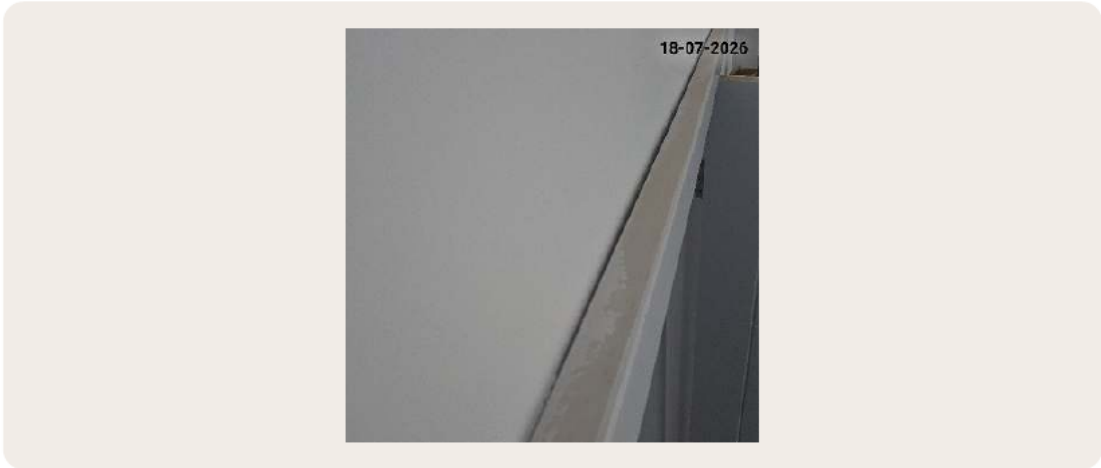
**OBSERVATION**  
The kitchen architrave head has not been fully decorated, leaving an incomplete finish.

**WHY THIS MATTERS**  
Visible decorative finishes should be complete, smooth and consistent at handover. Shrinkage, exposed fixings, marks, insufficient paint coverage and incomplete preparation reduce the quality of finish.

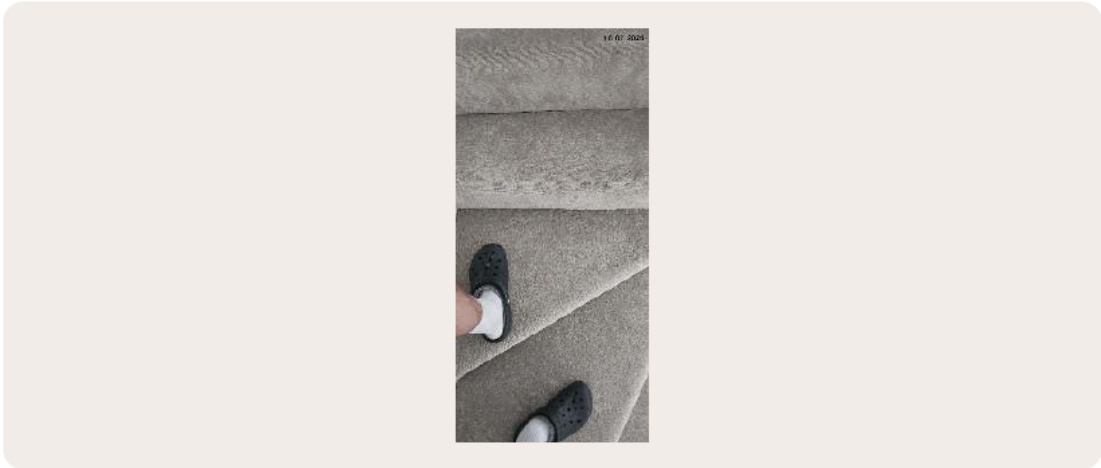
**OBSERVATION**  
A stair winder creaks under normal use.

**WHY THIS MATTERS**  
The plot was left incomplete for an extended period. The stair construction may have been adversely affected during that period and its structural integrity cannot be confirmed through a visual, non-destructive inspection alone.

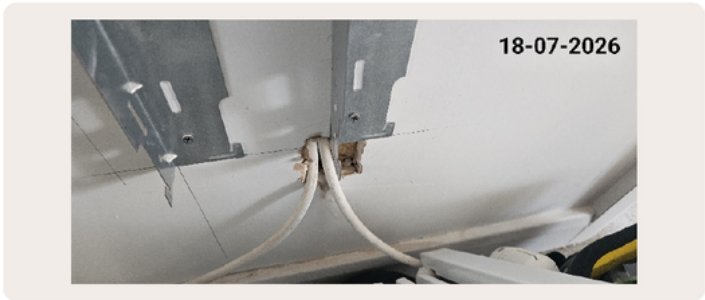
Required fitting: radiator pipe guide and seal

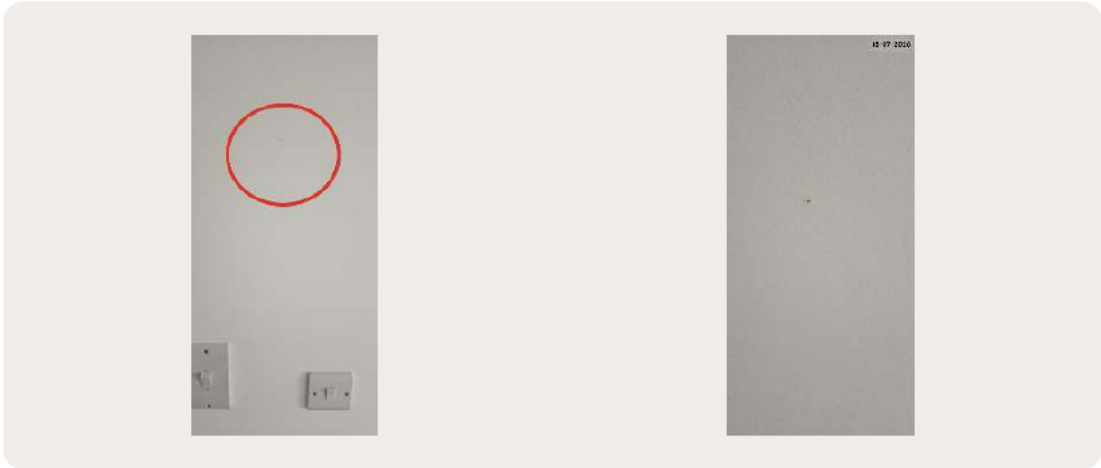
A plasterboard fixing head remains visible through the finished surface.

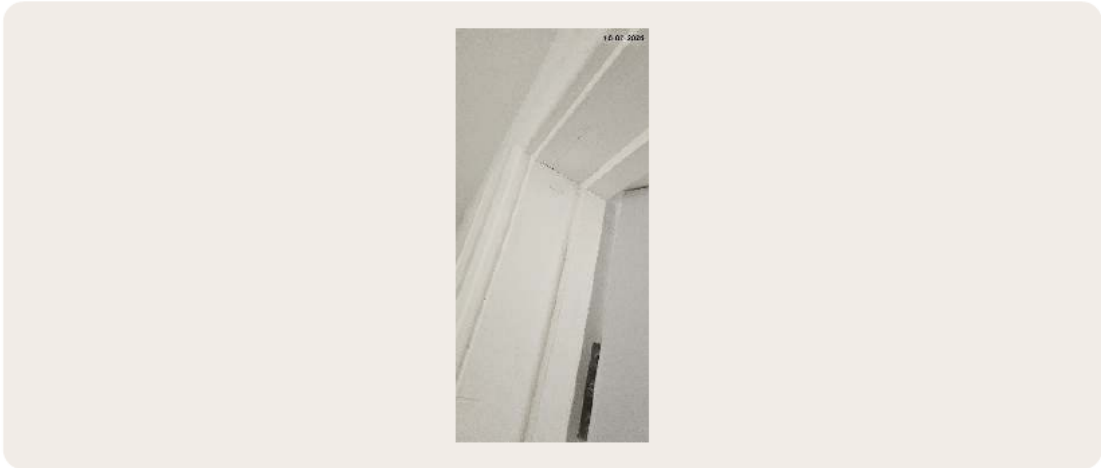
A visible shrinkage gap has opened around a landing door-frame junction at recorded location 1 of 7.

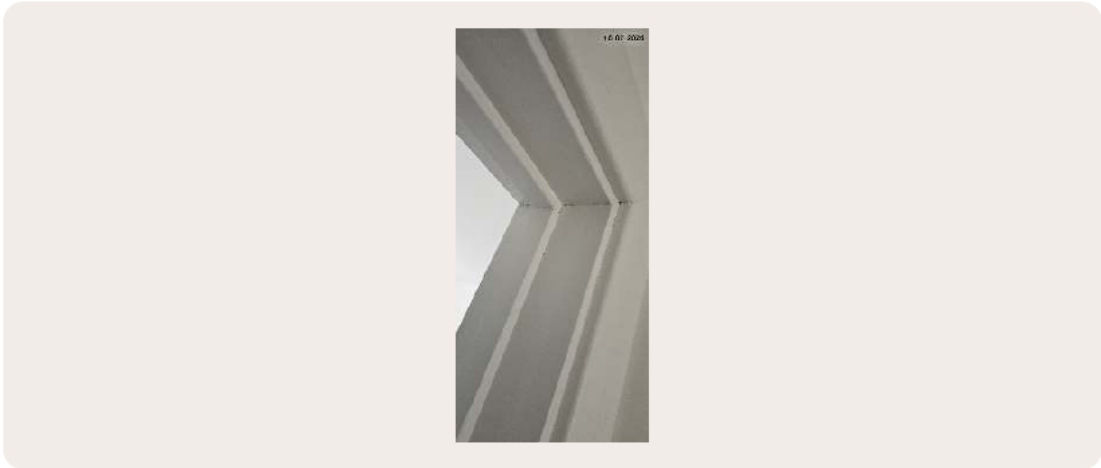
A visible shrinkage gap has opened around a landing door-frame junction at recorded location 2 of 7.

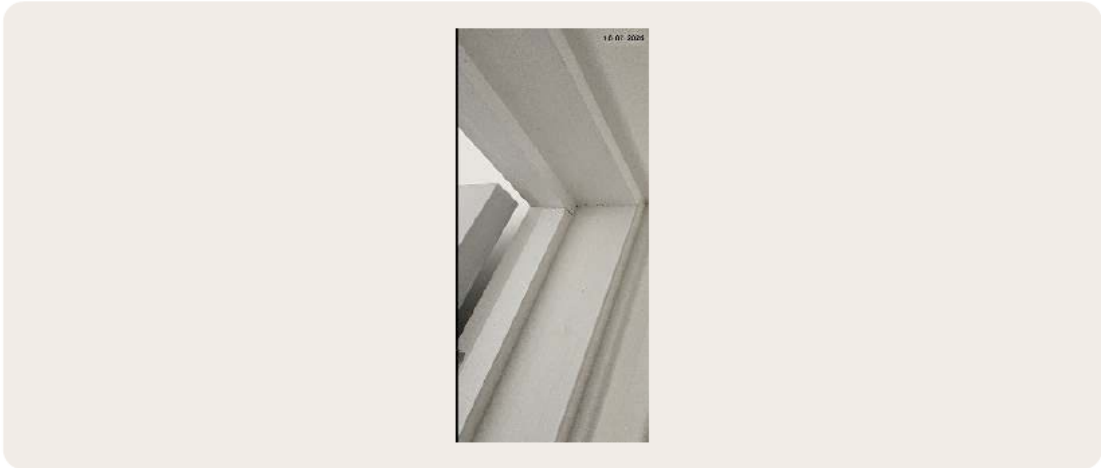
A visible shrinkage gap has opened around a landing door-frame junction at recorded location 3 of 7.

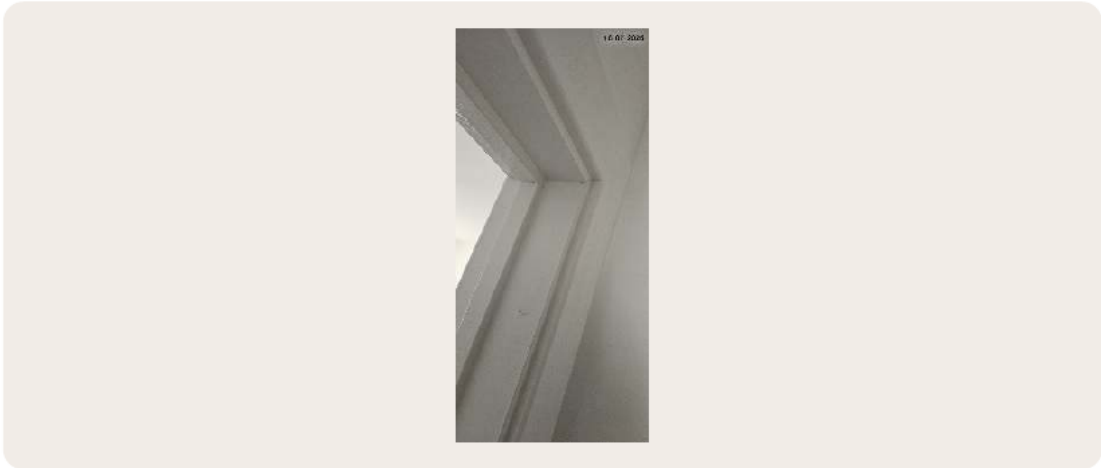
**OBSERVATION**  
A visible shrinkage gap has opened around a landing door-frame junction at recorded location 4 of 7.

**WHY THIS MATTERS**  
Visible decorative finishes should be complete, smooth and consistent at handover. Shrinkage, exposed fixings, marks, insufficient paint coverage and incomplete preparation reduce the quality of finish.

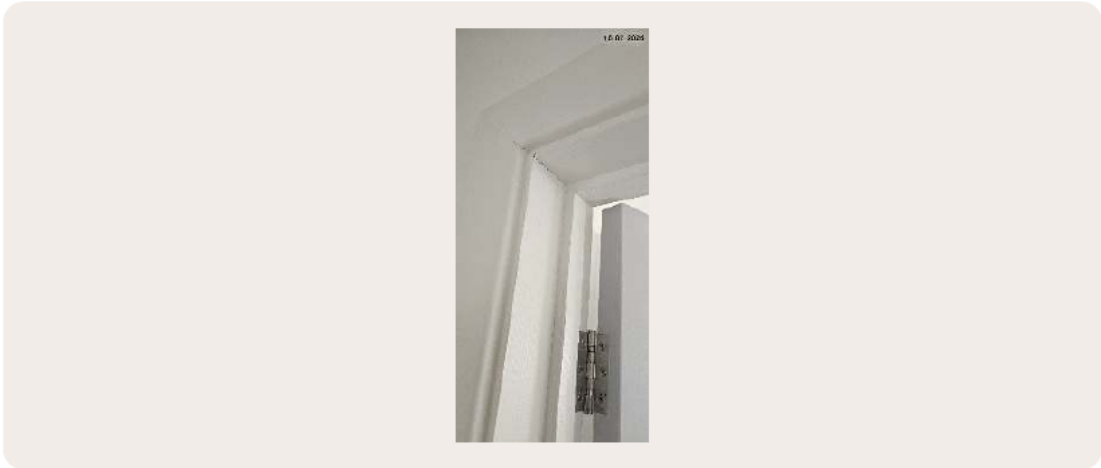
**OBSERVATION**  
A visible shrinkage gap has opened around a landing door-frame junction at recorded location 5 of 7.

**WHY THIS MATTERS**  
Visible decorative finishes should be complete, smooth and consistent at handover. Shrinkage, exposed fixings, marks, insufficient paint coverage and incomplete preparation reduce the quality of finish.

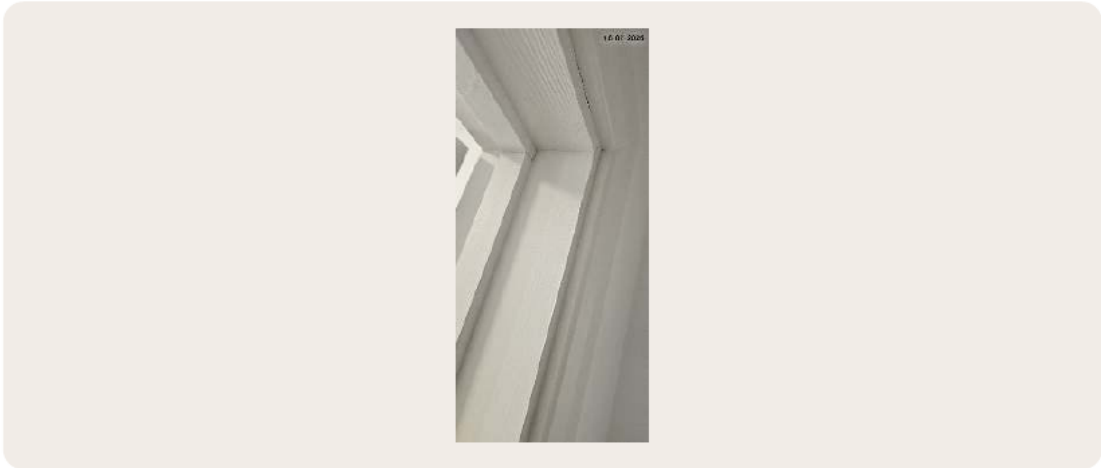
A visible shrinkage gap has opened around a landing door-frame junction at recorded location 6 of 7.

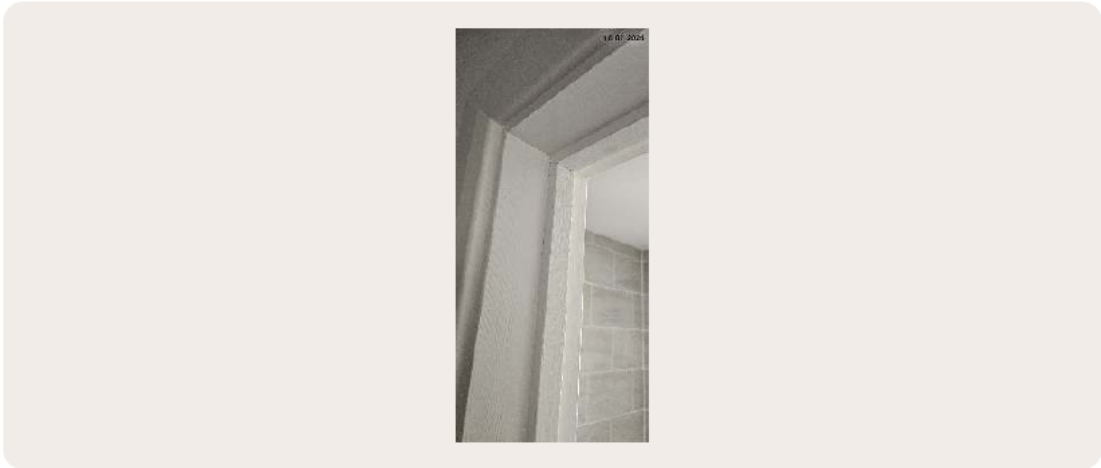
**OBSERVATION**  
A visible shrinkage gap has opened around a landing door-frame junction at recorded location 7 of 7.

**WHY THIS MATTERS**  
Visible decorative finishes should be complete, smooth and consistent at handover. Shrinkage, exposed fixings, marks, insufficient paint coverage and incomplete preparation reduce the quality of finish.

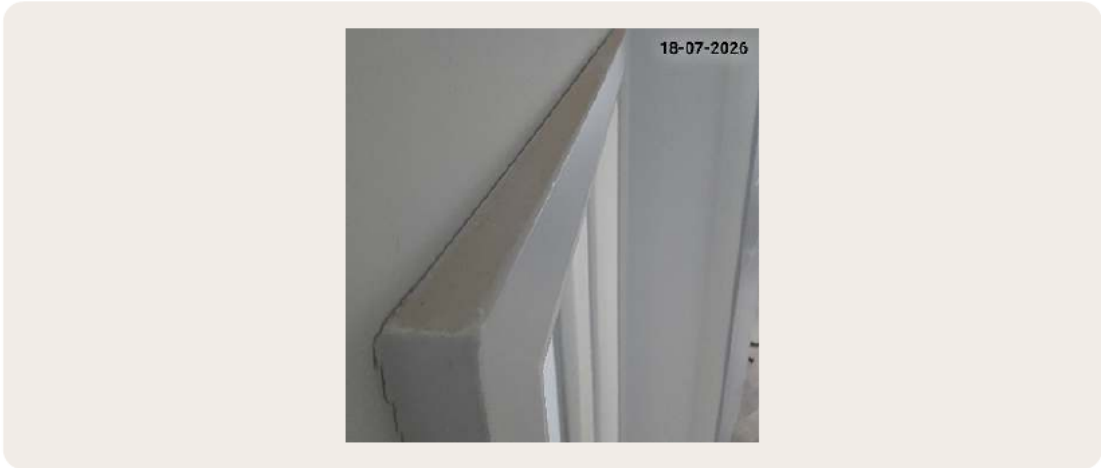
# Defect 93

**OBSERVATION**  
The landing architrave head has not been fully decorated, leaving an incomplete finish at recorded location 1 of 6.

**RECOMMENDED ACTION**  
Prepare the affected area, fill and sand as required, then redecorate to achieve a neat and uniform finish.

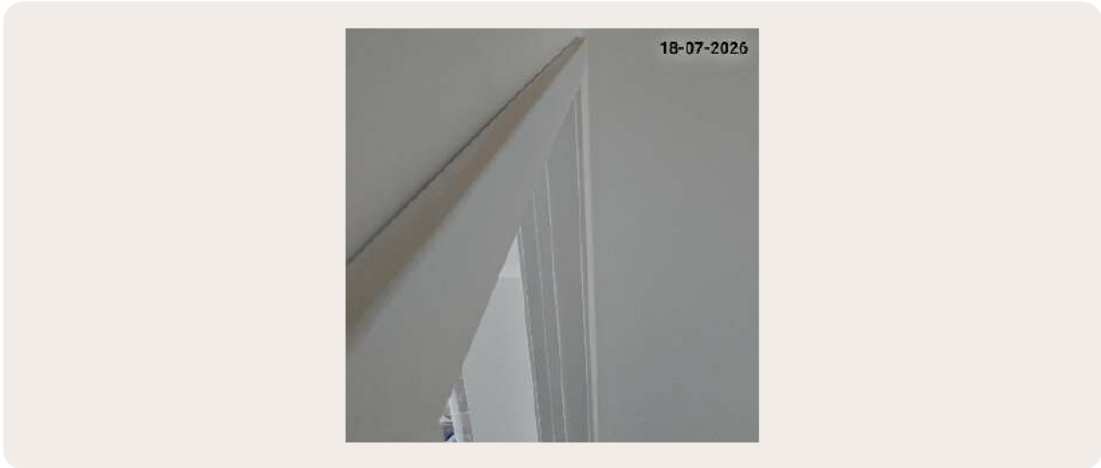
# Defect 94

**OBSERVATION**  
The landing architrave head has not been fully decorated, leaving an incomplete finish at recorded location 2 of 6.

**RECOMMENDED ACTION**  
Prepare the affected area, fill and sand as required, then redecorate to achieve a neat and uniform finish.

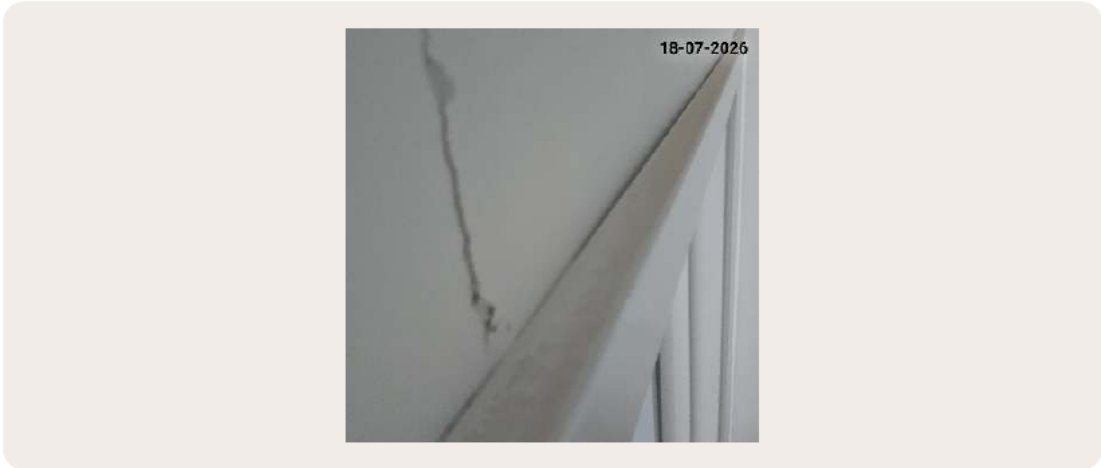
# Defect 95

**OBSERVATION**  
The landing architrave head has not been fully decorated, leaving an incomplete finish at recorded location 3 of 6.

**RECOMMENDED ACTION**  
Prepare the affected area, fill and sand as required, then redecorate to achieve a neat and uniform finish.
