# Professional Snagging Inspection Report

Post-completion inspection

Inspection date: 18 July 2026

South Wales Snagging Co was instructed to undertake a visual, non-destructive post-completion snagging inspection of an anonymised new-build property in South Wales. This report records visible defects, incomplete items and areas requiring developer or aftercare attention based on the condition observed on 18 July 2026.

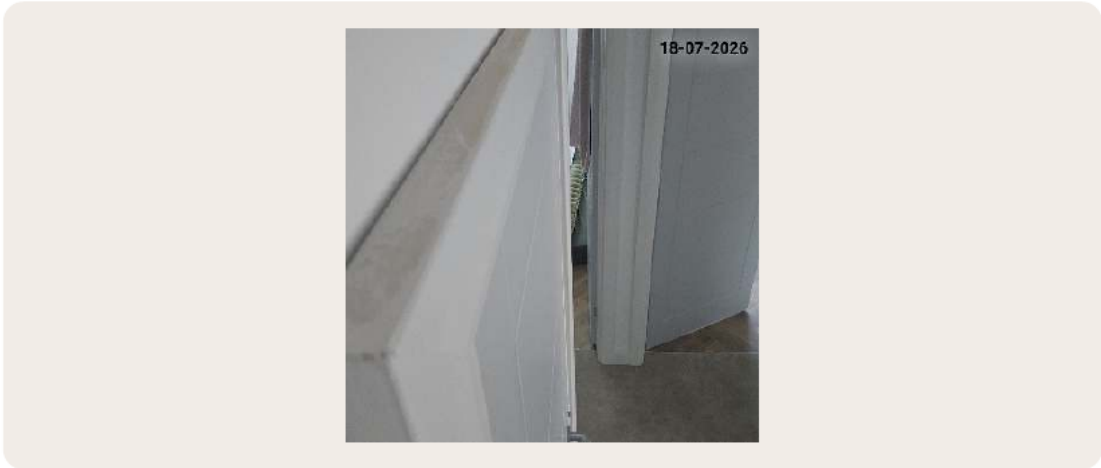
Defect 96

The landing architrave head has not been fully decorated, leaving an incomplete finish at recorded location 4 of 6.

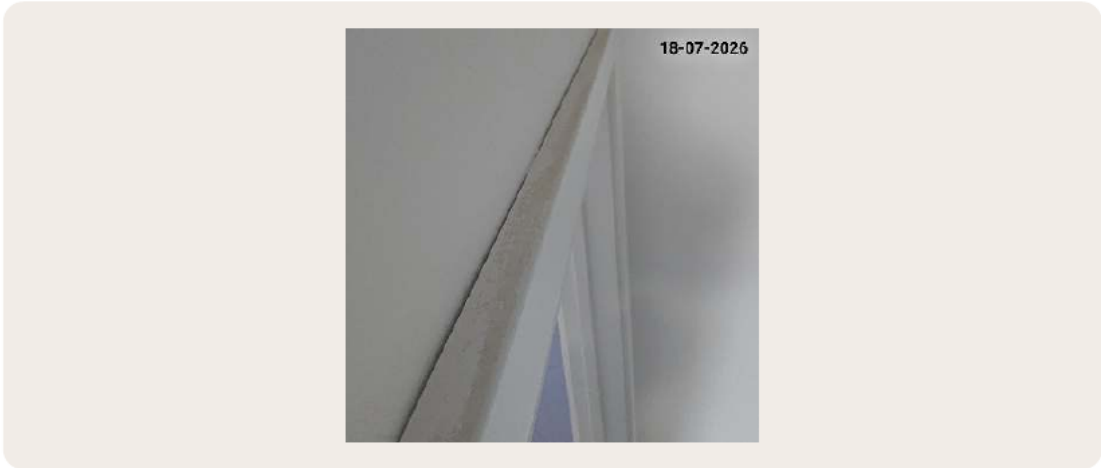
# Defect 97

**OBSERVATION**  
The landing architrave head has not been fully decorated, leaving an incomplete finish at recorded location 5 of 6.

**RECOMMENDED ACTION**  
Prepare the affected area, fill and sand as required, then redecorate to achieve a neat and uniform finish.

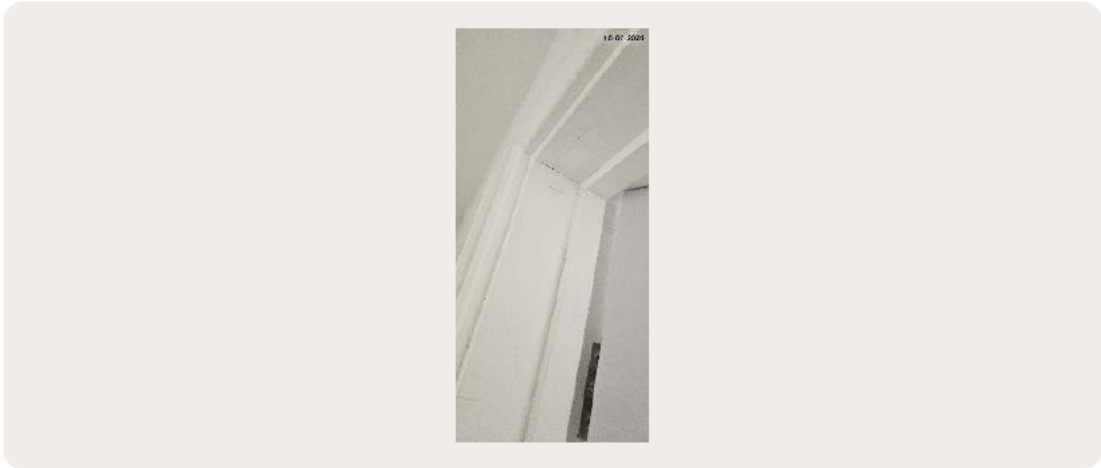
# Defect 98

**OBSERVATION**  
The landing architrave head has not been fully decorated, leaving an incomplete finish at recorded location 6 of 6.

**RECOMMENDED ACTION**  
Prepare the affected area, fill and sand as required, then redecorate to achieve a neat and uniform finish.

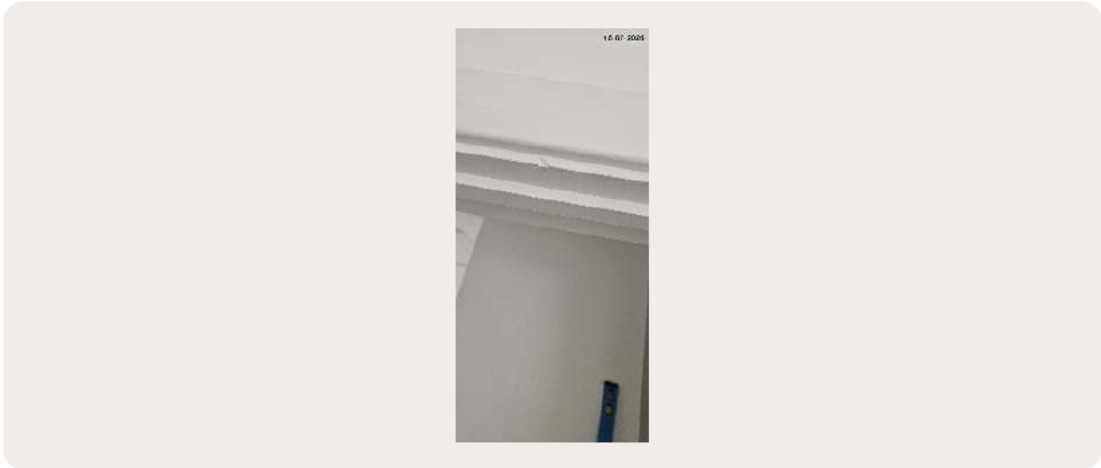
# Defect 99

**OBSERVATION**  
A localised indentation is visible in the bedroom 3 architrave head.

**RECOMMENDED ACTION**  
Prepare the affected area, fill and sand as required, then redecorate to achieve a neat and uniform finish.

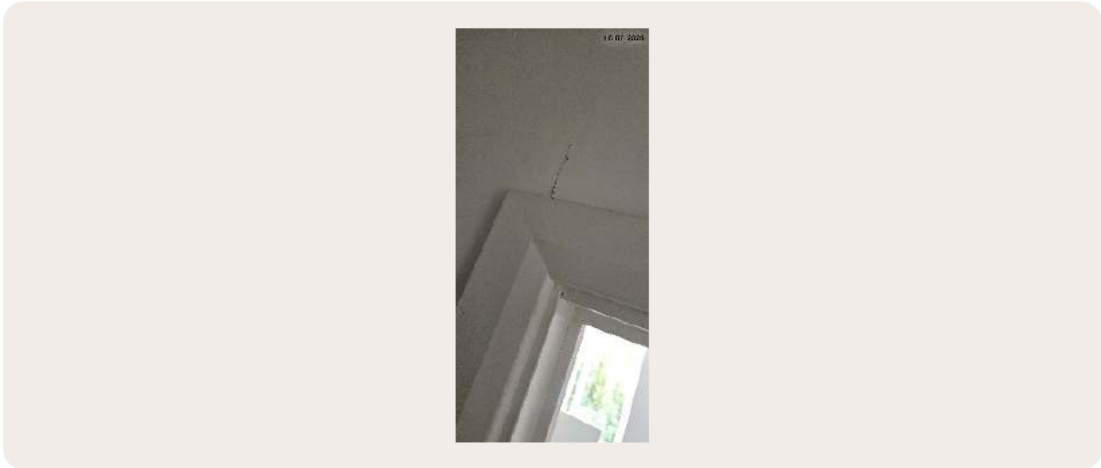
# Defect 100

Scrim tape above the bedroom 3 door has debonded and is visibly raised from the finished surface.

Plasterboard linings, joints, tapes and reveals should be securely formed, straight and finished without visible distortion or failed jointing materials.

Remove the failed scrim tape, re-tape the joint, apply suitable finishing coats, sand smooth and redecorate after drying.

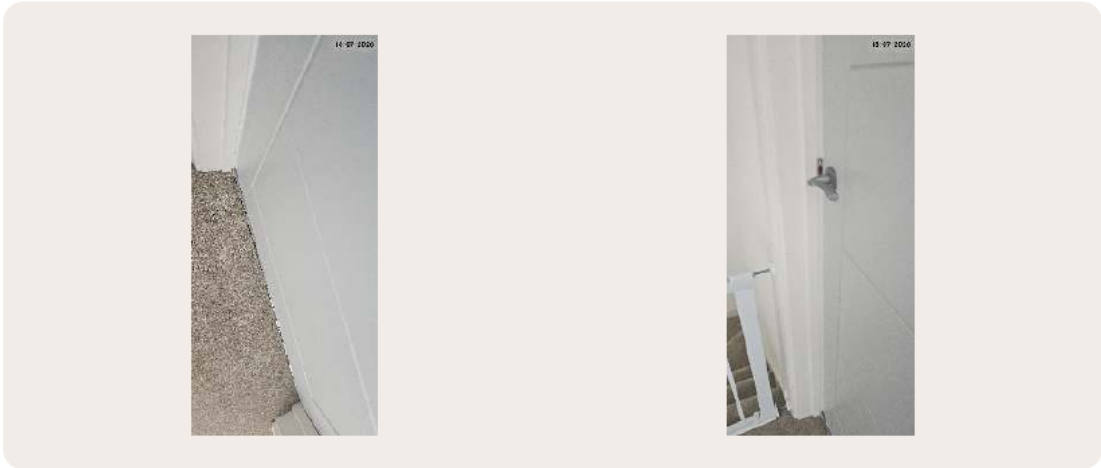
# Defect 101

**OBSERVATION**  
The bedroom door catches on the door bar and requires adjustment following the flooring installation.

**RECOMMENDED ACTION**  
Adjust, secure, ease, repair or replace the affected item as required, then make good disturbed finishes and confirm correct operation.

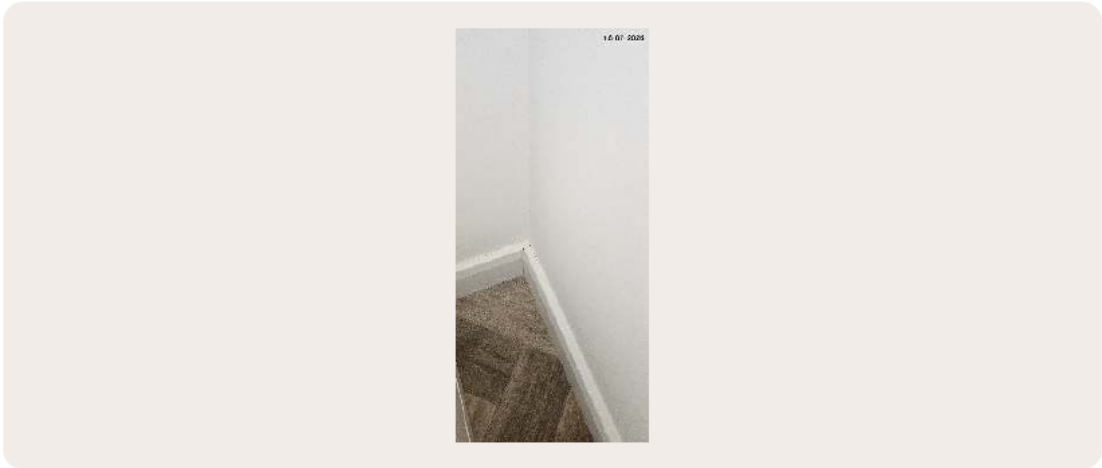
# Defect 102

An excessive shrinkage gap has opened at a bedroom 3 skirting or architrave junction at recorded location 1 of 5.

Prepare the affected junction, remove loose caulk, apply suitable decorator's caulk, smooth it neatly and redecorate to match the surrounding finish.

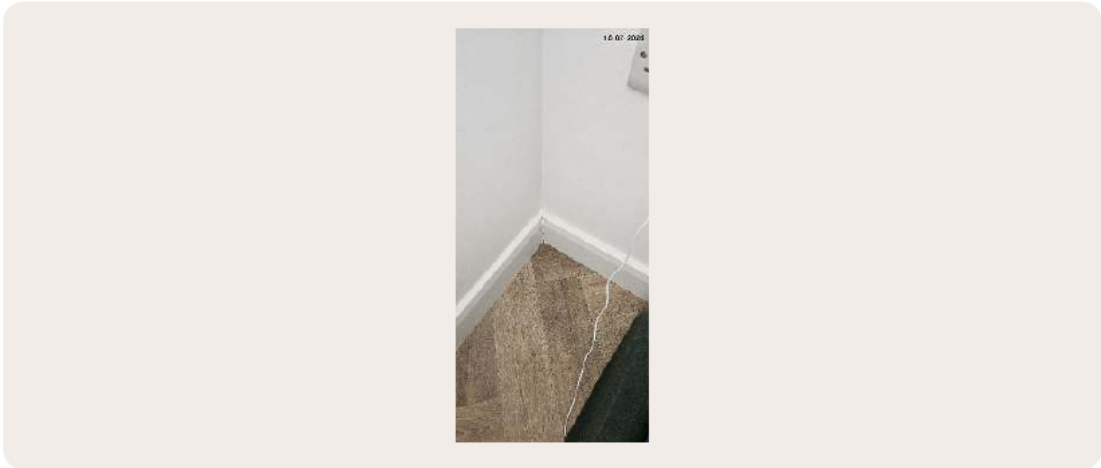
# Defect 103

**OBSERVATION**  
An excessive shrinkage gap has opened at a bedroom 3 skirting or architrave junction at recorded location 2 of 5.

**RECOMMENDED ACTION**  
Prepare the affected junction, remove loose caulk, apply suitable decorator's caulk, smooth it neatly and redecorate to match the surrounding finish.

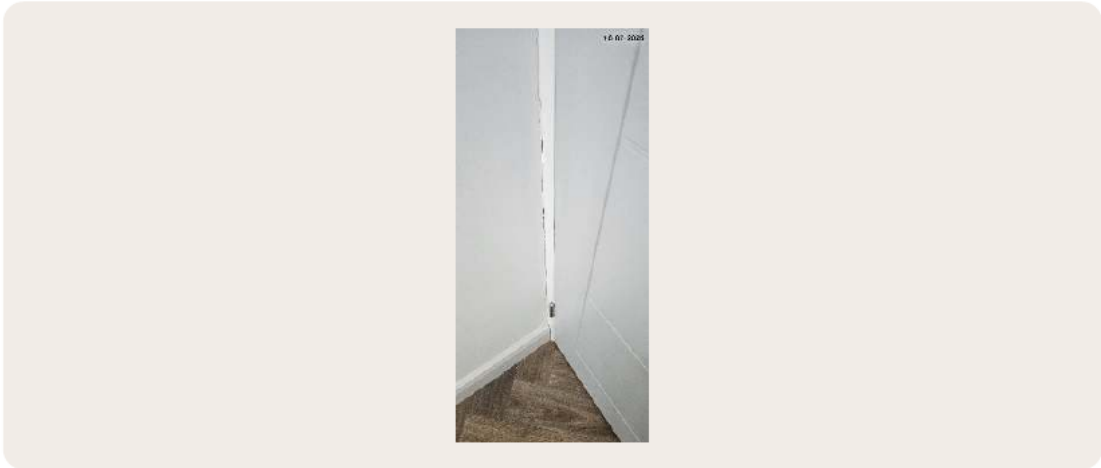
# Defect 104

**OBSERVATION**  
An excessive shrinkage gap has opened at a bedroom 3 skirting or architrave junction at recorded location 3 of 5.

**RECOMMENDED ACTION**  
Prepare the affected junction, remove loose caulk, apply suitable decorator's caulk, smooth it neatly and redecorate to match the surrounding finish.

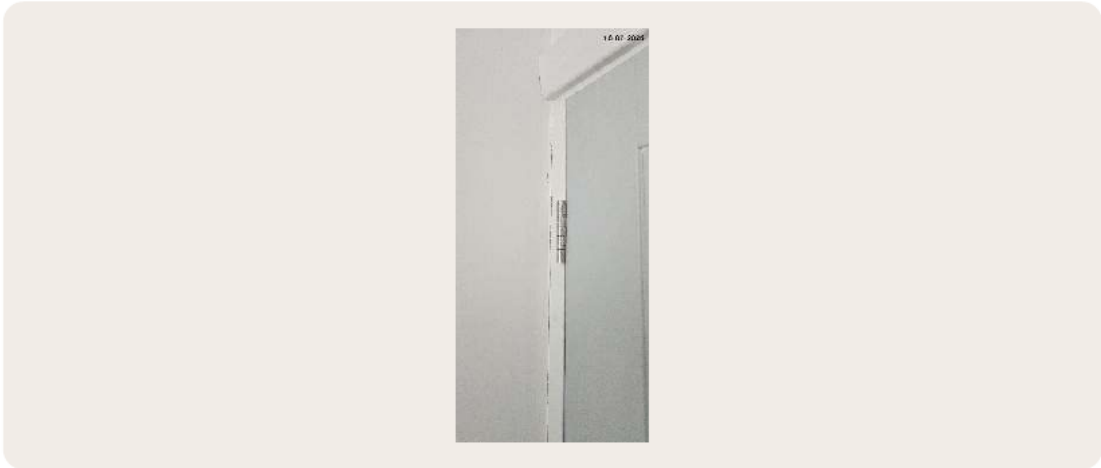
# Defect 105

**OBSERVATION**  
An excessive shrinkage gap has opened at a bedroom 3 skirting or architrave junction at recorded location 4 of 5.

**RECOMMENDED ACTION**  
Prepare the affected junction, remove loose caulk, apply suitable decorator's caulk, smooth it neatly and redecorate to match the surrounding finish.

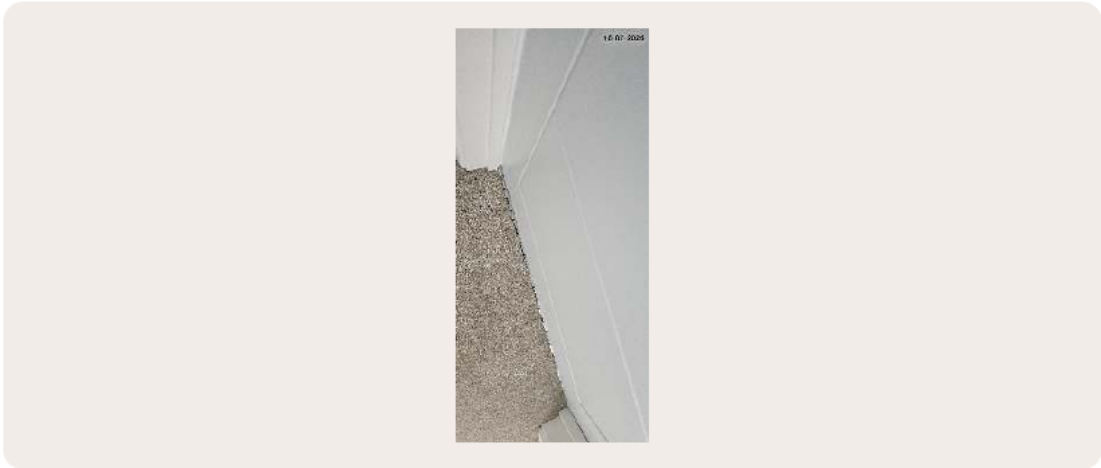
# Defect 106

**OBSERVATION**  
An excessive shrinkage gap has opened at a bedroom 3 skirting or architrave junction at recorded location 5 of 5.

**RECOMMENDED ACTION**  
Prepare the affected junction, remove loose caulk, apply suitable decorator's caulk, smooth it neatly and redecorate to match the surrounding finish.

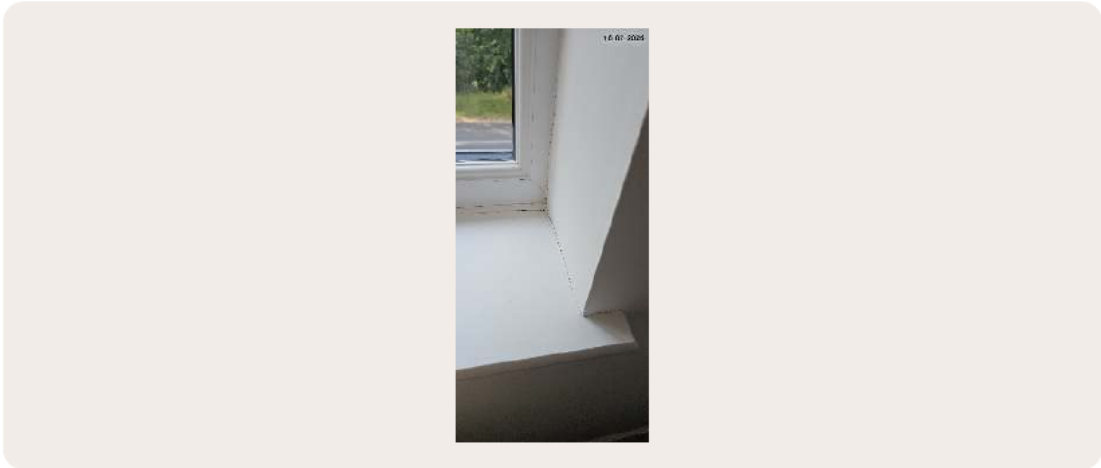
# Defect 107

**OBSERVATION**  
A visible shrinkage gap has opened around the bedroom 3 window junction at recorded location 1 of 2.

**RECOMMENDED ACTION**  
Prepare the affected junction, remove loose caulk, apply suitable decorator's caulk, smooth it neatly and redecorate to match the surrounding finish.

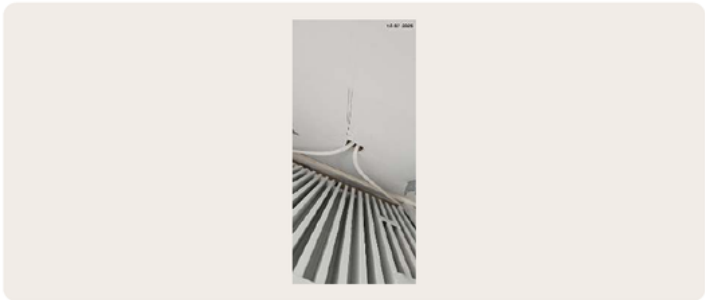
# Defect 109

The radiator pipe guide and seal is missing, leaving an unfinished opening behind the radiator.

Openings around radiator pipework should be properly sealed and finished. The missing radiator pipe guide and seal leaves an unfinished penetration and may allow draughts around the service route.

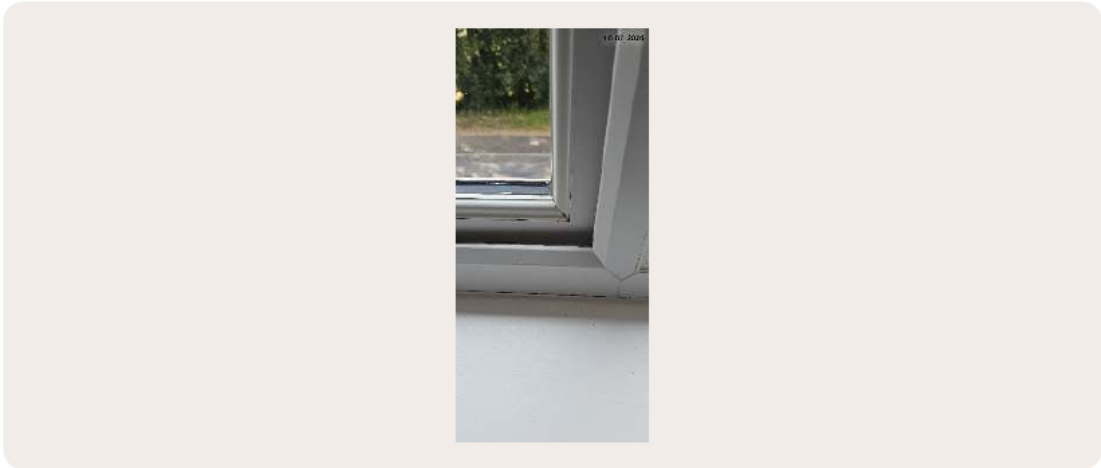
# Defect 111

**OBSERVATION**  
The window catches on the receiver and requires adjustment.

**RECOMMENDED ACTION**  
The window fitter should adjust, repair or replace the affected item and confirm correct operation, alignment and weather sealing in accordance with the manufacturer instructions.

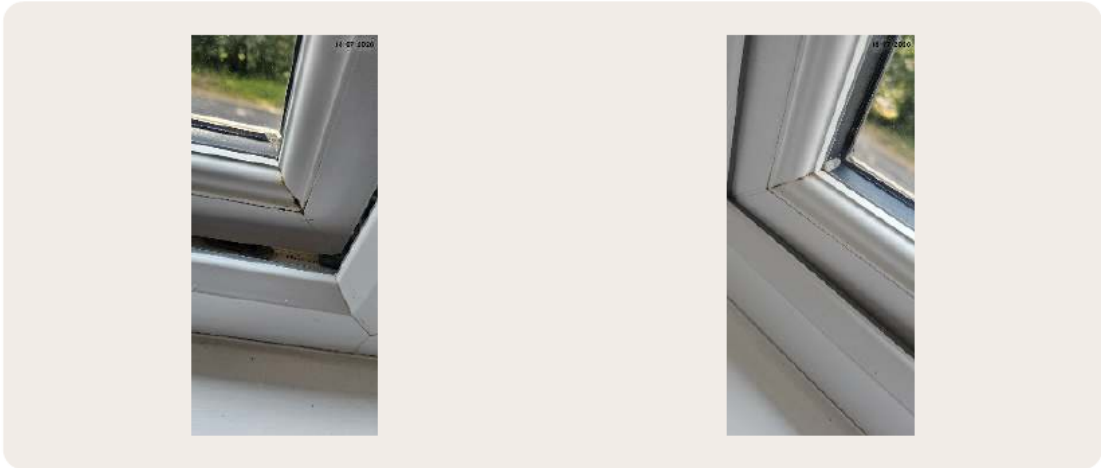
# Defect 112

**OBSERVATION**  
Dirty marks remain at the window bead mitres.

**RECOMMENDED ACTION**  
Remove the debris or contamination using a suitable non-damaging cleaning method and leave the area clean and ready for normal use.

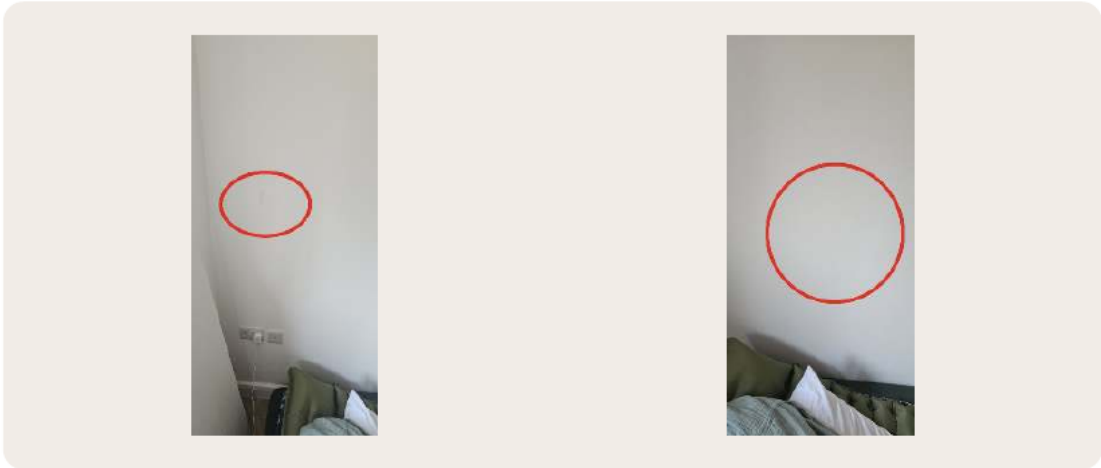
# Defect 113

**OBSERVATION**  
Visible marks remain on the wall above the electrical sockets.

**RECOMMENDED ACTION**  
Prepare the affected area, fill and sand as required, then redecorate to achieve a neat and uniform finish.

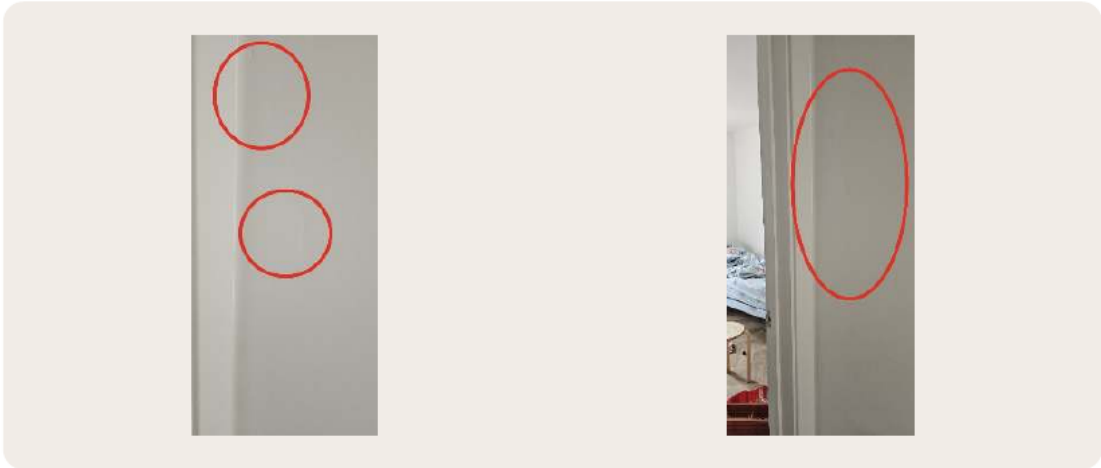
# Defect 114

**OBSERVATION**  
Localised indentations are visible in the wall finish beside the architrave.

**RECOMMENDED ACTION**  
Prepare the affected area, fill and sand as required, then redecorate to achieve a neat and uniform finish.

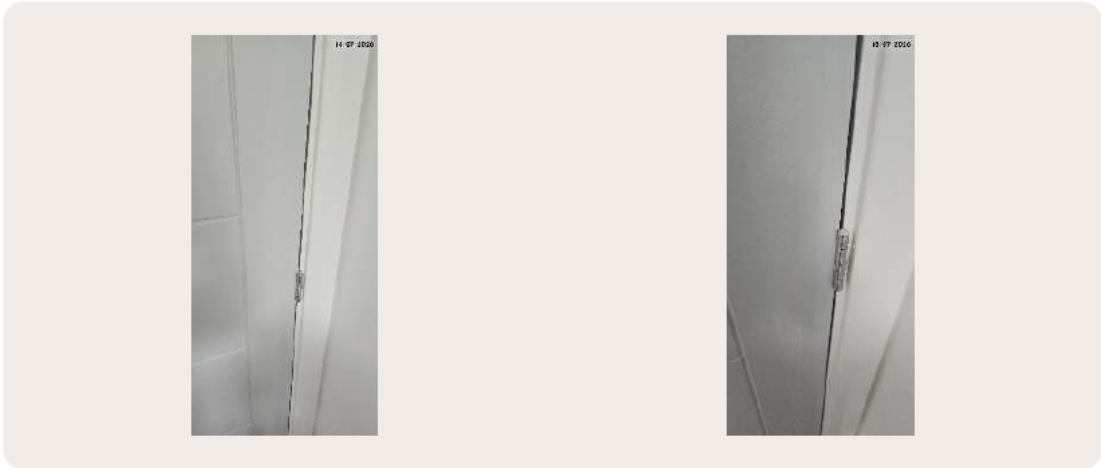
# Defect 115

**OBSERVATION**  
The decorative finish to the bedroom 2 door is uneven and does not provide a neat, consistent appearance.

**RECOMMENDED ACTION**  
Adjust, secure, ease, repair or replace the affected item as required, then make good disturbed finishes and confirm correct operation.

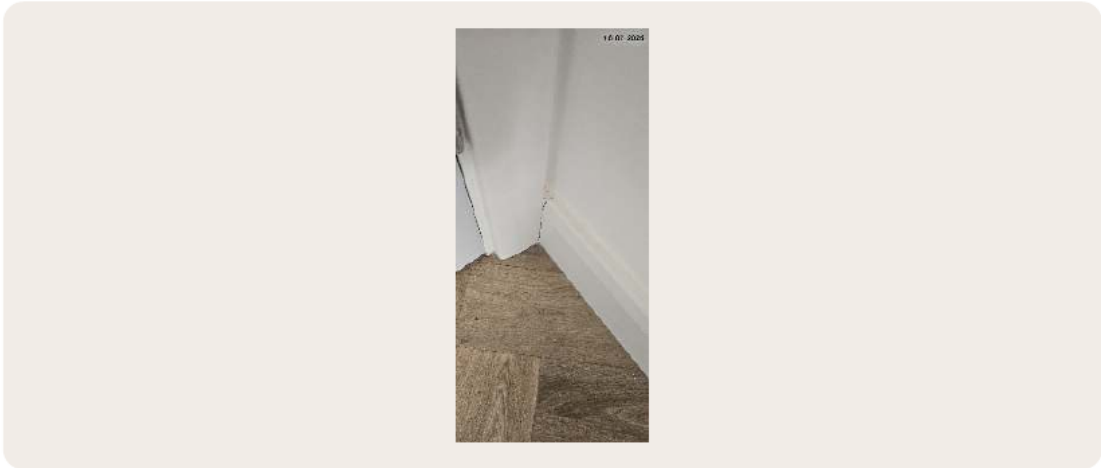
# Defect 116

A visible shrinkage gap has opened at the bedroom 2 skirting-board junction.

Prepare the affected junction, remove loose caulk, apply suitable decorator's caulk, smooth it neatly and redecorate to match the surrounding finish.

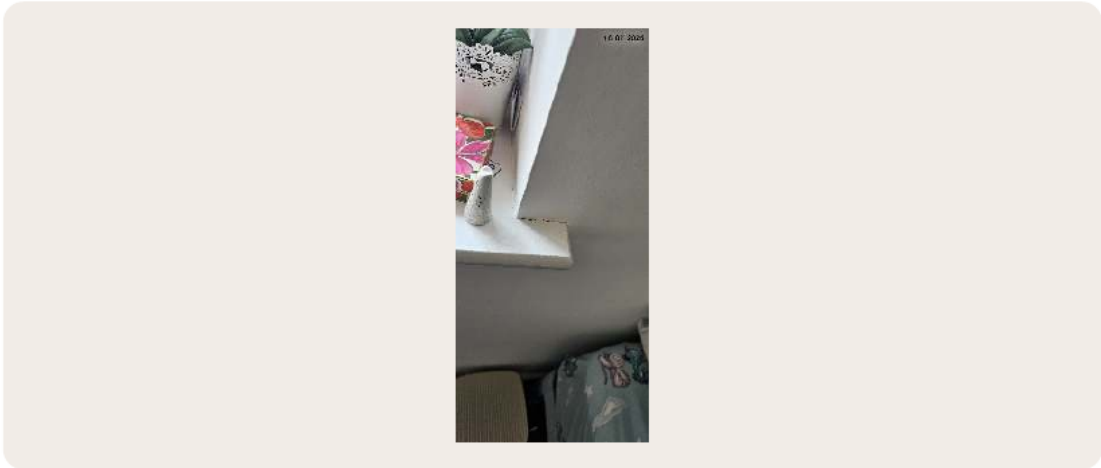
# Defect 117

A visible shrinkage gap has opened around the bedroom 2 window junction at recorded location 1 of 3.

Prepare the affected junction, remove loose caulk, apply suitable decorator's caulk, smooth it neatly and redecorate to match the surrounding finish.

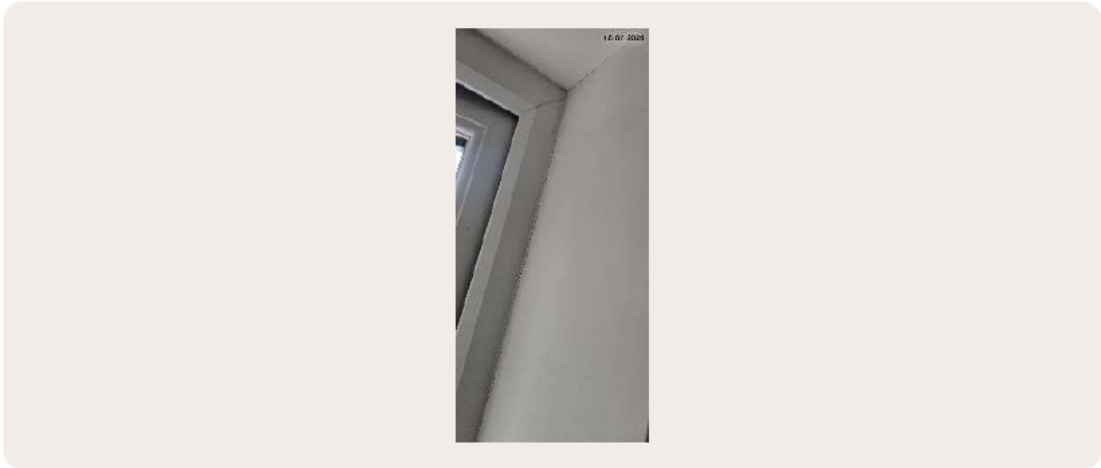
# Defect 118

A visible shrinkage gap has opened around the bedroom 2 window junction at recorded location 2 of 3.

Prepare the affected junction, remove loose caulk, apply suitable decorator's caulk, smooth it neatly and redecorate to match the surrounding finish.

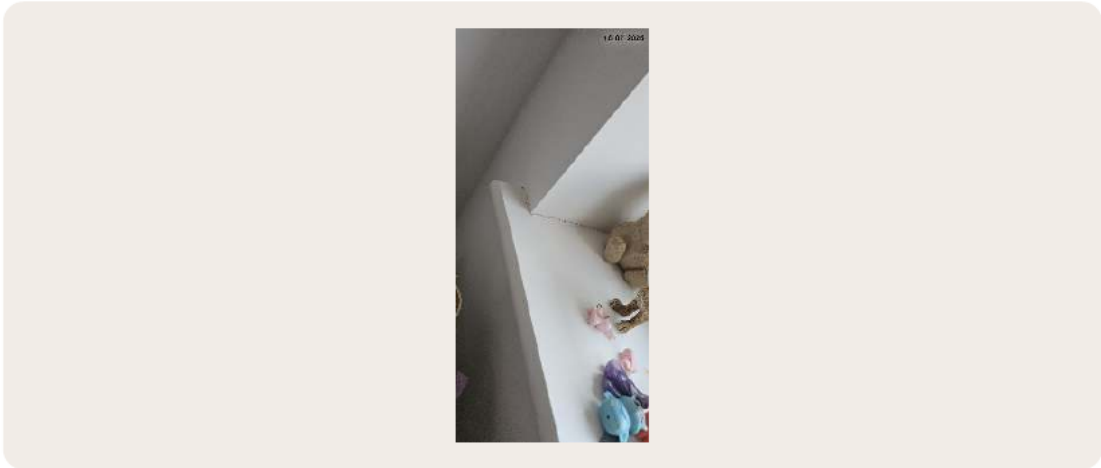
# Defect 119

**OBSERVATION**  
A visible shrinkage gap has opened around the bedroom 2 window junction at recorded location 3 of 3.

**RECOMMENDED ACTION**  
Prepare the affected junction, remove loose caulk, apply suitable decorator's caulk, smooth it neatly and redecorate to match the surrounding finish.

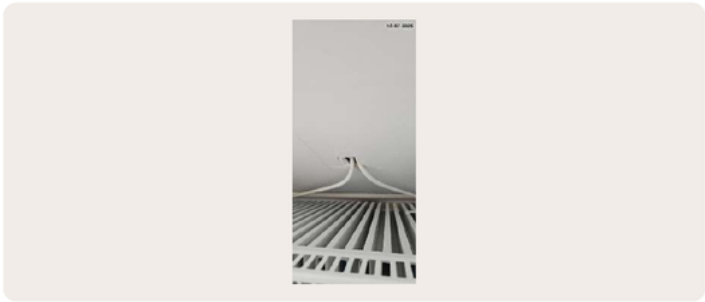
# Defect 120

The radiator pipe guide and seal is missing, leaving an unfinished opening behind the radiator.

Openings around radiator pipework should be properly sealed and finished. The missing radiator pipe guide and seal leaves an unfinished penetration and may allow draughts around the service route.

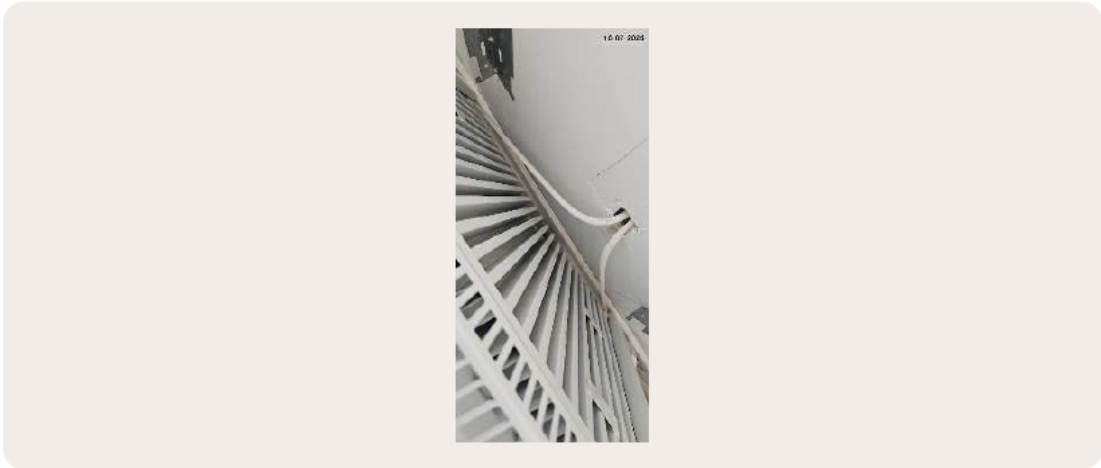
# Defect 121

The skirting board behind the radiator has not been decorated.

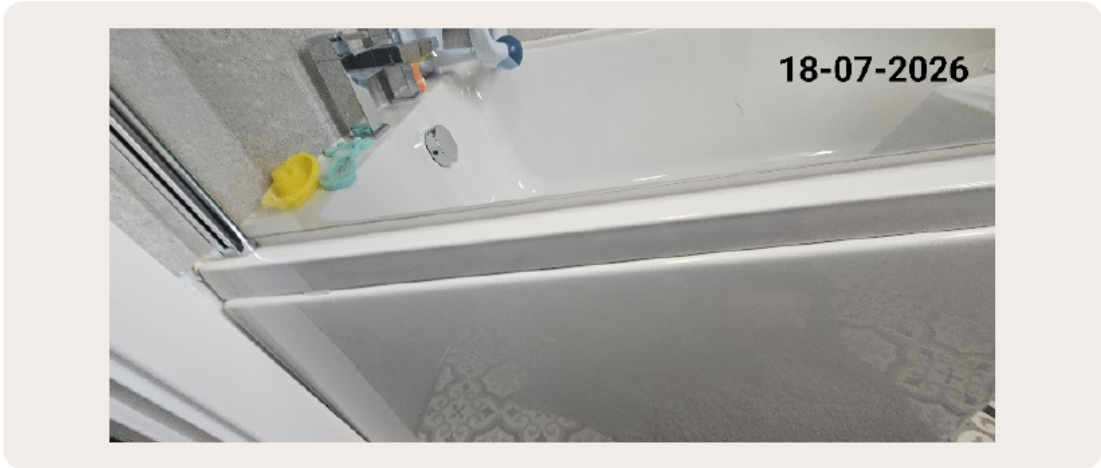
# Defect 123

**OBSERVATION**  
The shower door seal is missing.

**RECOMMENDED ACTION**  
Secure, connect, repair or replace the affected item, then test for stability, correct operation and leaks.

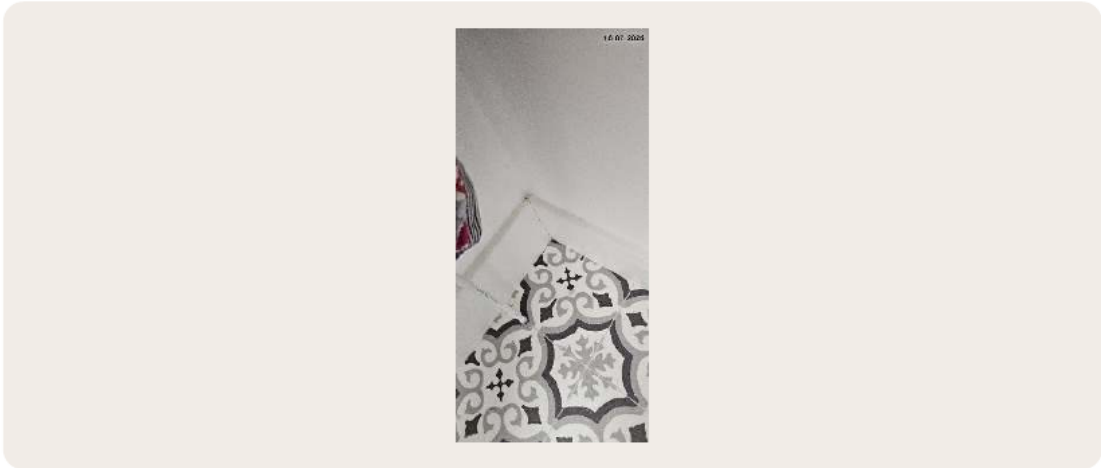
# Defect 124

A visible shrinkage gap has opened at a bathroom skirting-board junction at recorded location 1 of 3.

Prepare the affected junction, remove loose caulk, apply suitable decorator's caulk, smooth it neatly and redecorate to match the surrounding finish.

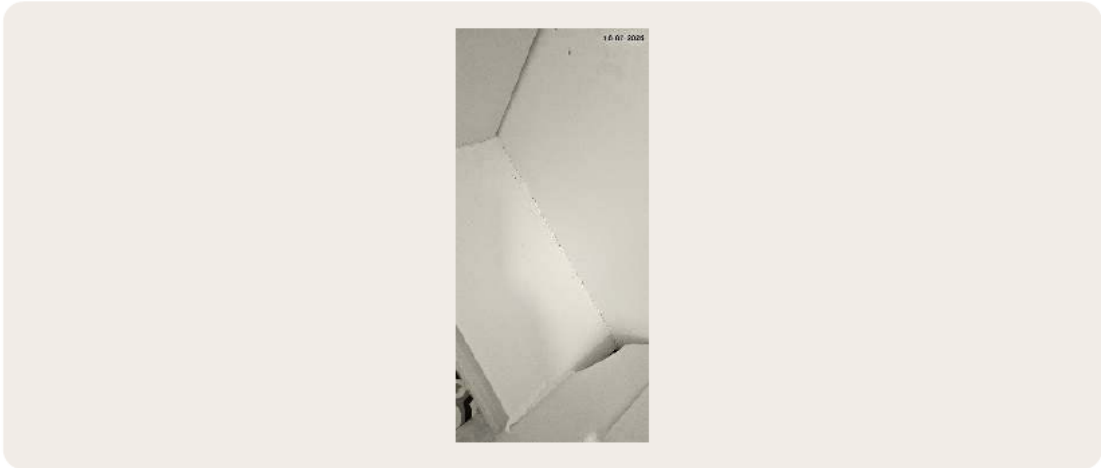
# Defect 125

**OBSERVATION**  
A visible shrinkage gap has opened at a bathroom skirting-board junction at recorded location 2 of 3.

**RECOMMENDED ACTION**  
Prepare the affected junction, remove loose caulk, apply suitable decorator's caulk, smooth it neatly and redecorate to match the surrounding finish.

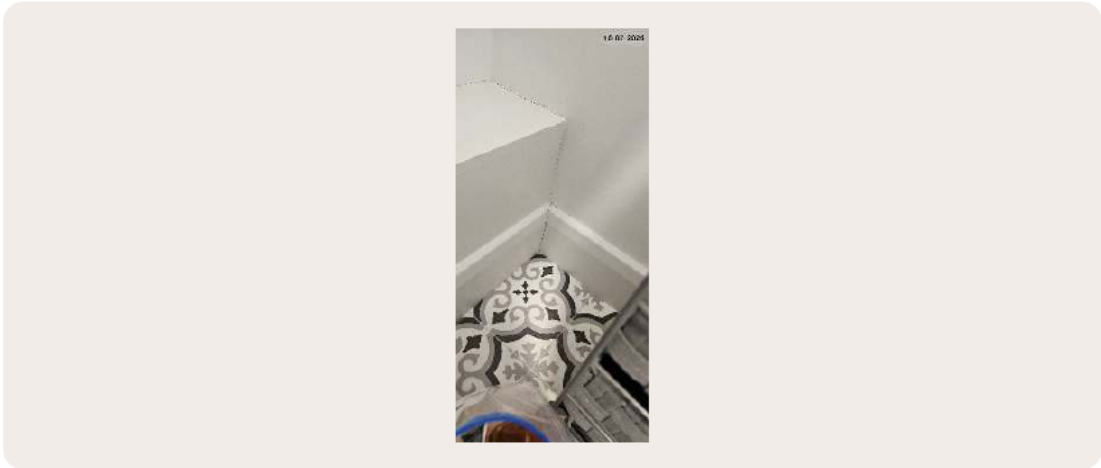
# Defect 126

A visible shrinkage gap has opened at a bathroom skirting-board junction at recorded location 3 of 3.

Prepare the affected junction, remove loose caulk, apply suitable decorator's caulk, smooth it neatly and redecorate to match the surrounding finish.

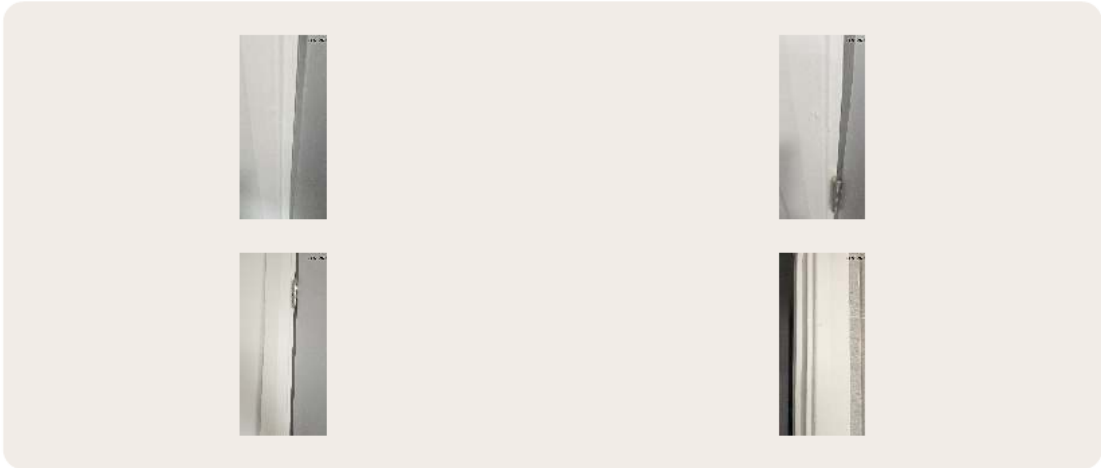
# Defect 127

**OBSERVATION**  
Pin heads to the architrave have not been filled and sanded flush.

**RECOMMENDED ACTION**  
Prepare the affected area, fill and sand as required, then redecorate to achieve a neat and uniform finish.

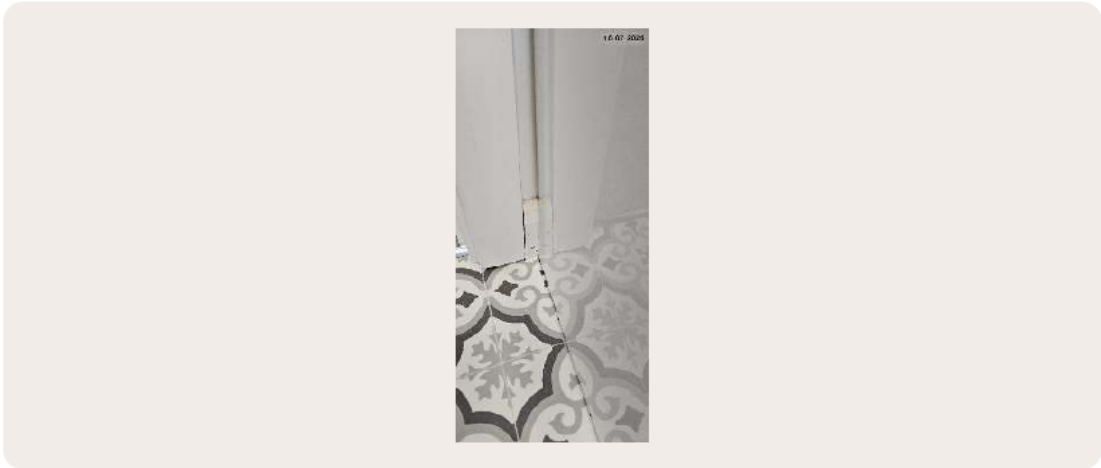
# Defect 128

**OBSERVATION**  
The skirting board beside the bath has not been decorated.

**RECOMMENDED ACTION**  
Prepare the affected area, fill and sand as required, then redecorate to achieve a neat and uniform finish.

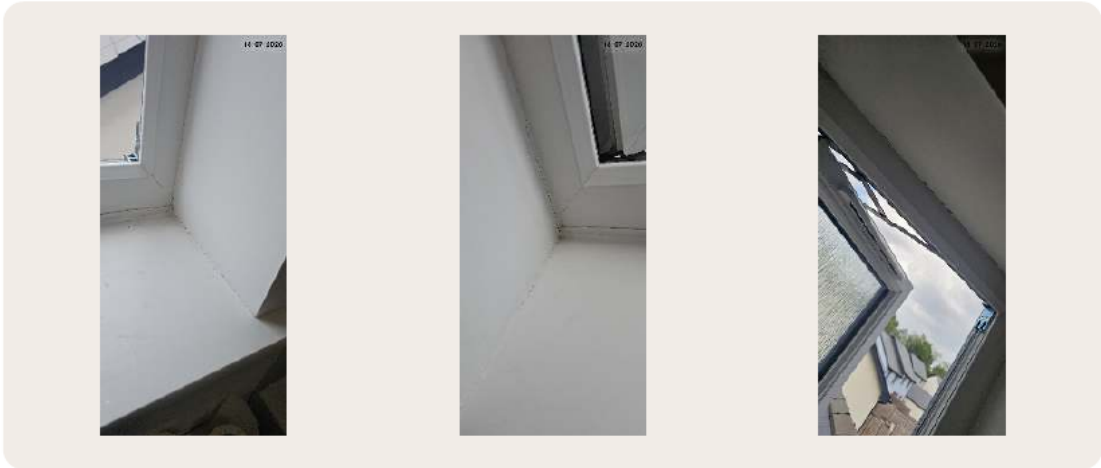
# Defect 129

**OBSERVATION**  
A visible shrinkage gap has opened around the bathroom window-frame junction.

**RECOMMENDED ACTION**  
Prepare the affected junction, remove loose caulk, apply suitable decorator's caulk, smooth it neatly and redecorate to match the surrounding finish.

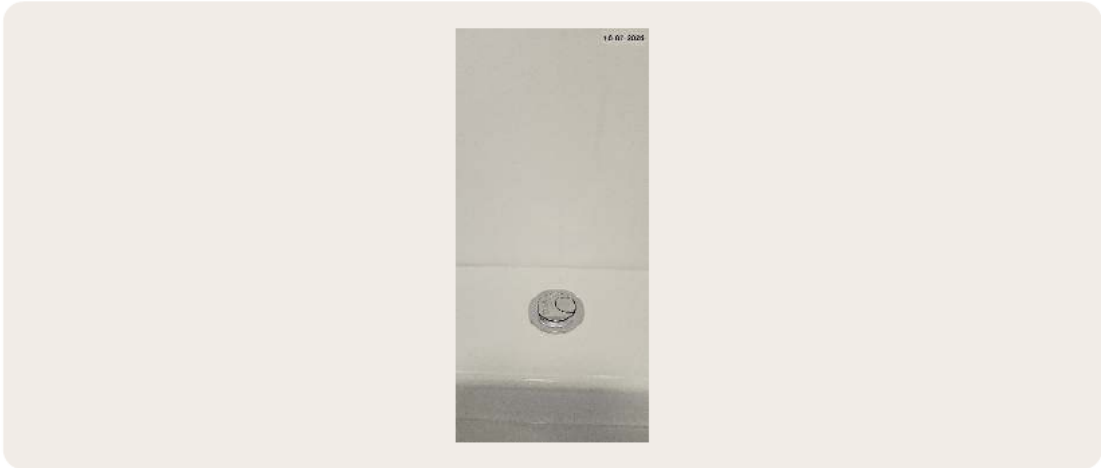
# Defect 130

Pencil marks remain on the wall above the WC.

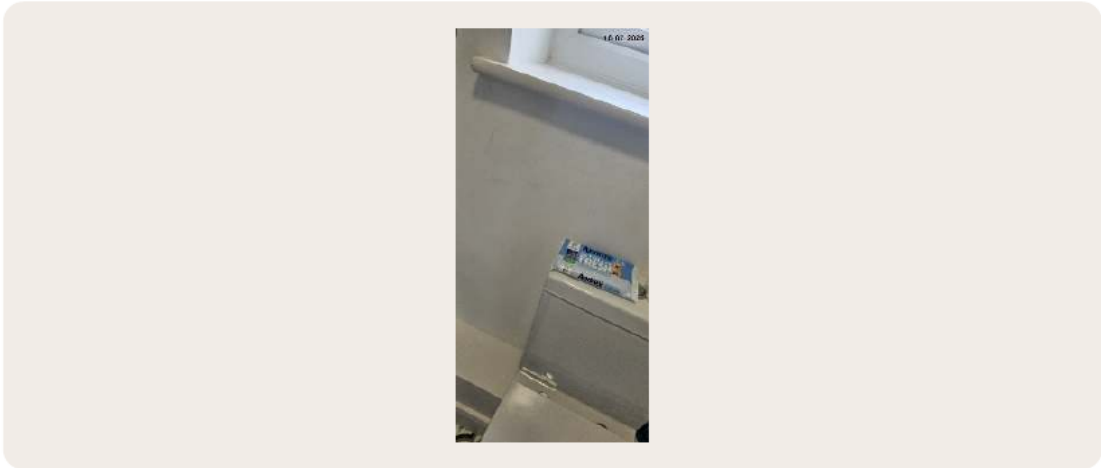
# Defect 131

The wall finish behind the WC is poor.

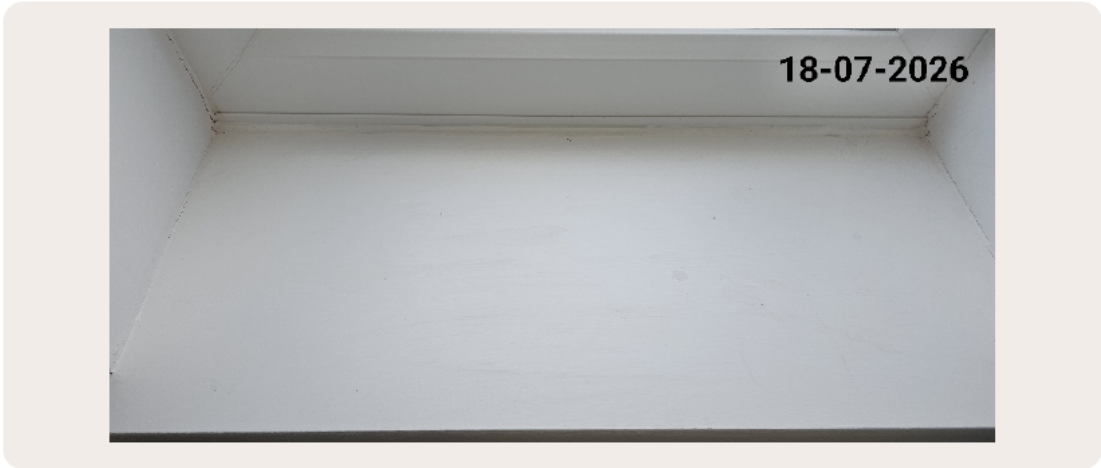
**OBSERVATION**  
The bathroom window sill has an uneven and incomplete surface finish.

**WHY THIS MATTERS**  
Visible decorative finishes should be complete, smooth and consistent. Uneven preparation or incomplete coating reduces the quality and durability of the finished surface.

**RECOMMENDED ACTION**  
Prepare the sill, fill and sand defects as required, then redecorate to provide a smooth, uniform and durable finish without contaminating the window frame or sealant joints.

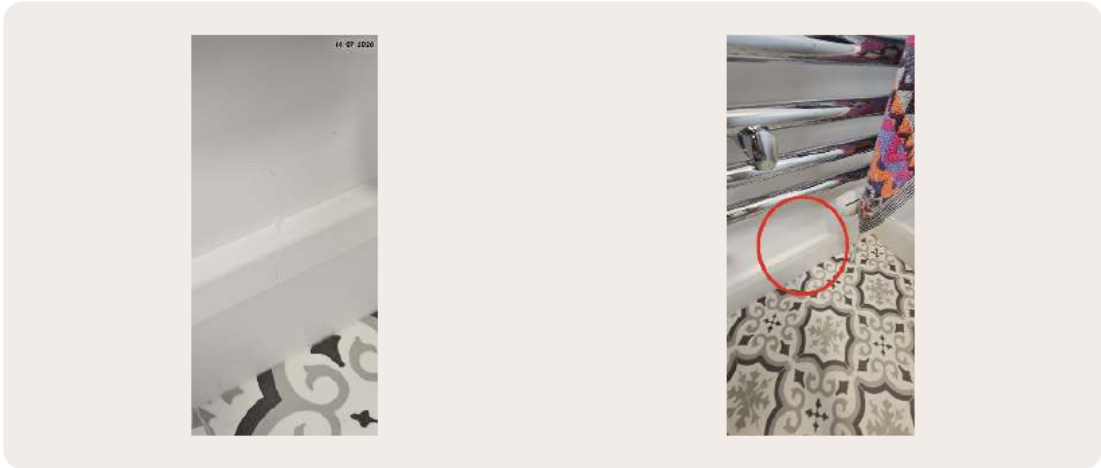
# Defect 133

A paint run is visible above the skirting board.

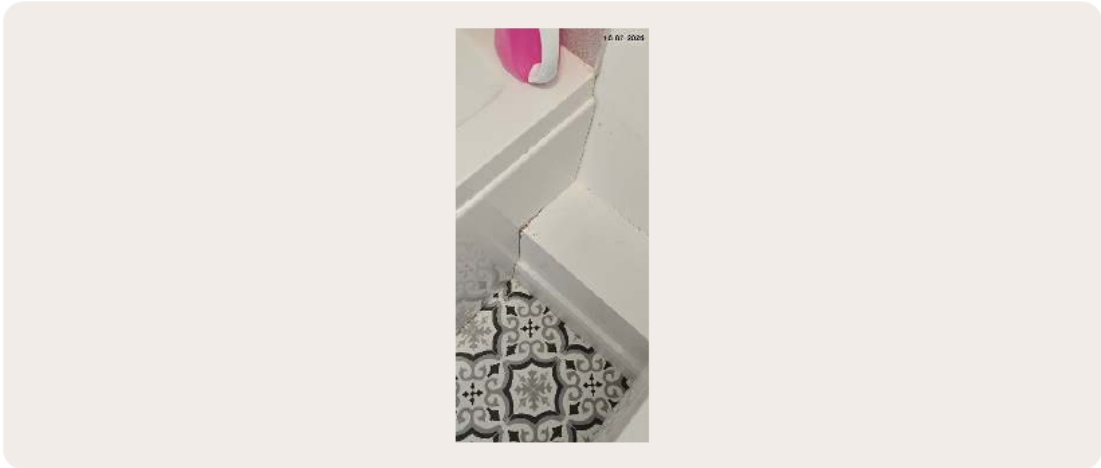
# Defect 135

**OBSERVATION**  
The boxing behind the WC has an uneven and incomplete finish.

**WHY THIS MATTERS**  
Boxing and associated decorative surfaces should be properly prepared and finished to a smooth, consistent standard. Incomplete finishing detracts from the quality of the bathroom and can make future cleaning more difficult.

**RECOMMENDED ACTION**  
Prepare the boxing, fill and sand uneven areas as required, then redecorate to achieve a neat and uniform finish. Protect the WC, pipework and sealant joints while the work is completed.

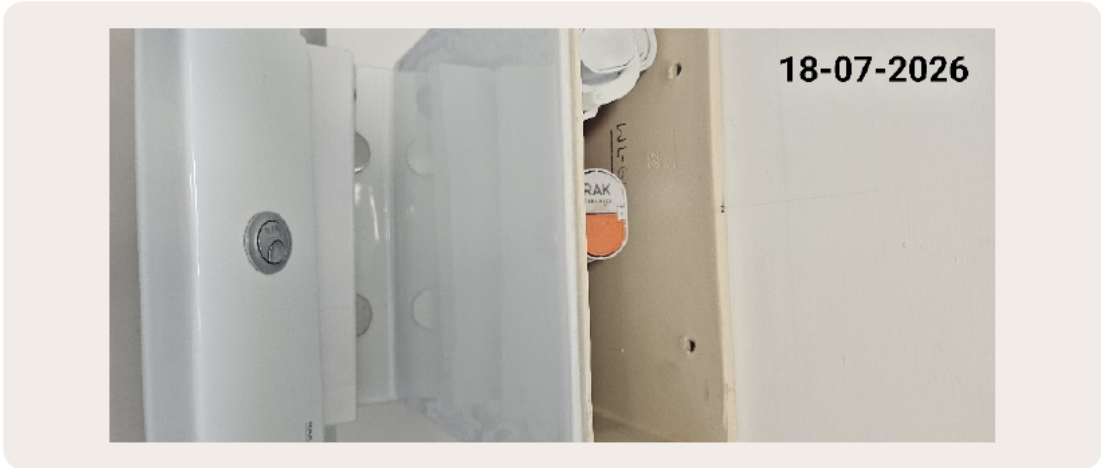
# Defect 136

**OBSERVATION**  
The WC cistern is not secured to the wall.

**WHY THIS MATTERS**  
Sanitary fittings, waste connections and plumbing items should be securely fixed and correctly connected for safe, reliable and watertight use.

**RECOMMENDED ACTION**  
Secure, connect, repair or replace the affected item, then test for stability, correct operation and leaks.

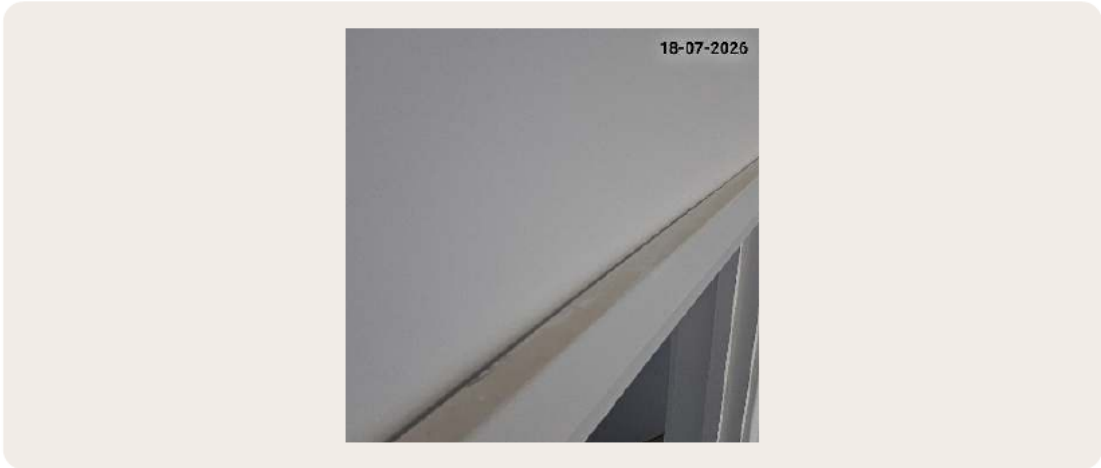
# Defect 137

**OBSERVATION**  
The bathroom architrave head has not been fully decorated, leaving an incomplete finish.

**WHY THIS MATTERS**  
Visible decorative finishes should be complete, smooth and consistent at handover. Shrinkage, exposed fixings, marks, insufficient paint coverage and incomplete preparation reduce the quality of finish.

**RECOMMENDED ACTION**  
Prepare the affected area, fill and sand as required, then redecorate to achieve a neat and uniform finish.

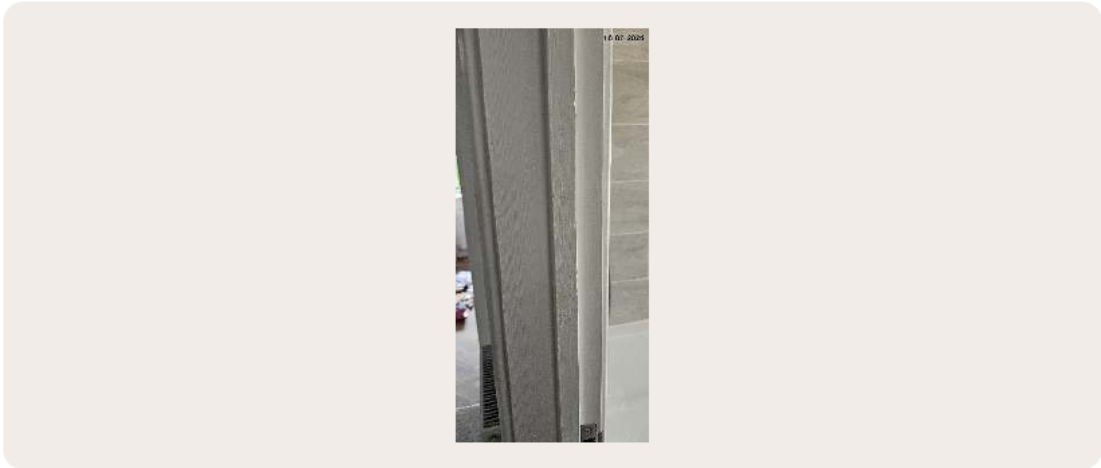
# Defect 138

**OBSERVATION**  
Resin staining from timber knots is visible through the decorative finish to the door stops.

**WHY THIS MATTERS**  
Visible decorative finishes should be complete, smooth and consistent at handover. Shrinkage, exposed fixings, marks, insufficient paint coverage and incomplete preparation reduce the quality of finish.

**RECOMMENDED ACTION**  
Prepare the affected area, fill and sand as required, then redecorate to achieve a neat and uniform finish.
