# Professional Snagging Inspection Report

Post-completion inspection

Inspection date: 18 July 2026

South Wales Snagging Co was instructed to undertake a visual, non-destructive post-completion snagging inspection of an anonymised new-build property in South Wales. This report records visible defects, incomplete items and areas requiring developer or aftercare attention based on the condition observed on 18 July 2026.

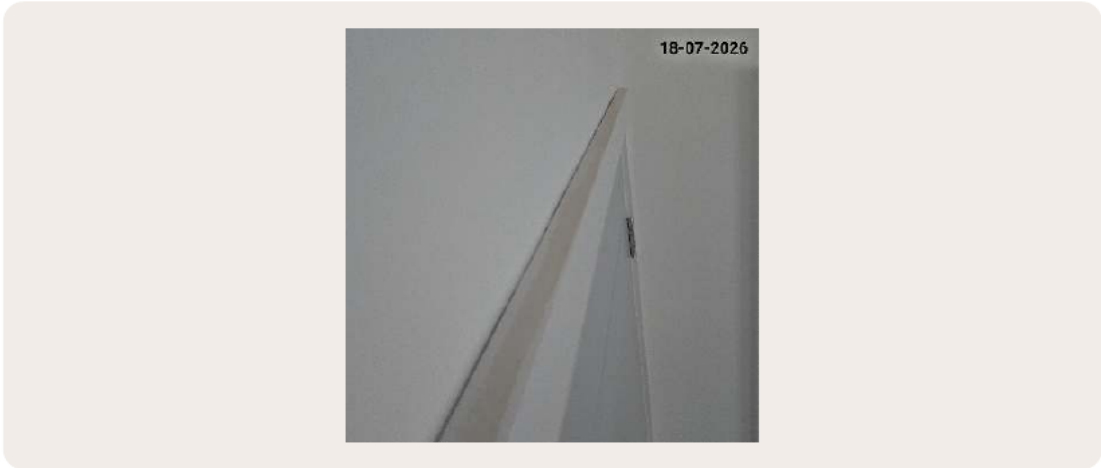
# Defect 139

**OBSERVATION**  
The bedroom 1 architrave head has not been fully decorated, leaving an incomplete finish.

**WHY THIS MATTERS**  
Visible decorative finishes should be complete, smooth and consistent at handover. Shrinkage, exposed fixings, marks, insufficient paint coverage and incomplete preparation reduce the quality of finish.

**RECOMMENDED ACTION**  
Prepare the affected area, fill and sand as required, then redecorate to achieve a neat and uniform finish.

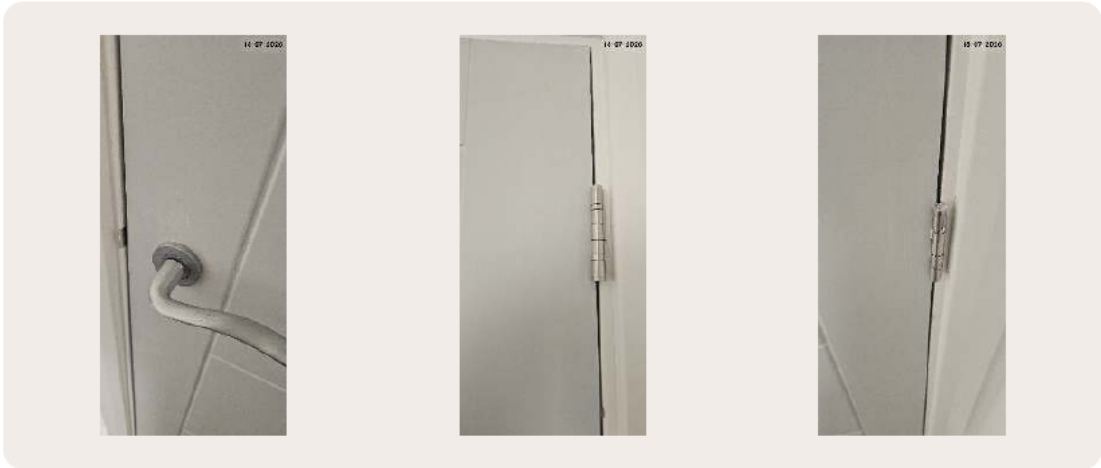
# Defect 140

The paint finish to the bedroom door is poor.

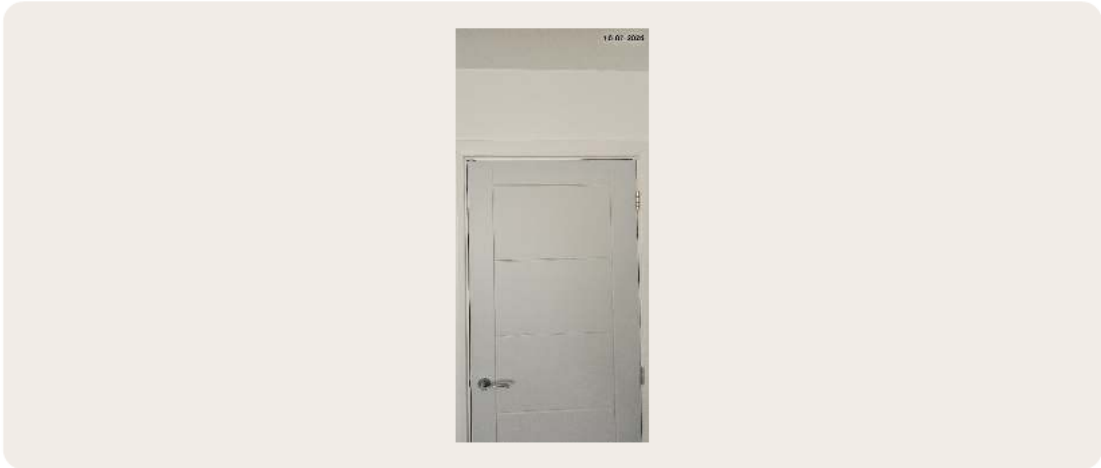
# Defect 141

**OBSERVATION**  
The bedroom door has an uneven margin.

**WHY THIS MATTERS**  
Joinery, doors, frames, thresholds, gates and associated ironmongery should be securely fitted, aligned and capable of operating correctly. Damaged or incomplete items reduce function and finish quality.

**RECOMMENDED ACTION**  
Adjust, secure, ease, repair or replace the affected item as required, then make good disturbed finishes and confirm correct operation.

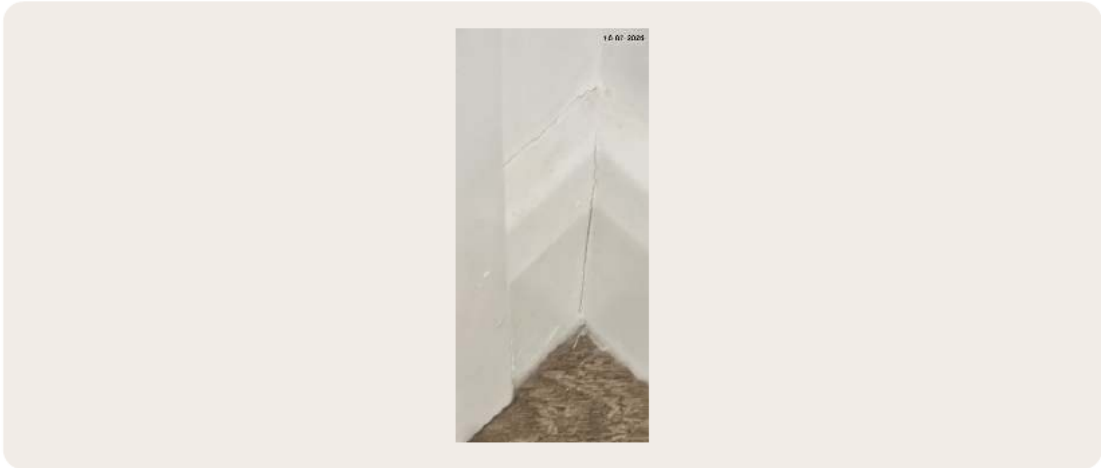
# Defect 142

**OBSERVATION**  
A visible shrinkage gap has opened at a bedroom 1 skirting-board junction at recorded location 1 of 3.

**WHY THIS MATTERS**  
Visible decorative finishes should be complete, smooth and consistent at handover. Shrinkage, exposed fixings, marks, insufficient paint coverage and incomplete preparation reduce the quality of finish.

**RECOMMENDED ACTION**  
Prepare the affected junction, remove loose caulk, apply suitable decorator's caulk, smooth it neatly and redecorate to match the surrounding finish.

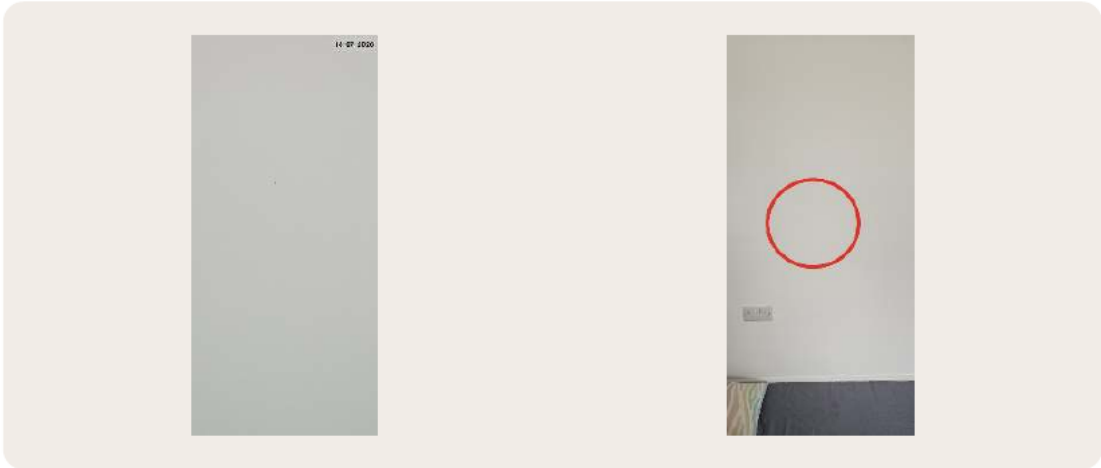
# Defect 145

**OBSERVATION**  
A visible pinhole remains in the wall finish.

**WHY THIS MATTERS**  
Visible decorative finishes should be complete, smooth and consistent at handover. Shrinkage, exposed fixings, marks, insufficient paint coverage and incomplete preparation reduce the quality of finish.

**RECOMMENDED ACTION**  
Prepare the affected area, fill and sand as required, then redecorate to achieve a neat and uniform finish.

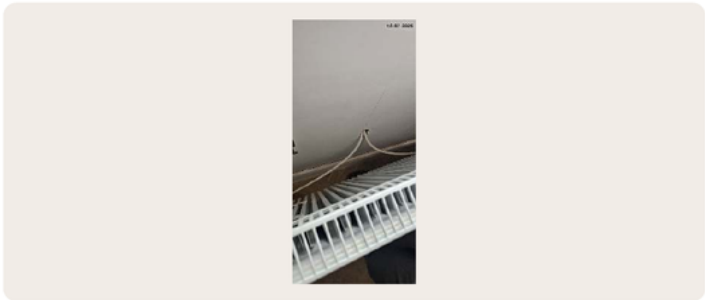
# Defect 146

The radiator pipe guide and seal is missing, leaving an unfinished opening behind the radiator.

Openings around radiator pipework should be properly sealed and finished. The missing radiator pipe guide and seal leaves an unfinished penetration and may allow draughts around the service route.

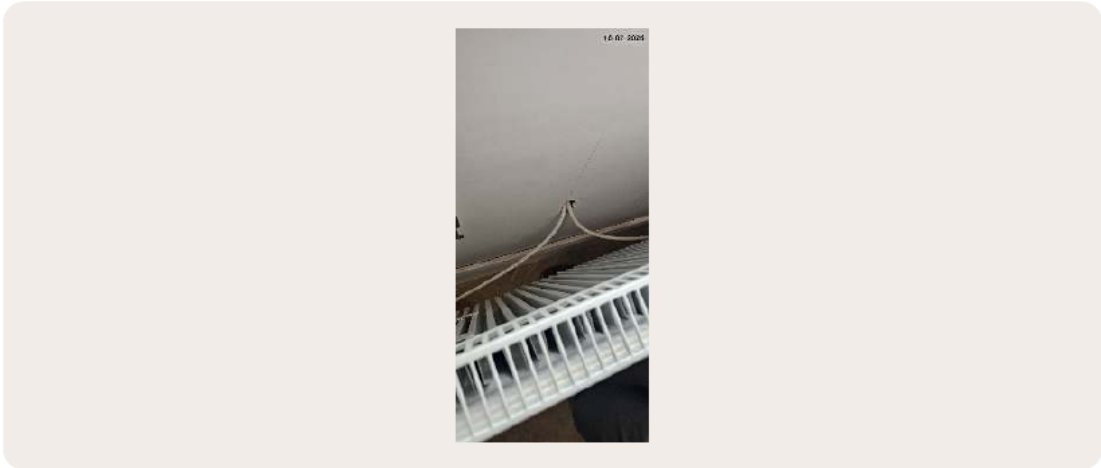
# Defect 147

**OBSERVATION**  
The skirting board behind the radiator has not been decorated.

**WHY THIS MATTERS**  
Visible decorative finishes should be complete, smooth and consistent at handover. Shrinkage, exposed fixings, marks, insufficient paint coverage and incomplete preparation reduce the quality of finish.

**RECOMMENDED ACTION**  
Prepare the affected area, fill and sand as required, then redecorate to achieve a neat and uniform finish.

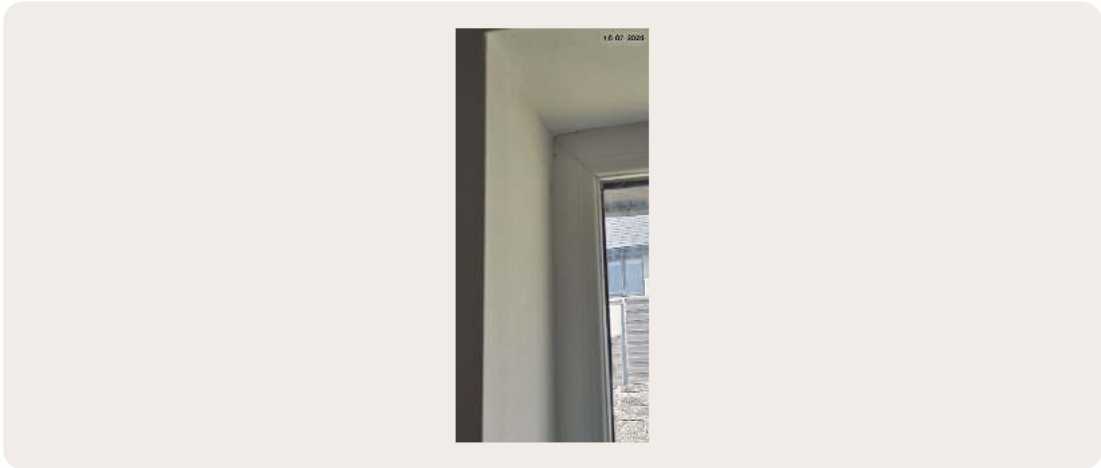
# Defect 148

A visible shrinkage gap has opened around the bedroom 1 window junction at recorded location 1 of 3.

Prepare the affected junction, remove loose caulk, apply suitable decorator's caulk, smooth it neatly and redecorate to match the surrounding finish.

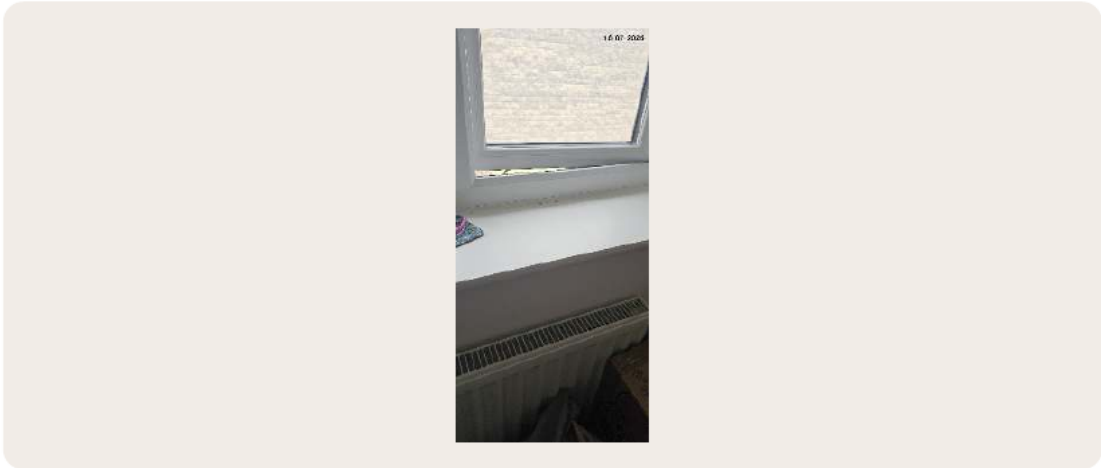
# Defect 149

**OBSERVATION**  
A visible shrinkage gap has opened around the bedroom 1 window junction at recorded location 2 of 3.

**WHY THIS MATTERS**  
Visible decorative finishes should be complete, smooth and consistent at handover. Shrinkage, exposed fixings, marks, insufficient paint coverage and incomplete preparation reduce the quality of finish.

**RECOMMENDED ACTION**  
Prepare the affected junction, remove loose caulk, apply suitable decorator's caulk, smooth it neatly and redecorate to match the surrounding finish.

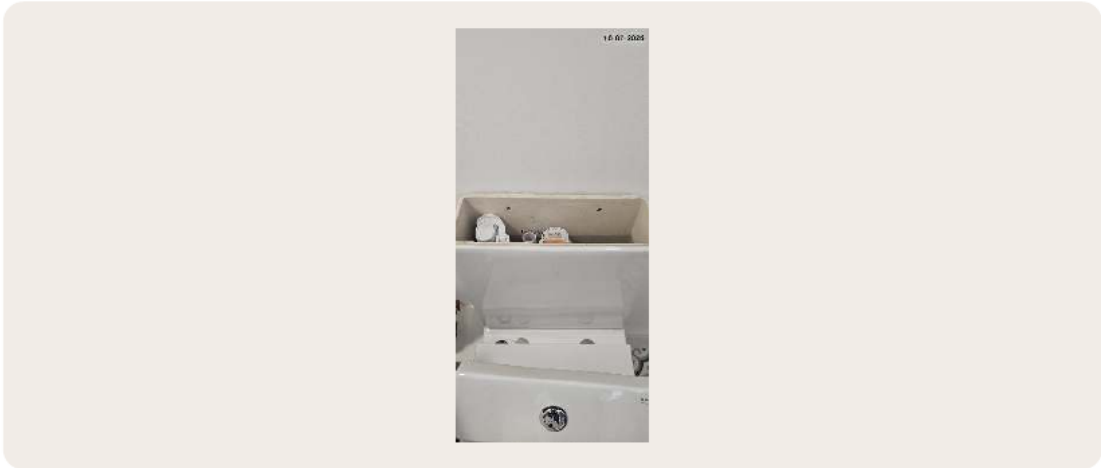
# Defect 151

**OBSERVATION**  
The en suite cistern is not secured to the wall.

**WHY THIS MATTERS**  
Sanitary fittings, waste connections and plumbing items should be securely fixed and correctly connected for safe, reliable and watertight use.

**RECOMMENDED ACTION**  
Secure, connect, repair or replace the affected item, then test for stability, correct operation and leaks.

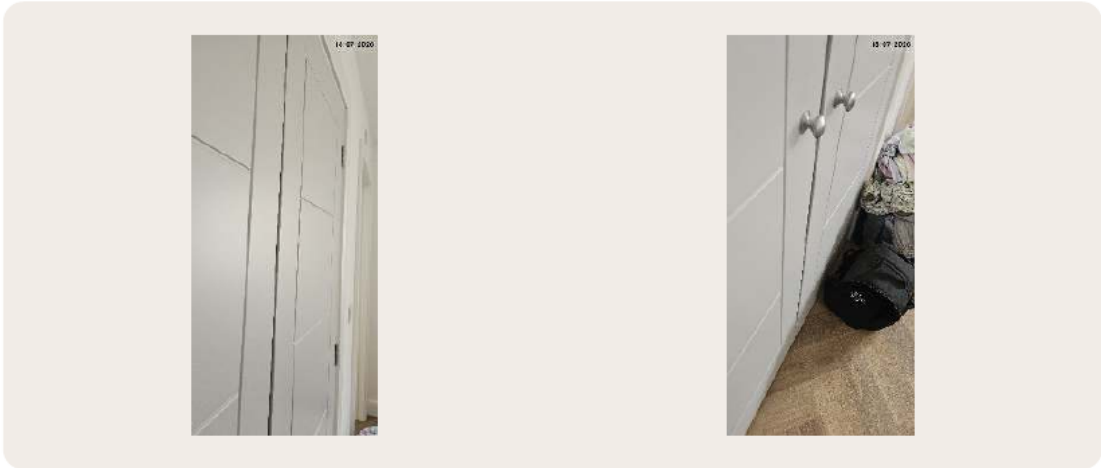
# Defect 152

**OBSERVATION**  
The wardrobe doors are warped.

**WHY THIS MATTERS**  
Joinery, doors, frames, thresholds, gates and associated ironmongery should be securely fitted, aligned and capable of operating correctly. Damaged or incomplete items reduce function and finish quality.

**RECOMMENDED ACTION**  
Adjust, secure, ease, repair or replace the affected item as required, then make good disturbed finishes and confirm correct operation.

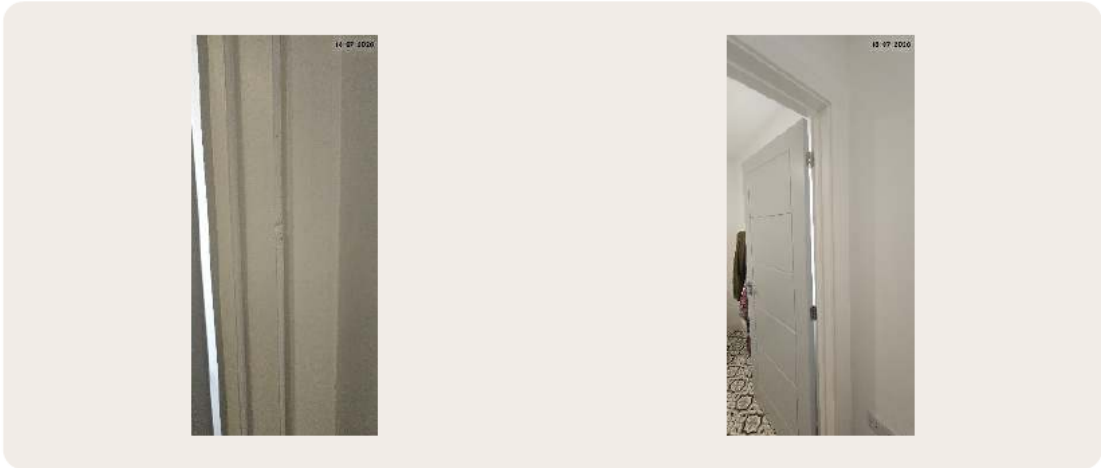
Defect 153

**OBSERVATION**  
A localised indentation is visible in the en suite door-frame finish.

**WHY THIS MATTERS**  
Visible decorative finishes should be complete, smooth and consistent at handover. Shrinkage, exposed fixings, marks, insufficient paint coverage and incomplete preparation reduce the quality of finish.

**RECOMMENDED ACTION**  
Prepare the affected area, fill and sand as required, then redecorate to achieve a neat and uniform finish.

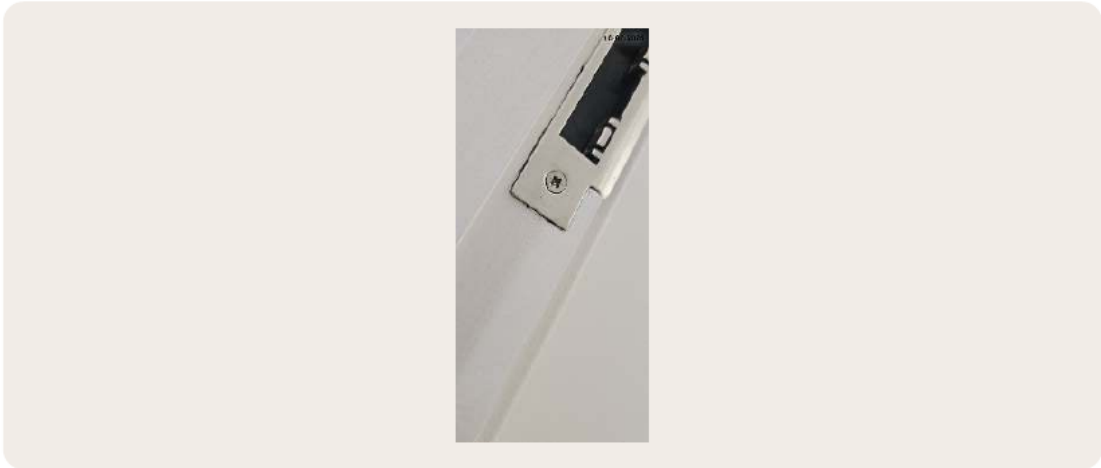
# Defect 154

The receiver is not recessed flush with the door frame.

Joinery, doors, frames, thresholds, gates and associated ironmongery should be securely fitted, aligned and capable of operating correctly. Damaged or incomplete items reduce function and finish quality.

Adjust, secure, ease, repair or replace the affected item as required, then make good disturbed finishes and confirm correct operation.

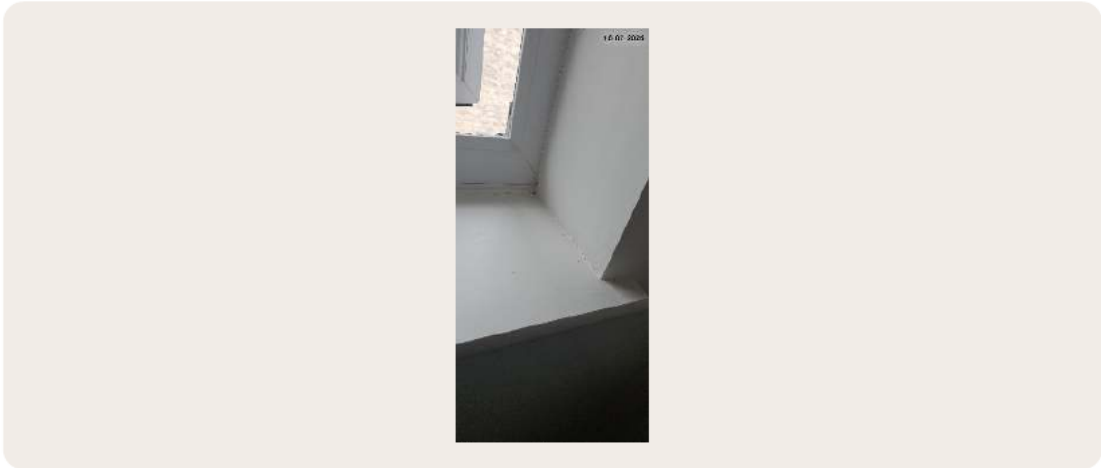
# Defect 155

**OBSERVATION**  
A visible shrinkage gap has opened around the en suite window junction at recorded location 1 of 2.

**WHY THIS MATTERS**  
Visible decorative finishes should be complete, smooth and consistent at handover. Shrinkage, exposed fixings, marks, insufficient paint coverage and incomplete preparation reduce the quality of finish.

**RECOMMENDED ACTION**  
Prepare the affected junction, remove loose caulk, apply suitable decorator's caulk, smooth it neatly and redecorate to match the surrounding finish.

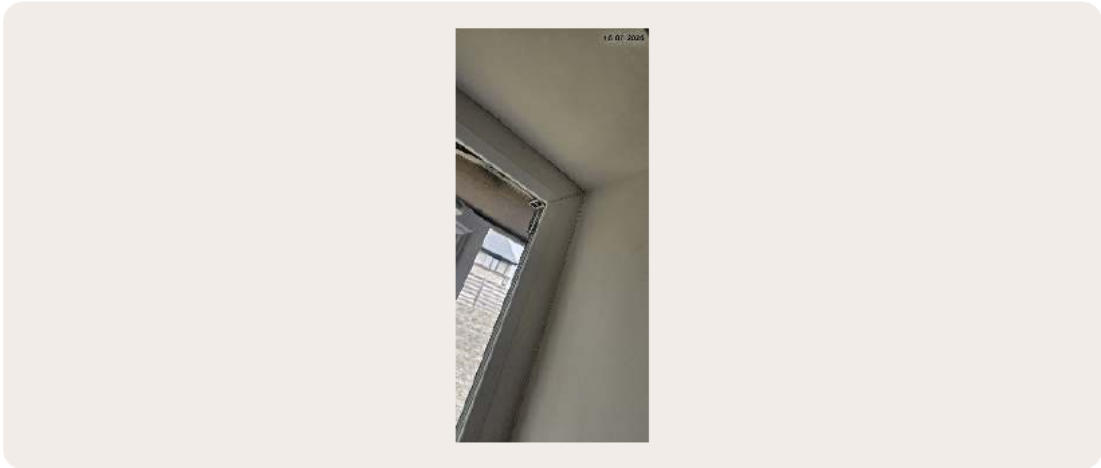
# Defect 156

**OBSERVATION**  
A visible shrinkage gap has opened around the en suite window junction at recorded location 2 of 2.

**WHY THIS MATTERS**  
Visible decorative finishes should be complete, smooth and consistent at handover. Shrinkage, exposed fixings, marks, insufficient paint coverage and incomplete preparation reduce the quality of finish.

**RECOMMENDED ACTION**  
Prepare the affected junction, remove loose caulk, apply suitable decorator's caulk, smooth it neatly and redecorate to match the surrounding finish.

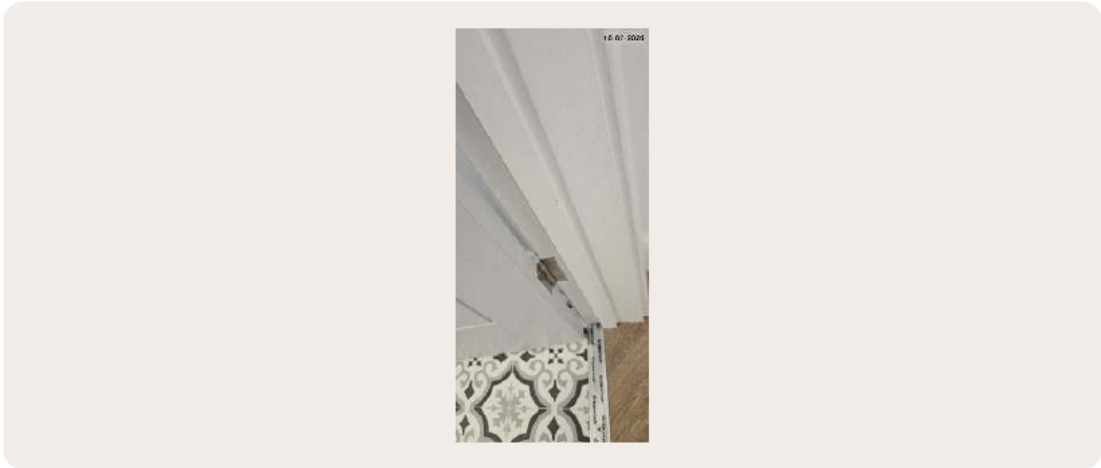
# Defect 157

A localised indentation is visible in the en suite door-stop finish.

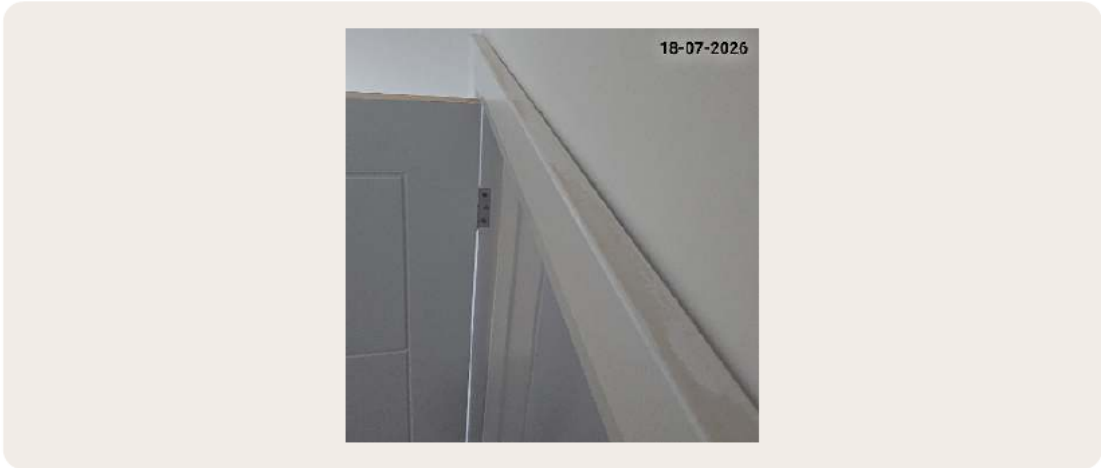
# Defect 158

The en suite architrave head has not been fully decorated, leaving an incomplete finish.

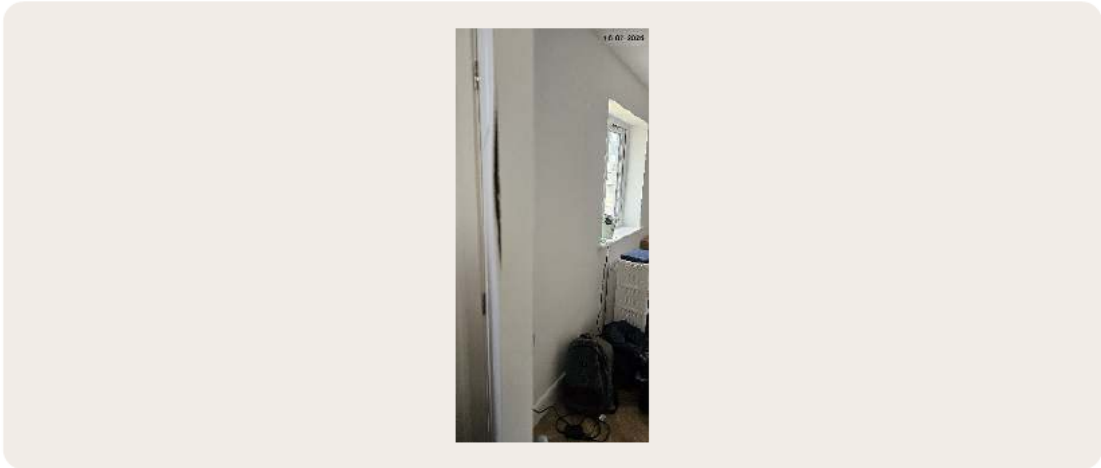
# Defect 159

The en suite door leaf has blown.

Joinery, doors, frames, thresholds, gates and associated ironmongery should be securely fitted, aligned and capable of operating correctly. Damaged or incomplete items reduce function and finish quality.

Adjust, secure, ease, repair or replace the affected item as required, then make good disturbed finishes and confirm correct operation.

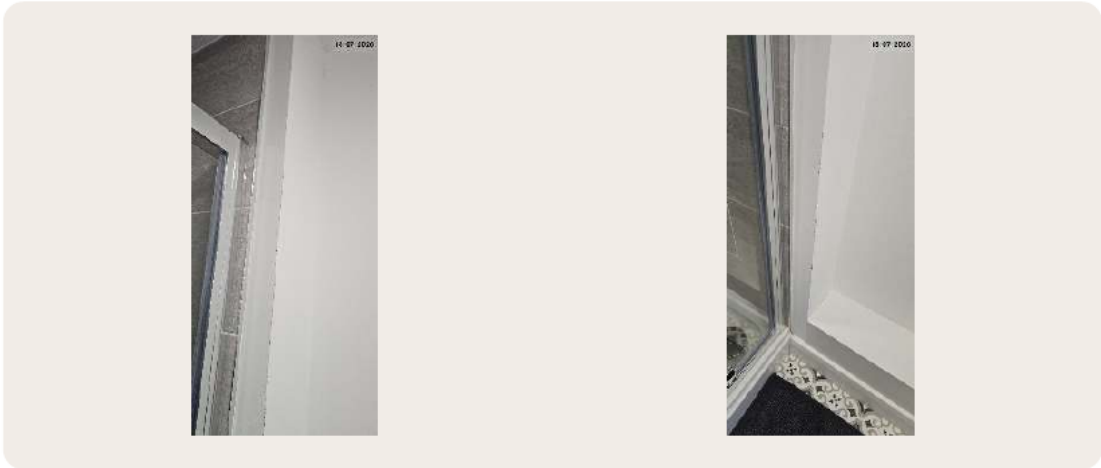
Defect 160

**OBSERVATION**  
The corner bead beside the shower door is corroding and staining the surrounding finish.

**WHY THIS MATTERS**  
Rusted corner beads can continue to stain the surrounding finish and may indicate that an unsuitable or damaged bead has been used in a moisture-prone location.

**RECOMMENDED ACTION**  
The plasterer / dryliner should remove the rusted corner bead, install a suitable corrosion-resistant replacement, make good the surrounding plaster finish and arrange redecoration after the repair has dried.

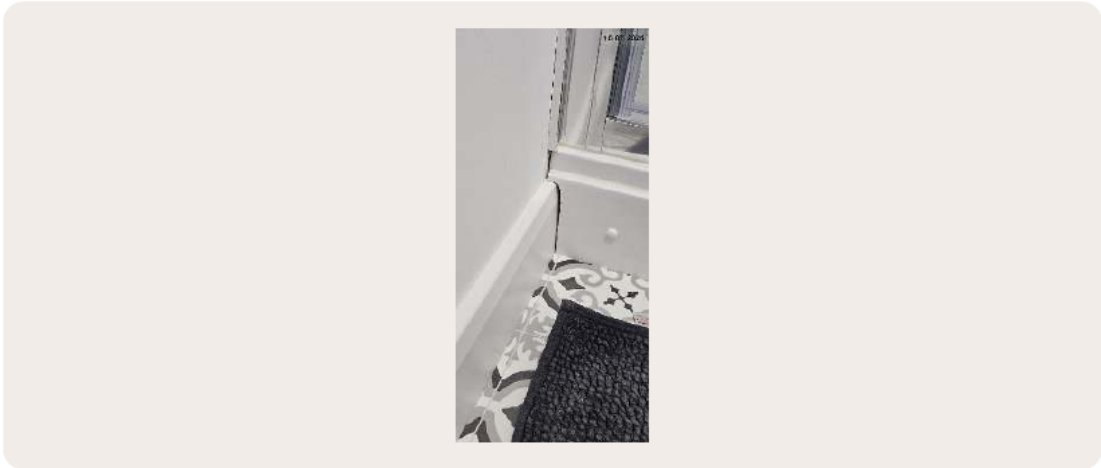
# Defect 162

**OBSERVATION**  
The left-hand cover at the plastic trim beneath the shower is poorly aligned and does not form a neat, continuous junction.

**WHY THIS MATTERS**  
The open or poorly finished trim junction can retain moisture and leaves the shower installation incomplete.

**RECOMMENDED ACTION**  
Clean and prepare the junction, then apply a compatible sanitary-grade mastic seal to form a neat, continuous and watertight finish.

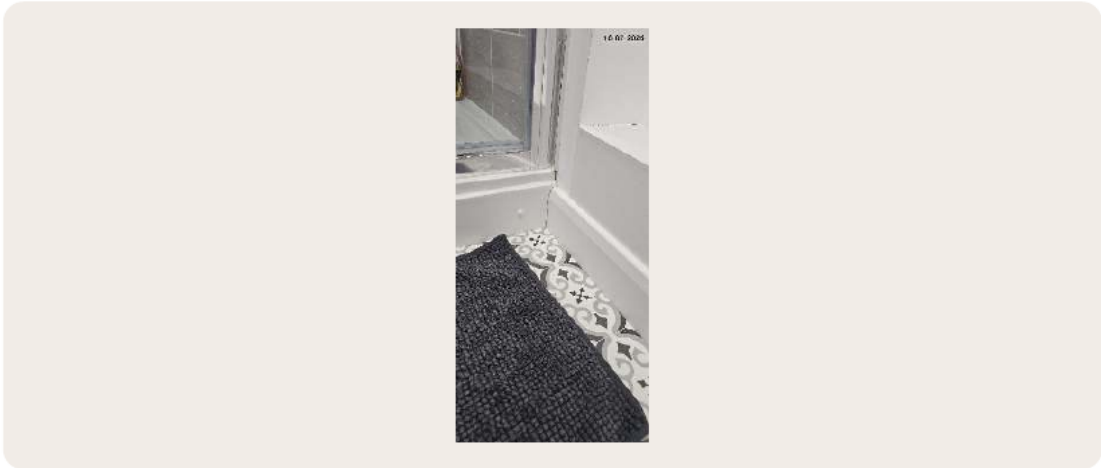
# Defect 163

**OBSERVATION**  
The plastic trim beneath the shower tray is unevenly finished and does not form a neat, continuous junction.

**WHY THIS MATTERS**  
Wet-area junctions should be neat, continuous and suitably sealed. An uneven or incomplete junction may retain moisture and reduce the quality and durability of the finish.

**RECOMMENDED ACTION**  
Remove unsuitable or poorly finished material, clean and prepare the junction, then install a compatible trim and sealant system to form a neat, continuous and watertight finish in accordance with the product manufacturer guidance.

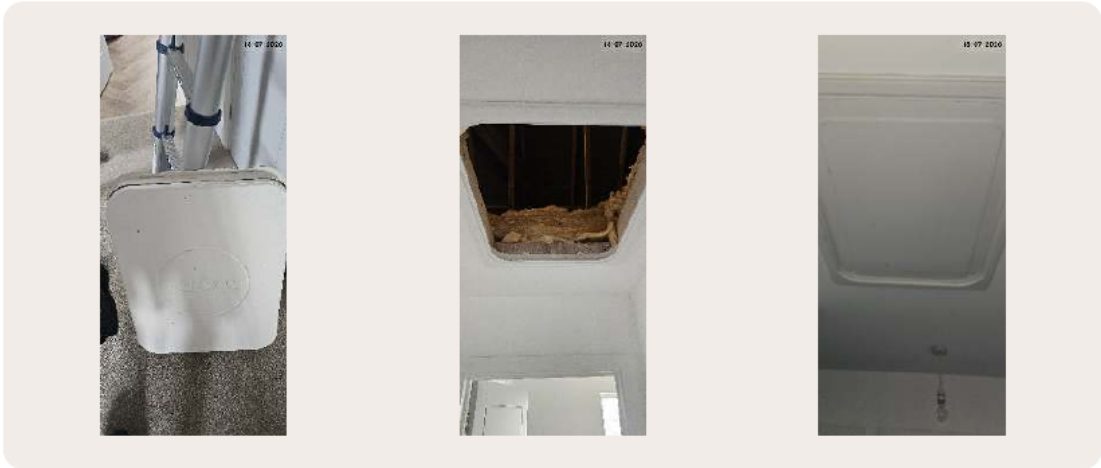
Defect 164

**OBSERVATION**  
The loft hatch is damaged, incorrectly fitted and does not open downwards on a suitable hinged arrangement.

**WHY THIS MATTERS**  
Joinery, doors, frames, thresholds, gates and associated ironmongery should be securely fitted, aligned and capable of operating correctly. Damaged or incomplete items reduce function and finish quality.

**RECOMMENDED ACTION**  
Adjust, secure, ease, repair or replace the affected item as required, then make good disturbed finishes and confirm correct operation.

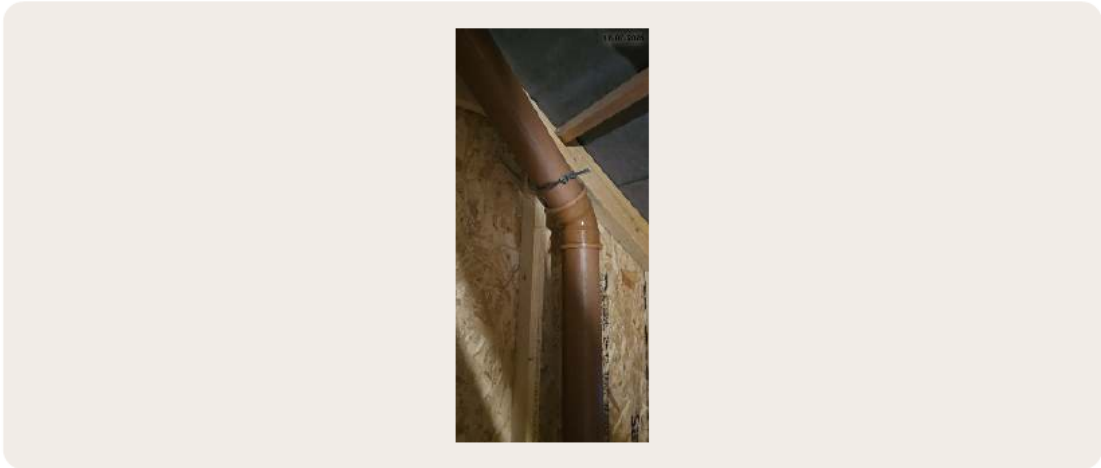
# Defect 165

The soil and vent pipe has been installed with an unsuitable or incomplete fixing arrangement.

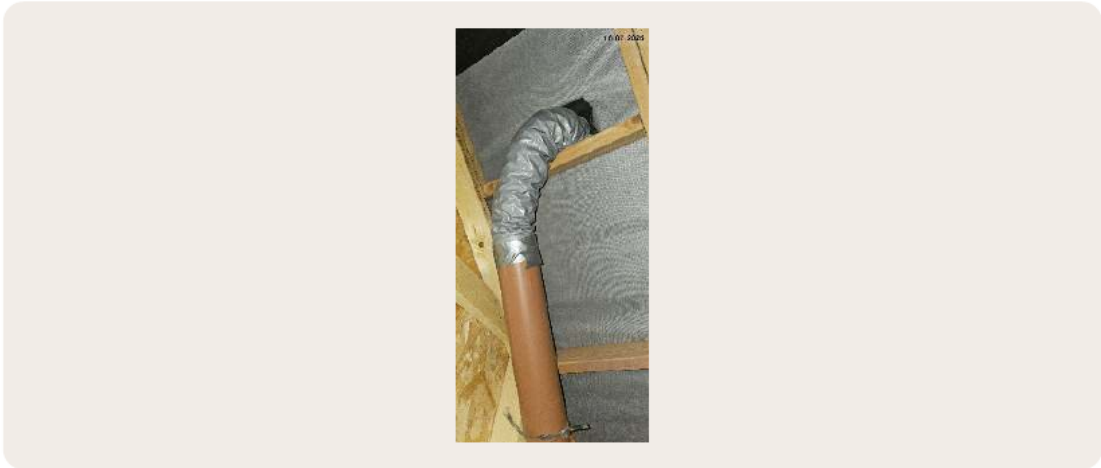
Defect 166

**OBSERVATION**  
The soil and vent pipe is not mechanically secured to the roof tile vent connection.

**WHY THIS MATTERS**  
Sanitary fittings, waste connections and plumbing items should be securely fixed and correctly connected for safe, reliable and watertight use.

**RECOMMENDED ACTION**  
Provide a secure manufacturer-compatible mechanical connection between the soil and vent pipe and the roof tile vent. Confirm that the connection is stable, correctly aligned and weather-tight.

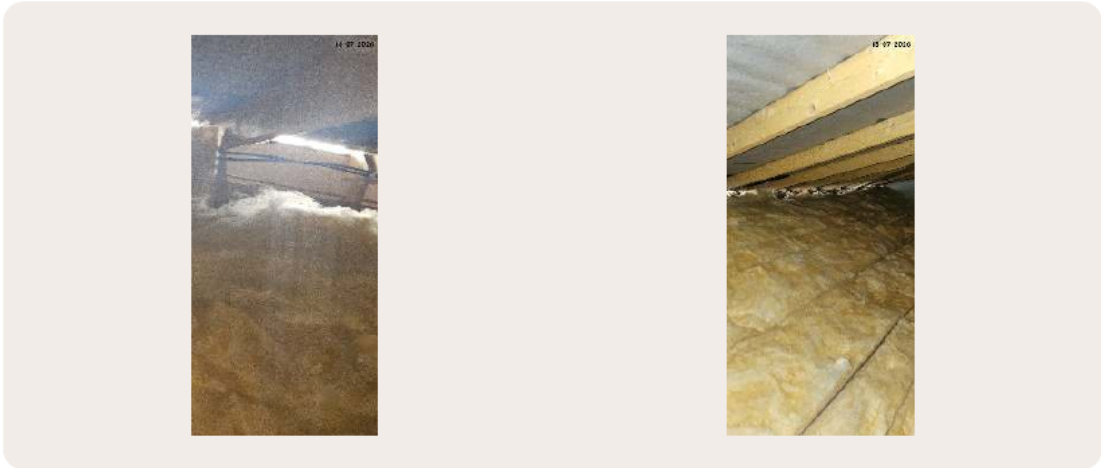
# Defect 167

Loft insulation terminates short of the eaves and is not continuous with the external wall insulation. The eaves ventilation route must remain unobstructed.

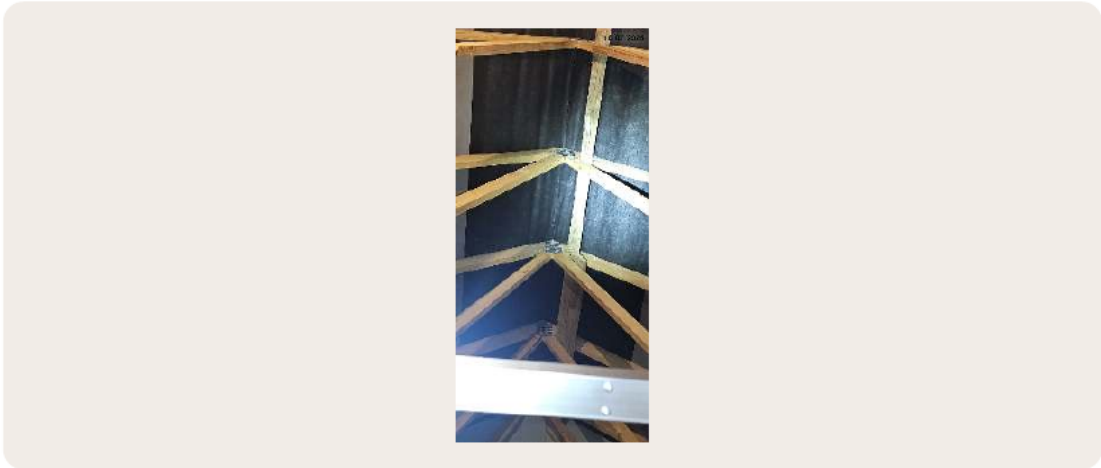
# Defect 168

**OBSERVATION**  
The roof ridge does not appear to provide the required ventilation gap.

**WHY THIS MATTERS**  
The roof-space ventilation strategy should provide the designed airflow while maintaining weather protection. Inadequate high-level ventilation can increase the risk of condensation, moisture accumulation and deterioration of roof components.

**RECOMMENDED ACTION**  
The roofer should verify the approved roof ventilation design and manufacturer requirements, then form or reinstate the required ridge ventilation path without compromising weather tightness. Provide confirmation of the completed detail before closing the defect.

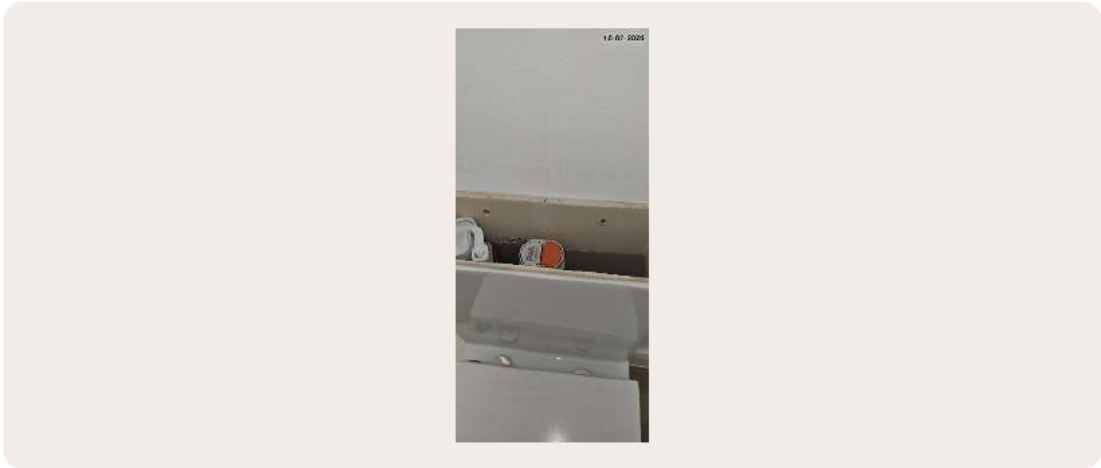
# Defect 169

**OBSERVATION**  
The cloakroom WC cistern is not secured to the wall.

**WHY THIS MATTERS**  
Sanitary fittings, waste connections and plumbing items should be securely fixed and correctly connected for safe, reliable and watertight use.

**RECOMMENDED ACTION**  
Secure, connect, repair or replace the affected item, then test for stability, correct operation and leaks.

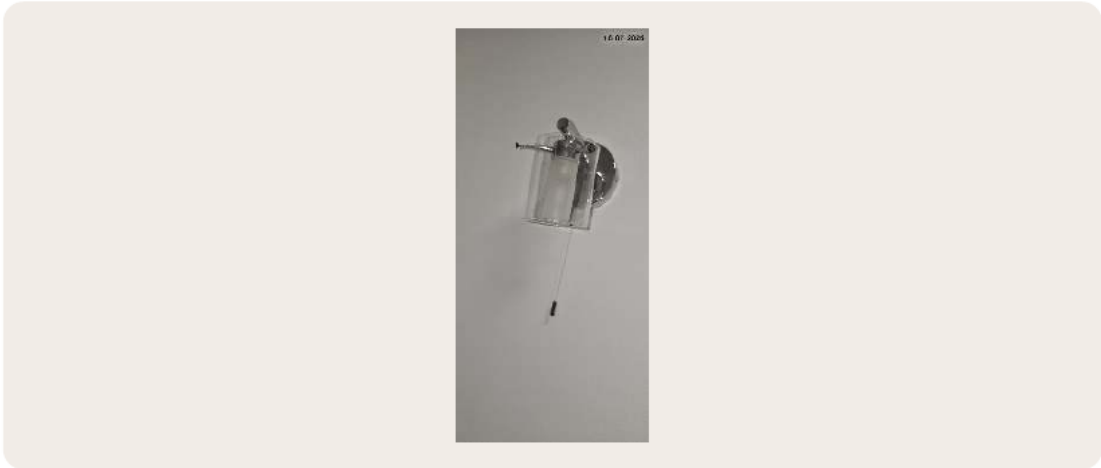
# Defect 170

A plasterboard fixing screw has been driven into the cloakroom light fitting, potentially damaging the fitting or associated electrical components.

A fixing driven into an electrical fitting may damage the fitting, cable insulation or internal electrical components and may present a risk of electric shock, overheating or premature failure.

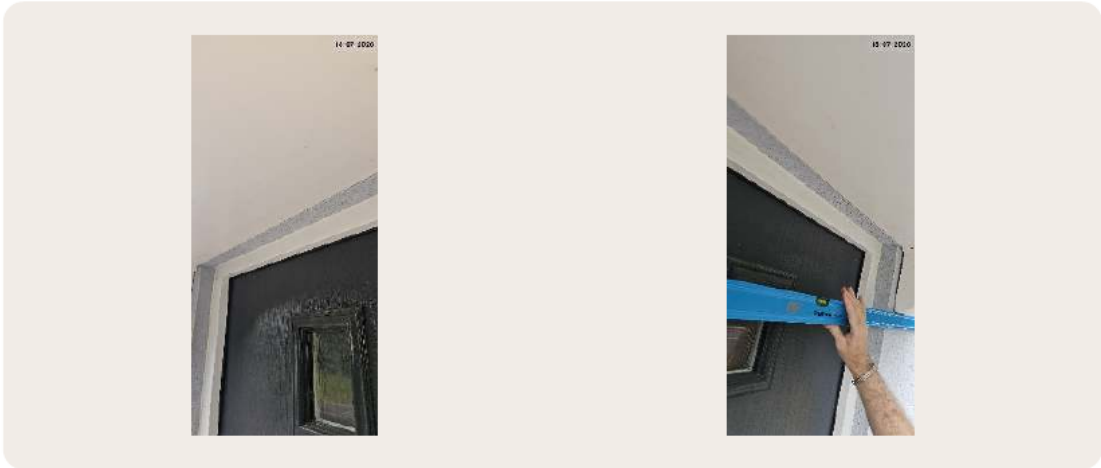
# Defect 171

**OBSERVATION**  
The entrance canopy is misaligned with the adjoining render bead, resulting in an uneven and poorly coordinated junction.

**WHY THIS MATTERS**  
The canopy and adjoining render detail should be aligned, securely fixed and coordinated to provide a neat, durable and weather-resistant junction.

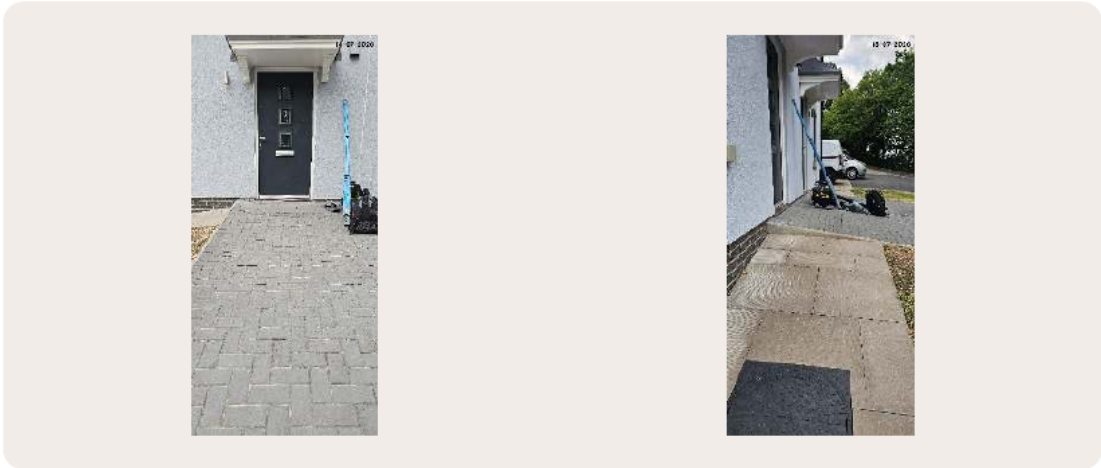
Defect 172

**OBSERVATION**  
The approach to the principal entrance does not provide a suitable level, ramped or compliant stepped access arrangement.

**WHY THIS MATTERS**  
The principal approach should provide reasonable access for occupants and visitors, including people with restricted mobility. Unsuitable gradients, cross-falls, abrupt level changes or deficient landings may prevent safe and convenient access.

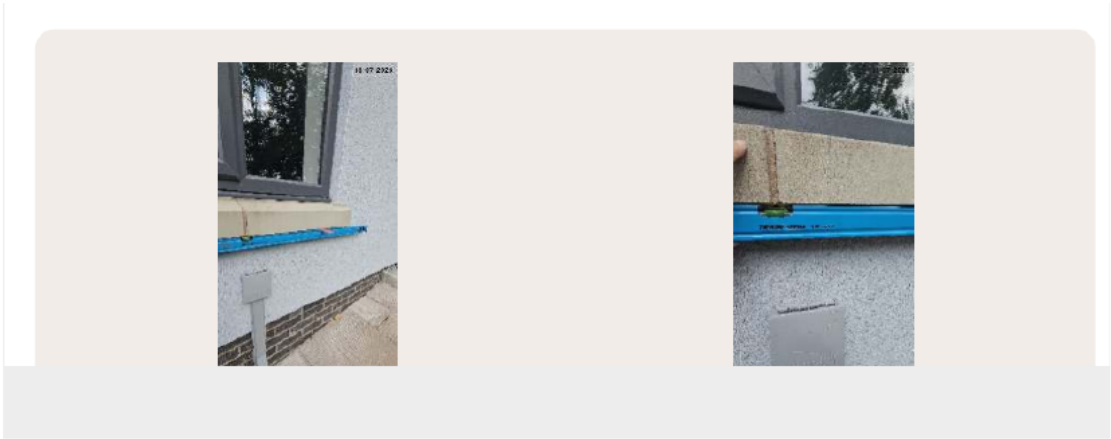
# Defect 173

**OBSERVATION**  
The stone sill beneath the lounge window is visibly out of level and does not provide a true, consistent installation.

**WHY THIS MATTERS**  
A stone sill should be level, securely bedded and formed to provide effective weathering. An out-of-level sill affects appearance and may compromise the adjoining window and drainage junctions.

**RECOMMENDED ACTION**  
The bricklayer should carefully remove and relay or replace the stone sill so it is level, securely and fully bedded, correctly weathered and neatly pointed. Protect the window frame and make good disturbed sealant and finishes.

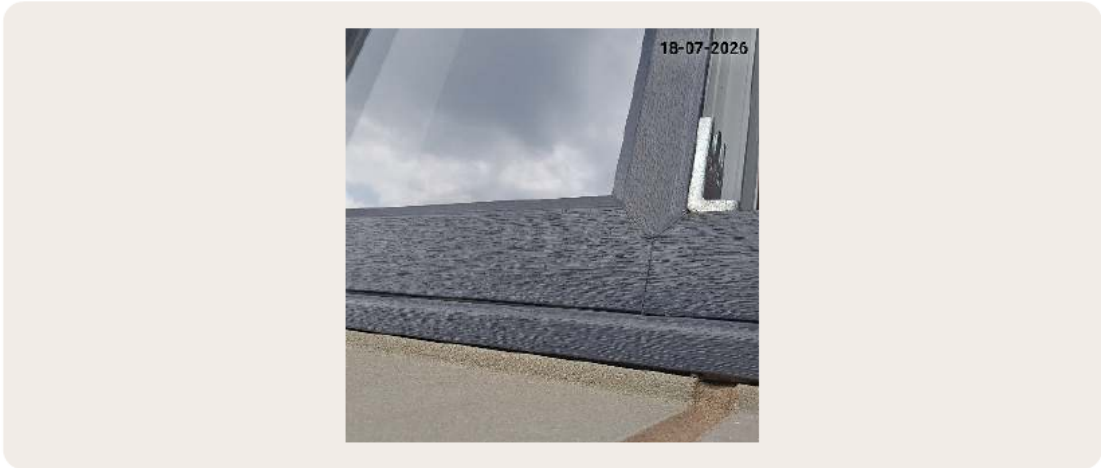
# Defect 174

The recorded compressible movement allowance beneath the first-floor window frame has not been provided at recorded location 1 of 4. The dwelling is understood to have been constructed in 2022.

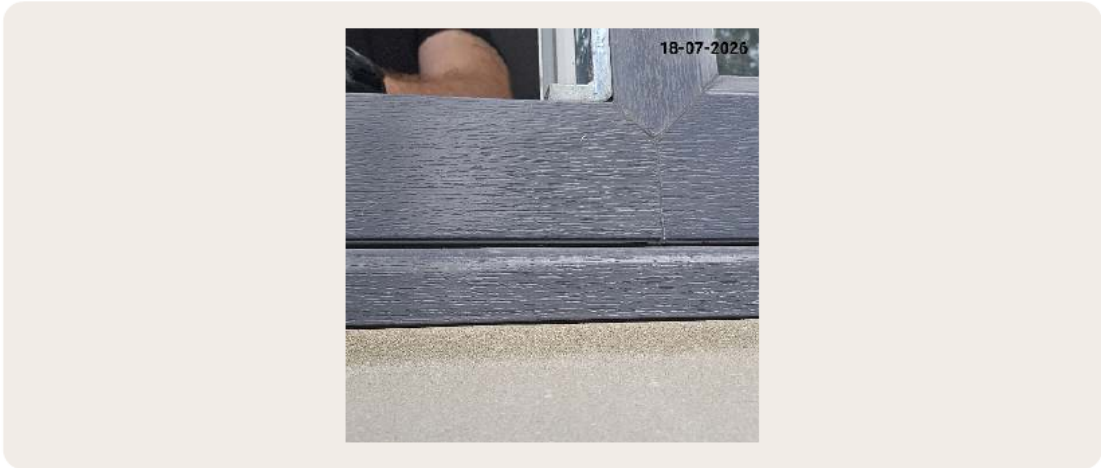
# Defect 175

The recorded compressible movement allowance beneath the first-floor window frame has not been provided at recorded location 2 of 4. The dwelling is understood to have been constructed in 2022.

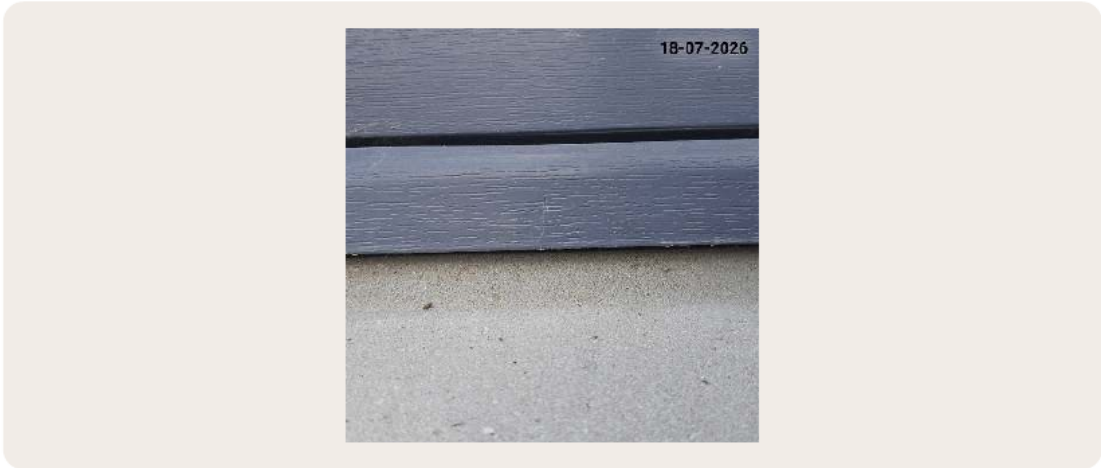
# Defect 176

The recorded compressible movement allowance beneath the first-floor window frame has not been provided at recorded location 3 of 4. The dwelling is understood to have been constructed in 2022.

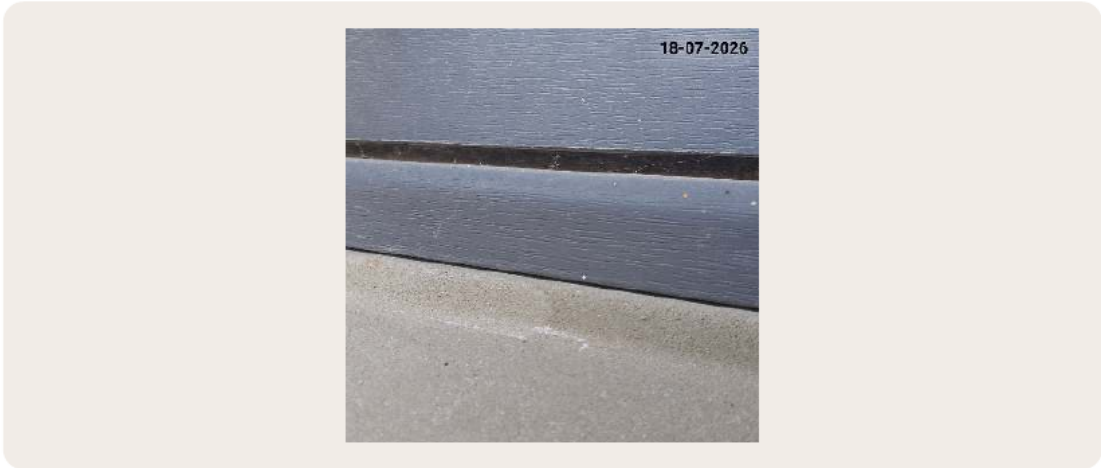
# Defect 177

The recorded compressible movement allowance beneath the first-floor window frame has not been provided at recorded location 4 of 4. The dwelling is understood to have been constructed in 2022.

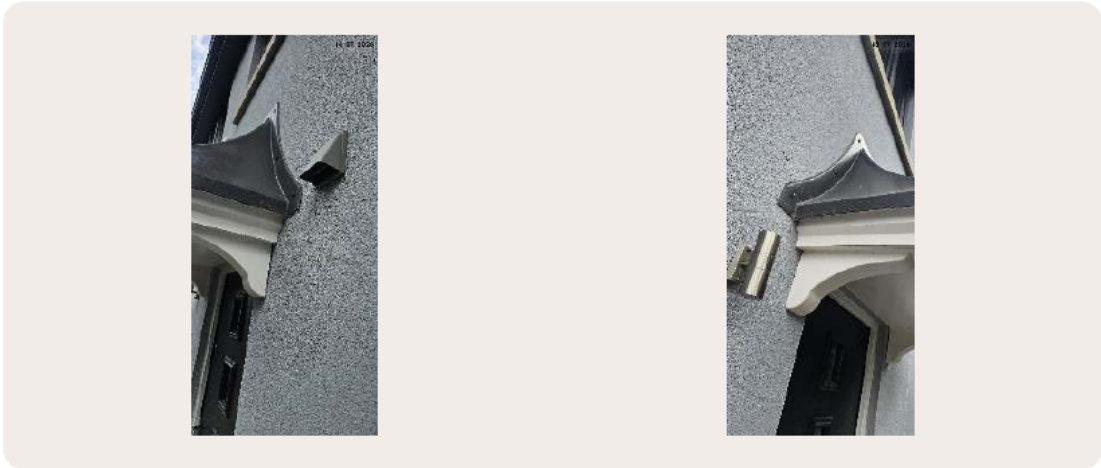
# Defect 178

The entrance canopy has not been sealed at the adjoining junction.

External and wet-area junctions should be continuously sealed to reduce the risk of water ingress, staining and deterioration. Open or poorly finished joints can allow moisture to enter concealed interfaces.

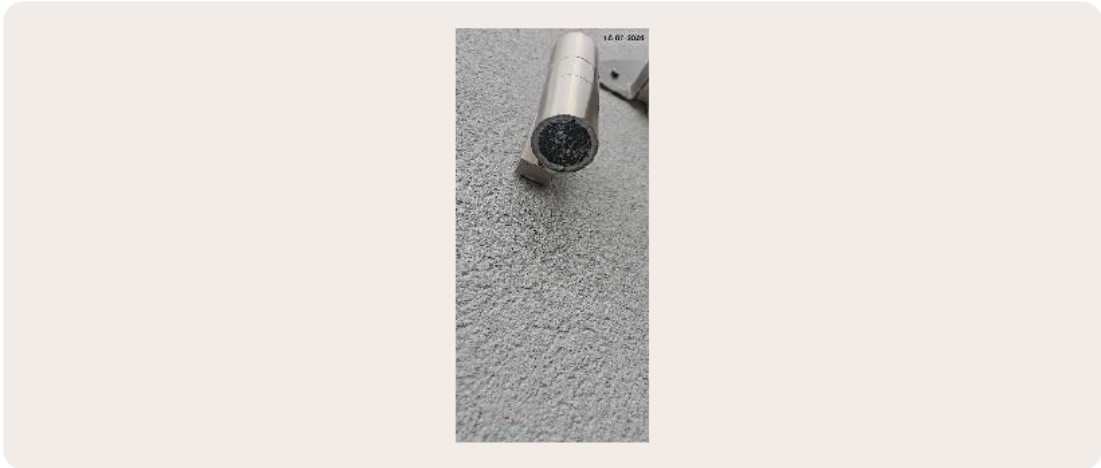
# Defect 179

**OBSERVATION**  
The external wall light is damaged.

**WHY THIS MATTERS**  
Electrical items should be securely installed and protected against damage. Visible damage, unsuitable fixings or incomplete external protection may present a safety risk.

**RECOMMENDED ACTION**  
Arrange inspection and remedial work by a competent electrician. Isolate the item where necessary, repair or replace affected parts and provide updated electrical confirmation where required.
