# Professional Snagging Inspection Report

Post-completion inspection

Inspection date: 18 July 2026

South Wales Snagging Co was instructed to undertake a visual, non-destructive post-completion snagging inspection of an anonymised new-build property in South Wales. This report records visible defects, incomplete items and areas requiring developer or aftercare attention based on the condition observed on 18 July 2026.

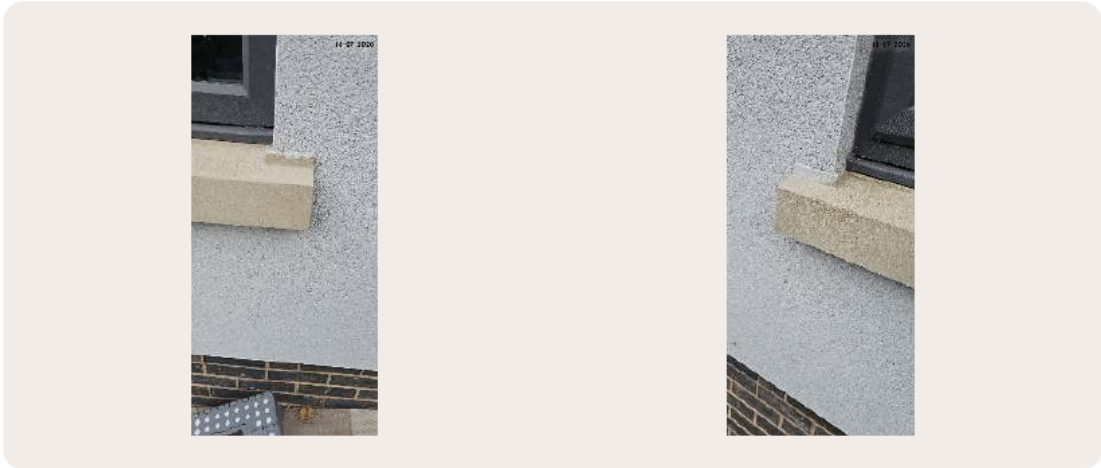
Defect 180

**OBSERVATION**  
Render paint contamination is present on the window sill surface.

**WHY THIS MATTERS**  
Render paint contamination detracts from the completed appearance and may become difficult to remove without damaging the stone surface if left untreated.

**RECOMMENDED ACTION**  
The decorator should carefully remove the render paint using a suitable non-damaging method, protect adjoining finishes and leave the sill clean and uniform.

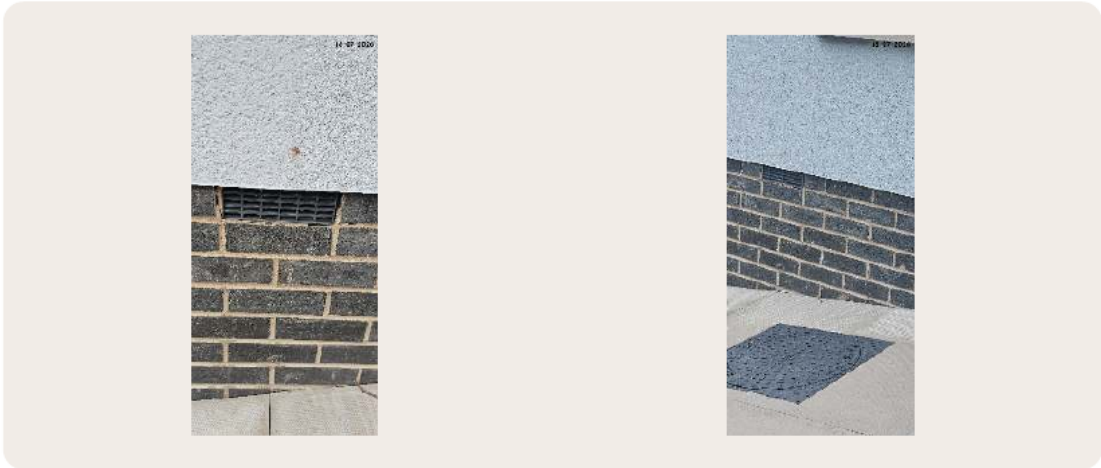
Defect 181

Open perpend joints, or perps, and incomplete bed joints are present around the brick vent.

The bricklayer should rake out loose material as necessary and fully point the perpend and bed joints around the vent using compatible mortar. Protect the vent opening and leave the masonry clean.

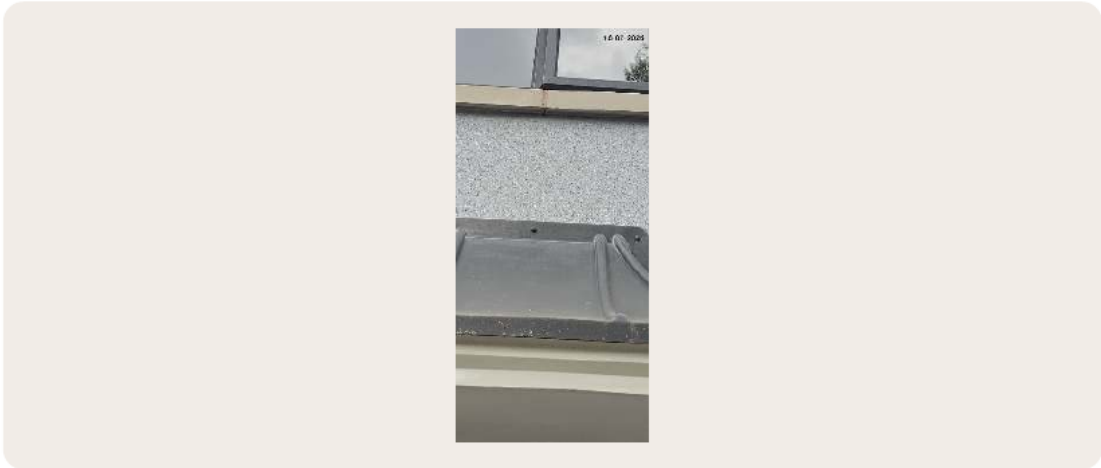
# Defect 182

**OBSERVATION**  
The bedroom 3 window sill is locally damaged and requires a specialist colour-matched repair.

**WHY THIS MATTERS**  
The damaged sill is visually unacceptable and may deteriorate further if the exposed area is not repaired and protected.

**RECOMMENDED ACTION**  
A competent plastic surgeon should complete a durable, colour-matched specialist repair to the damaged sill. The finished repair should be smooth, unobtrusive and compatible with the original material.

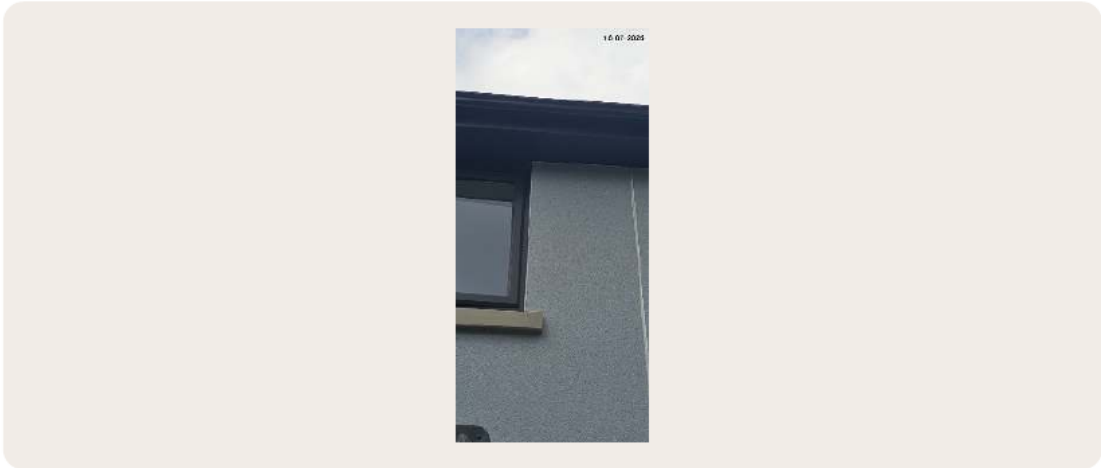
# Defect 183

The required 20mm movement gap has not been maintained above the render bead below the soffit.

The recorded 20mm movement gap is intended to accommodate differential movement and reduce the risk of cracking or compression damage. The dwelling is understood to have been constructed in 2022 and may have undergone initial settlement, but completion of settlement cannot be confirmed visually.

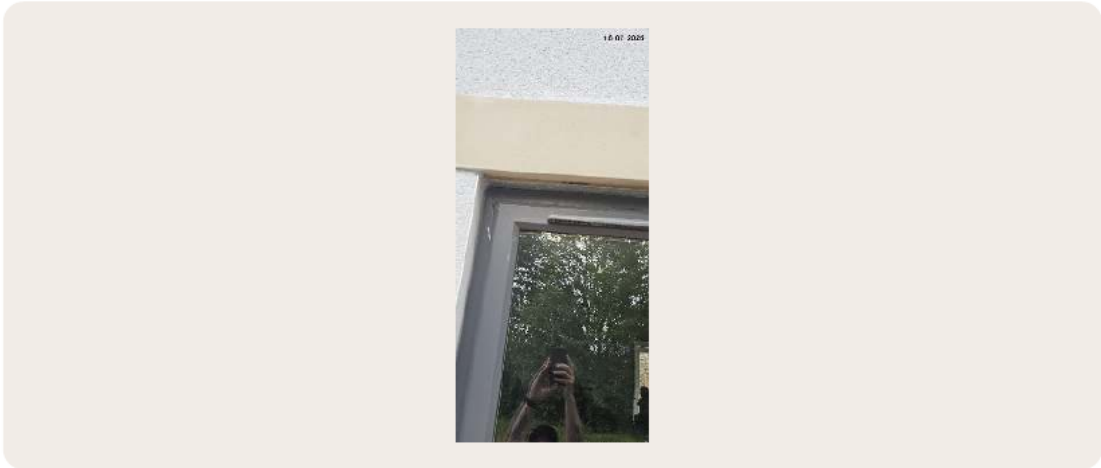
# Defect 184

**OBSERVATION**  
The lintel is not fully bedded.

**WHY THIS MATTERS**  
Masonry, stone, lintel, sill and cavity drainage details should be complete, stable and capable of shedding water. Open joints or incomplete bedding may affect durability and weather resistance.

**RECOMMENDED ACTION**  
The bricklayer should inspect the affected detail and complete the required bedding, pointing, drainage, cleaning or replacement work in accordance with the approved design and product guidance.

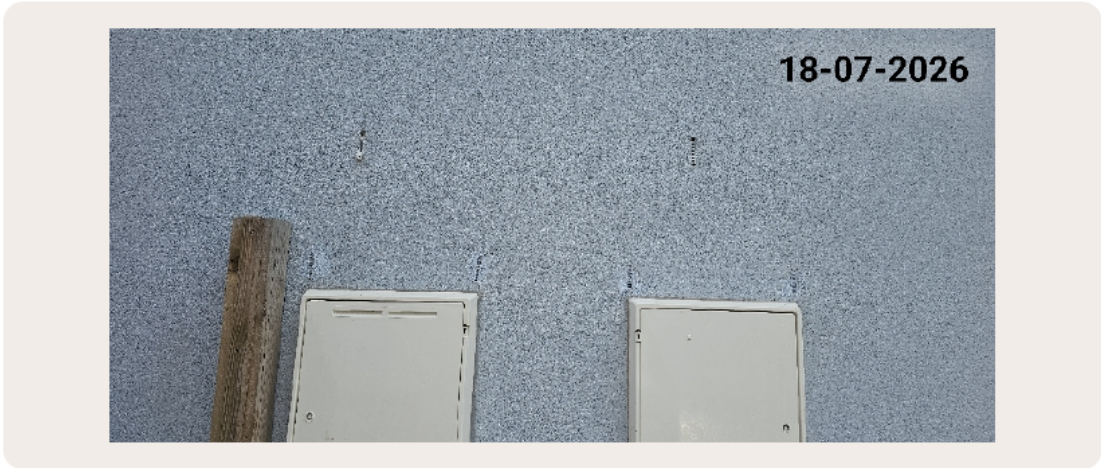
# Defect 185

**OBSERVATION**  
The weep vents above the meter boxes are poorly positioned and installed.

**WHY THIS MATTERS**  
Weep vents should be correctly positioned and installed so that moisture within the cavity can discharge effectively without being obstructed or misdirected.

**RECOMMENDED ACTION**  
The bricklayer should correct the installation and positioning of the weep vents above the meter boxes in accordance with the approved cavity tray and masonry detail.

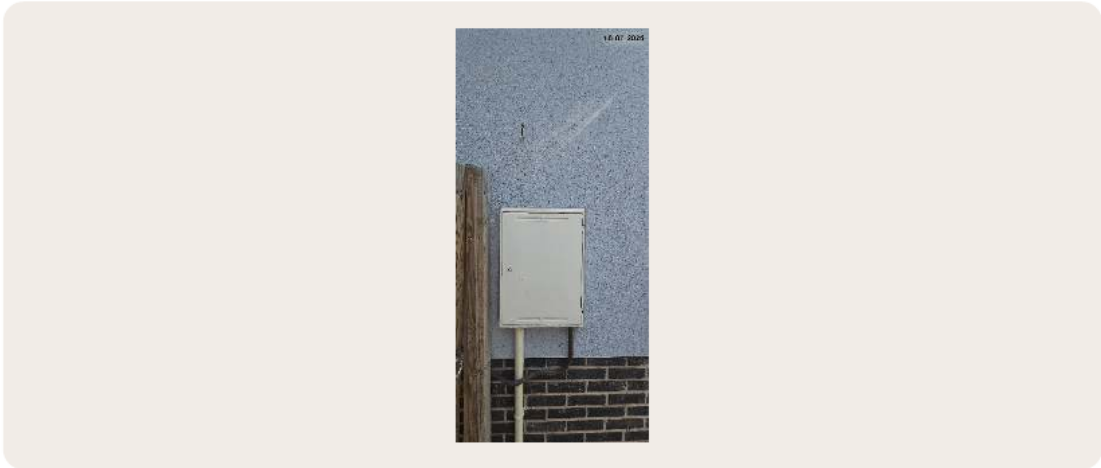
# Defect 186

**OBSERVATION**  
The weep vents beside the gas meter box are positioned too close to the opening and do not reflect an acceptable cavity drainage arrangement.

**WHY THIS MATTERS**  
Cavity drainage outlets should be suitably located in relation to openings and service boxes so that water is discharged safely and the approved weathering detail is maintained.

**RECOMMENDED ACTION**  
The bricklayer should review the weep vent positions against the approved detail and reposition or otherwise correct them as required. Make good the surrounding masonry neatly.

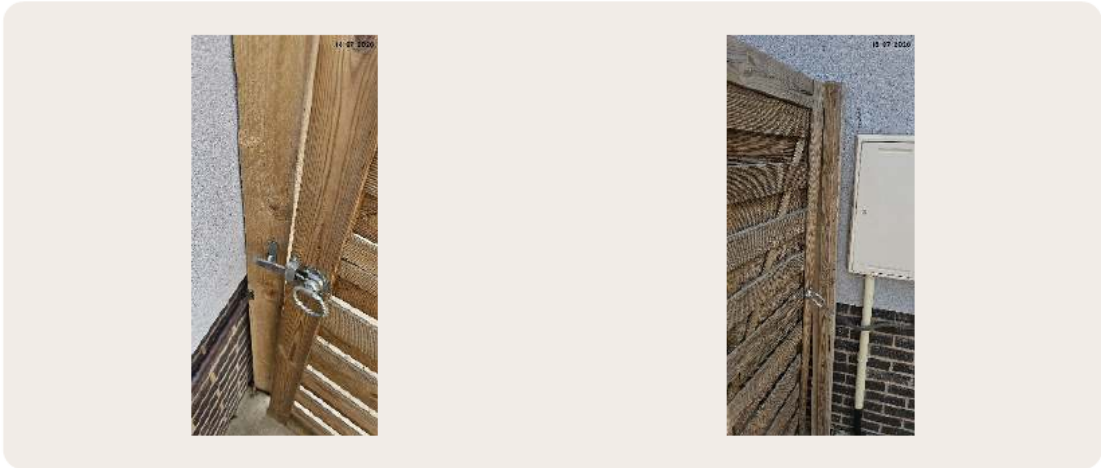
Defect 187

**OBSERVATION**  
The external gate is misaligned and does not sit squarely within the opening.

**WHY THIS MATTERS**  
The gate should be securely fixed, aligned and capable of opening, closing and latching without binding or placing undue stress on the posts and ironmongery.

**RECOMMENDED ACTION**  
The carpenter / fencer should adjust and securely refix the gate, posts and ironmongery as required so the gate is level, correctly aligned and operates reliably.

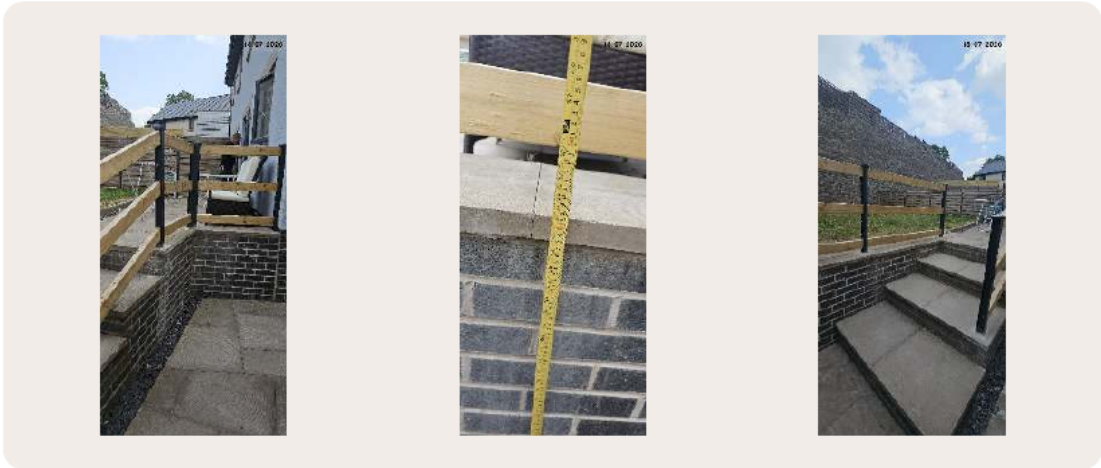
Defect 189

The customer advised that concerns regarding inadequate guarding to falls were raised with the site manager and were initially dismissed. Following further challenge, guard rails were installed. The guarding observed remained inadequate and did not provide compliant or effective protection against the identified fall risk. This sequence raises serious concerns regarding the adequacy of the safety assessment, technical understanding and site management oversight.

**OBSERVATION**  
External changes in level exceeding 600mm are accessible to occupants. The guarding installed after the concern was raised is inadequate and does not provide effective protection from falling.

**WHY THIS MATTERS**  
The accessible change in level presents a foreseeable risk of serious injury from falling. The customer reported that the concern was initially dismissed and that the later guarding remained inadequate. The horizontal rails also provide climbable features.

The affected areas should be made safe immediately and remain restricted until compliant permanent works are complete.

**RECOMMENDED ACTION**  
Restrict access immediately. Remove the inadequate guarding and install a permanent, location-specific system designed and installed by a competent contractor. It should protect the accessible top edge and the sides of the steps, be structurally secure, suitably high, non-climbable and free from unsafe openings. Provide design, fixing and completion confirmation before closing the defect.

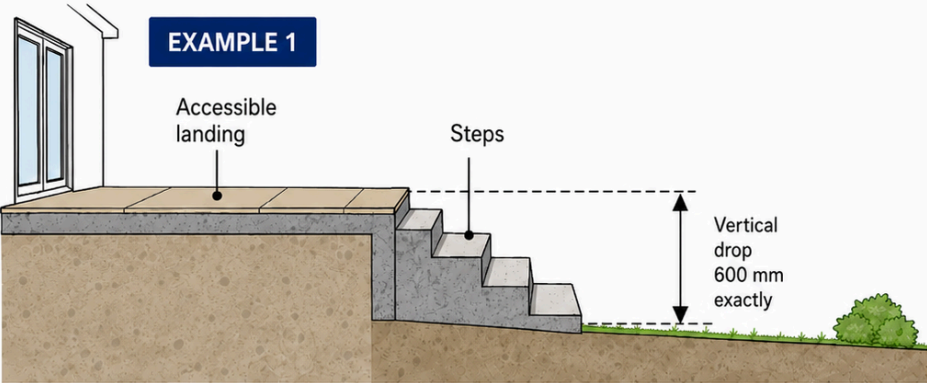
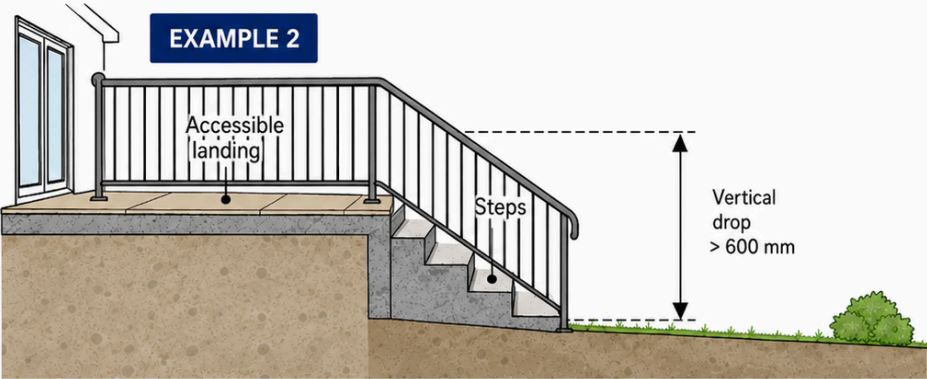
APPLICATION TO DEFECT 189

600 mm exactly. Guidance does not automatically trigger guarding on height alone.

Where there is a risk of falling from a height of more than 600 mm, guarding is normally required at accessible top edges and alongside steps.

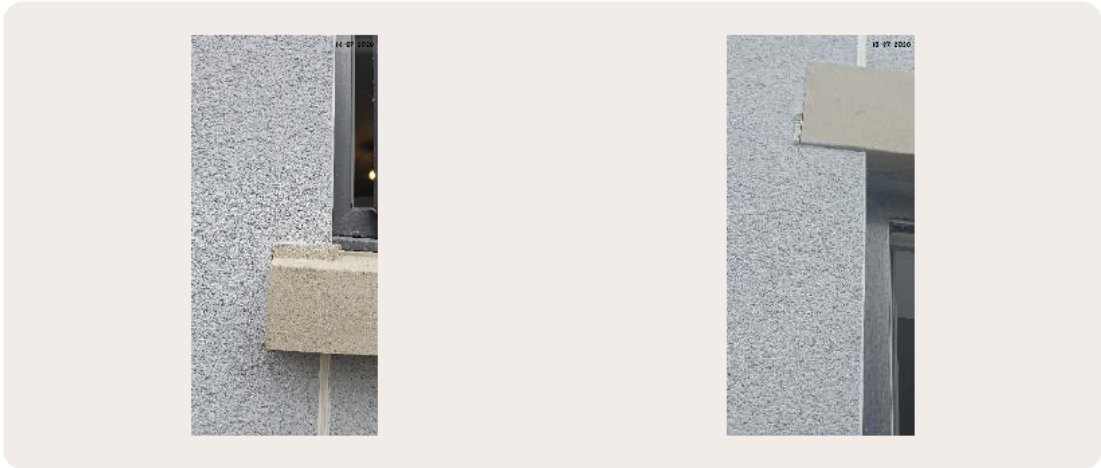
# Defect 190

**OBSERVATION**  
Cracking is visible in the render finish around the expansion bead.

**WHY THIS MATTERS**  
Render, movement joints and bead details are important for water shedding, crack control and long-term durability. Damaged or incorrectly formed details may lead to cracking and staining.

**RECOMMENDED ACTION**  
The renderer, coordinating with the bricklayer where necessary, should repair or replace the affected detail in accordance with the approved render system and manufacturer guidance.

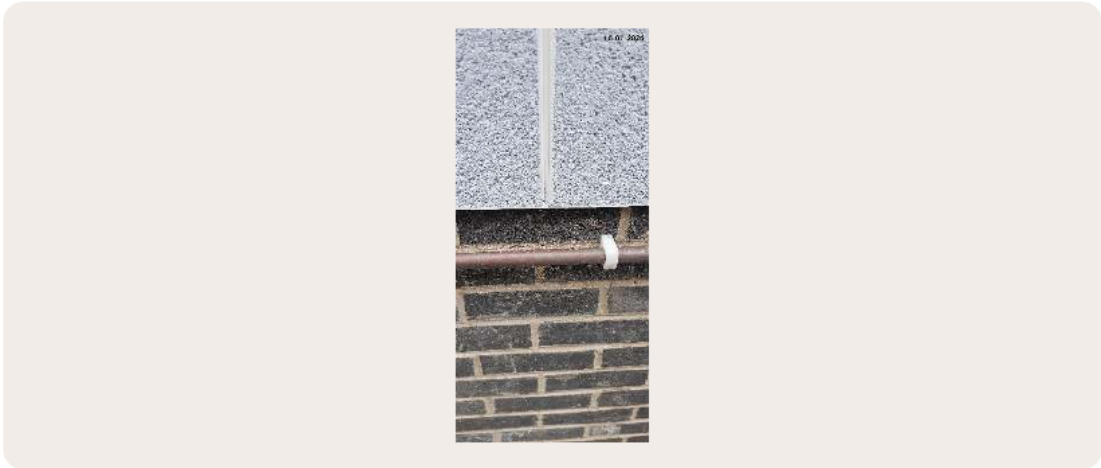
# Defect 191

**OBSERVATION**  
The expansion bead has not been continued through the drip bead.

**WHY THIS MATTERS**  
The discontinuity between the expansion bead and drip bead may interrupt the designed movement and water-shedding arrangement, increasing the risk of cracking and staining.

**RECOMMENDED ACTION**  
The renderer should expose and correct the junction so the expansion bead is properly continued through the drip bead in accordance with the approved render system detail. Reinstall the finish neatly.

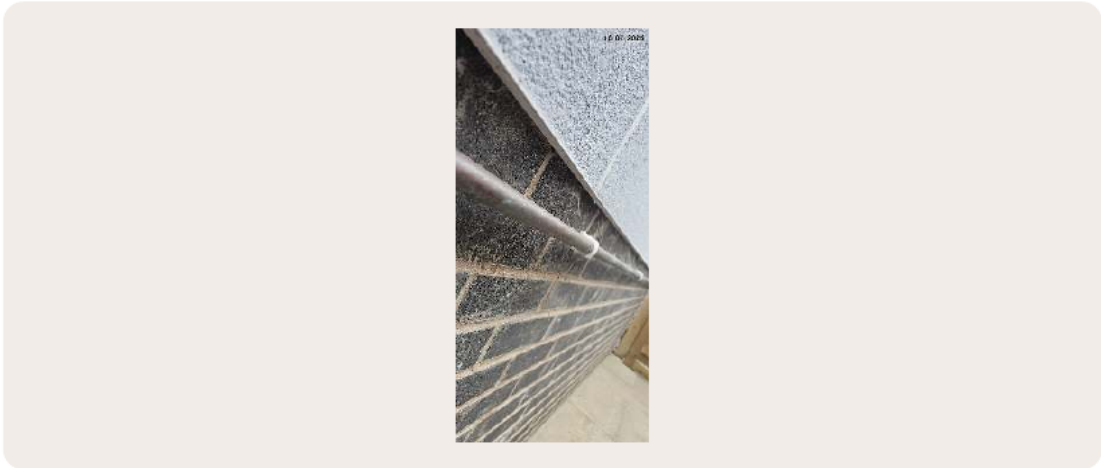
# Defect 192

**OBSERVATION**  
A stop bead has been used instead of a drip bead at the base of the render.

**WHY THIS MATTERS**  
Render, movement joints and bead details are important for water shedding, crack control and long-term durability. Damaged or incorrectly formed details may lead to cracking and staining.

**RECOMMENDED ACTION**  
The renderer, coordinating with the bricklayer where necessary, should repair or replace the affected detail in accordance with the approved render system and manufacturer guidance.

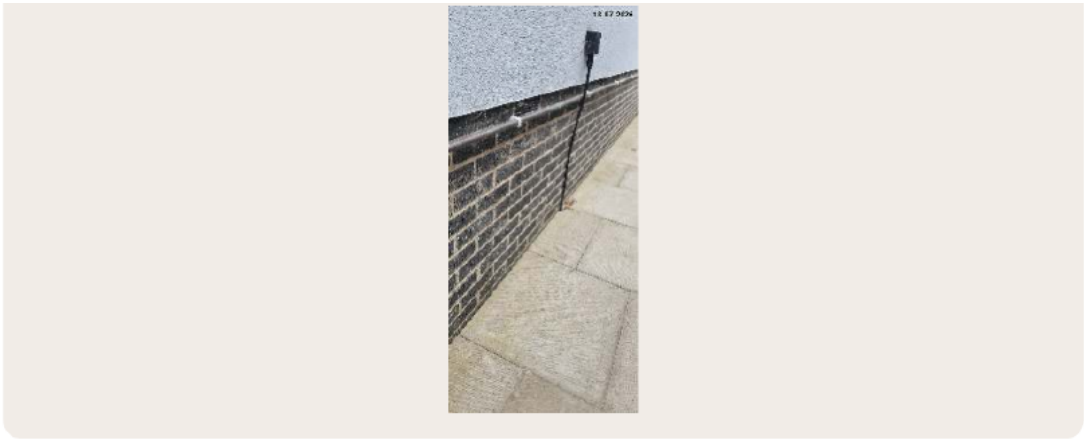
# Defect 193

An external cable has been left loose, unsupported and unterminated against the elevation.

Electrical items should be securely installed and protected against damage. Visible damage, unsuitable fixings or incomplete external protection may present a safety risk.

Arrange inspection and remedial work by a competent electrician. Isolate the item where necessary, repair or replace affected parts and provide updated electrical confirmation where required.

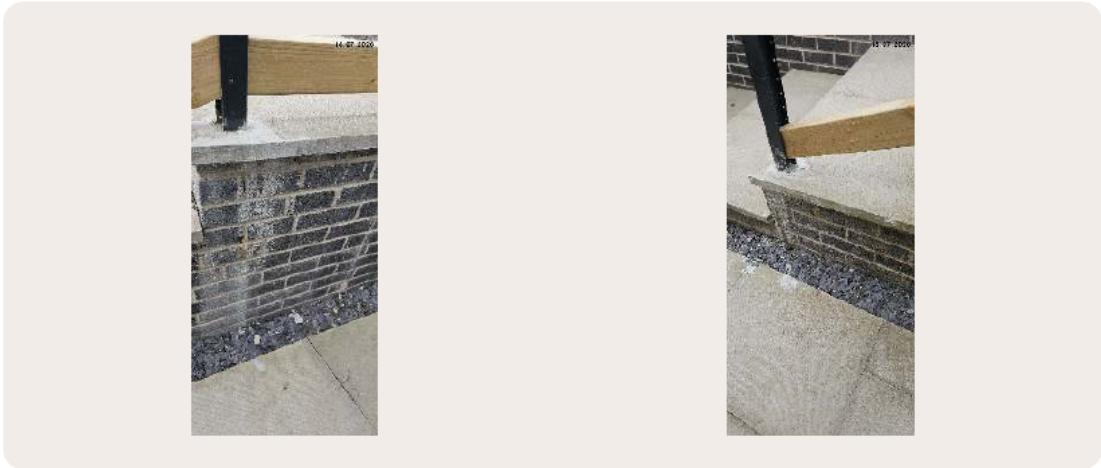
# Defect 194

**OBSERVATION**  
Concrete staining is visible across the brickwork adjacent to the external wall and retaining features.

**WHY THIS MATTERS**  
Concrete staining detracts from the completed masonry appearance and inappropriate cleaning methods may permanently damage brick faces or mortar joints.

**RECOMMENDED ACTION**  
The bricklayer should carefully clean the staining using a suitable trialled method that will not damage the bricks, mortar or adjacent finishes. Avoid aggressive acids or abrasion unless specifically approved for the masonry product.

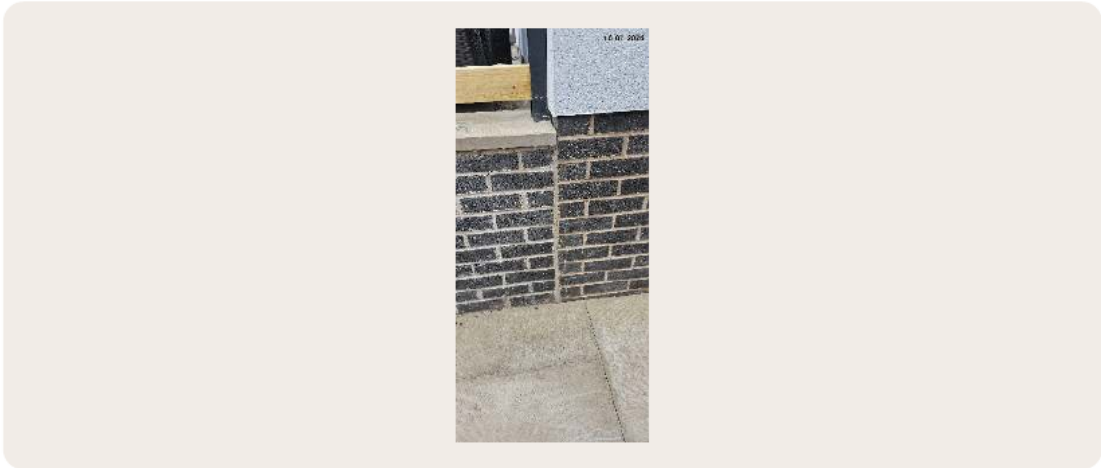
# Defect 195

The expansion joint has been filled with mortar.

The bricklayer should inspect the affected detail and complete the required bedding, pointing, drainage, cleaning or replacement work in accordance with the approved design and product guidance.

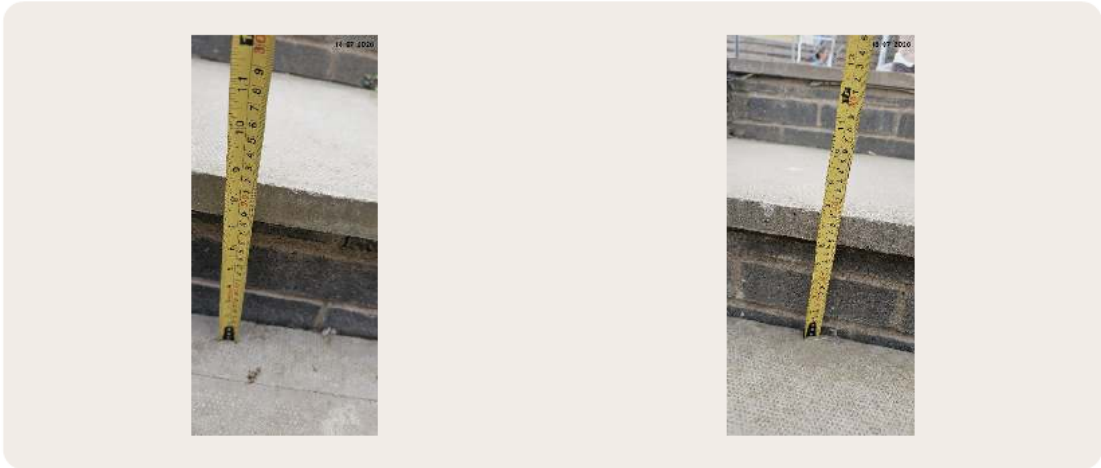
# Defect 196

The steps to the rear garden have unequal riser heights.

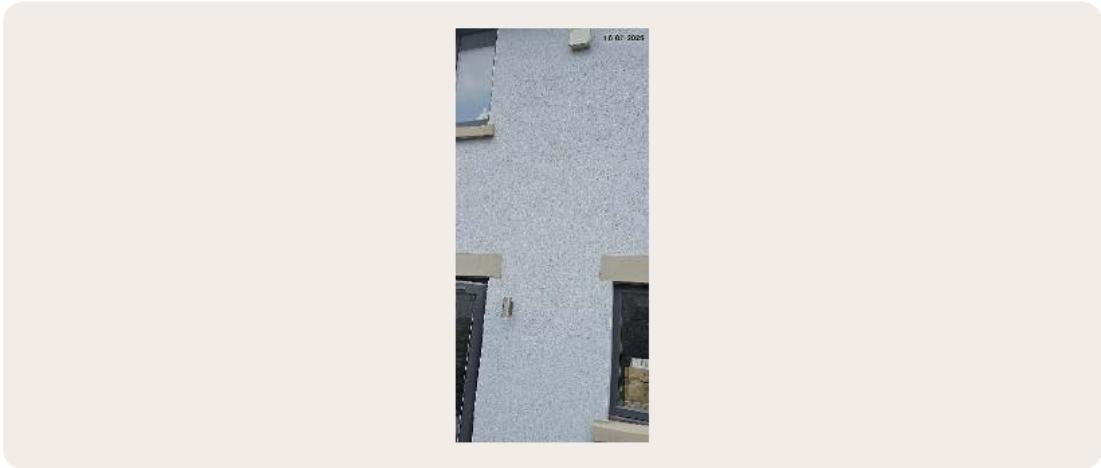
# Defect 197

**OBSERVATION**  
The rear elevation render is scarred.

**WHY THIS MATTERS**  
Render, movement joints and bead details are important for water shedding, crack control and long-term durability. Damaged or incorrectly formed details may lead to cracking and staining.

**RECOMMENDED ACTION**  
The renderer, coordinating with the bricklayer where necessary, should repair or replace the affected detail in accordance with the approved render system and manufacturer guidance.

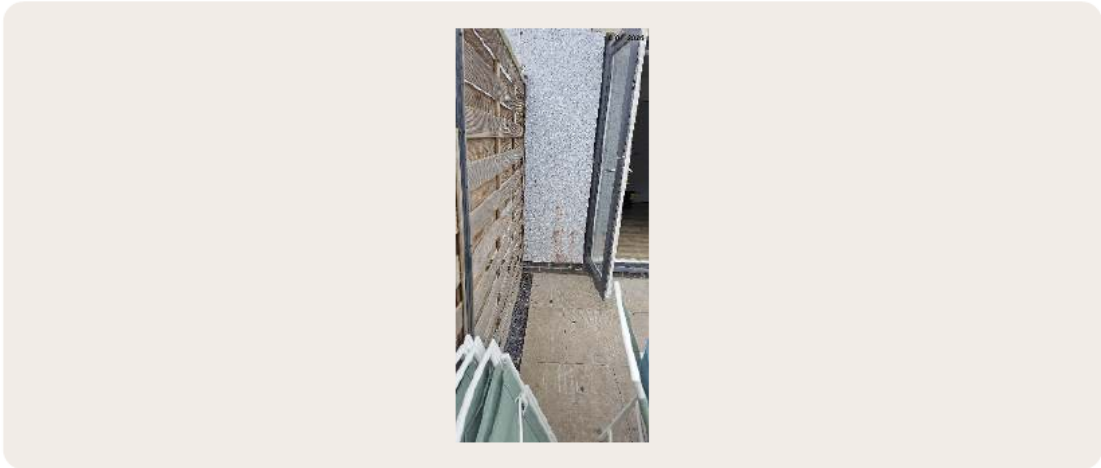
# Defect 198

**OBSERVATION**  
Dirty marks remain on the render beside the French doors.

**WHY THIS MATTERS**  
The property should be handed over clean and free from construction debris, residue, staining and trade contamination.

**RECOMMENDED ACTION**  
Remove the debris or contamination using a suitable non-damaging cleaning method and leave the area clean and ready for normal use.

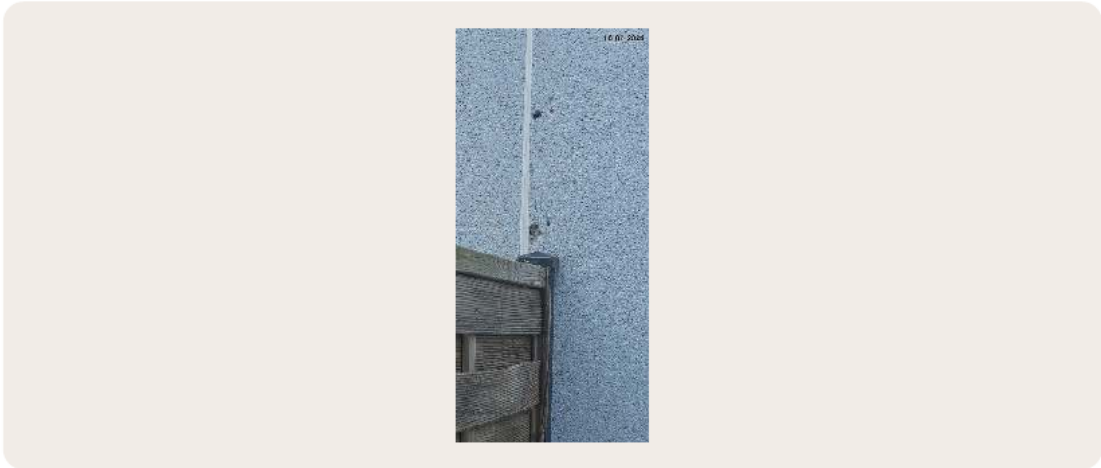
# Defect 199

**OBSERVATION**  
The render above the fence post is locally damaged.

**WHY THIS MATTERS**  
Render, movement joints and bead details are important for water shedding, crack control and long-term durability. Damaged or incorrectly formed details may lead to cracking and staining.

**RECOMMENDED ACTION**  
The renderer, coordinating with the bricklayer where necessary, should repair or replace the affected detail in accordance with the approved render system and manufacturer guidance.

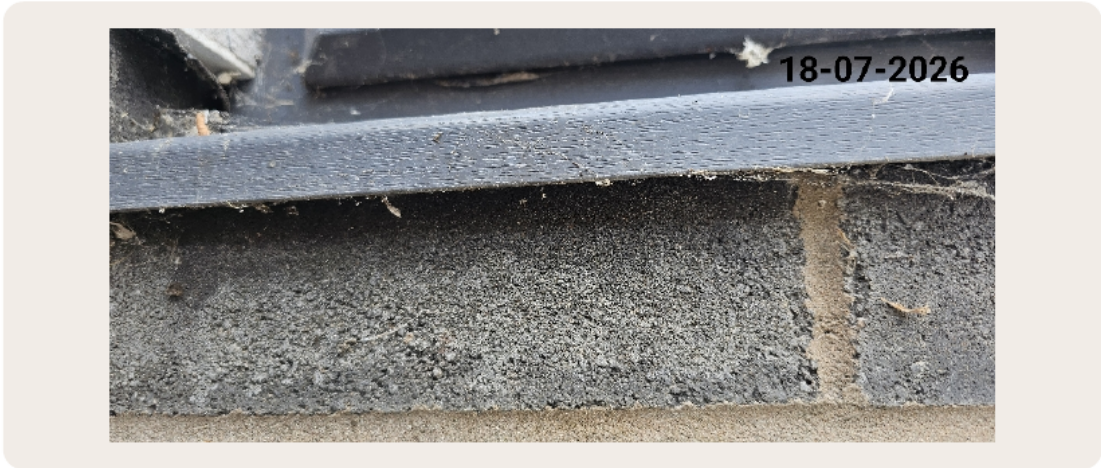
# Defect 200

**OBSERVATION**  
The French door perimeter has not been sealed.

**WHY THIS MATTERS**  
External and wet-area junctions should be continuously sealed to reduce the risk of water ingress, staining and deterioration. Open or poorly finished joints can allow moisture to enter concealed interfaces.

**RECOMMENDED ACTION**  
Remove unsuitable or incomplete material, clean and prepare the joint, then apply a compatible sealant to form a neat, continuous and durable weather seal.

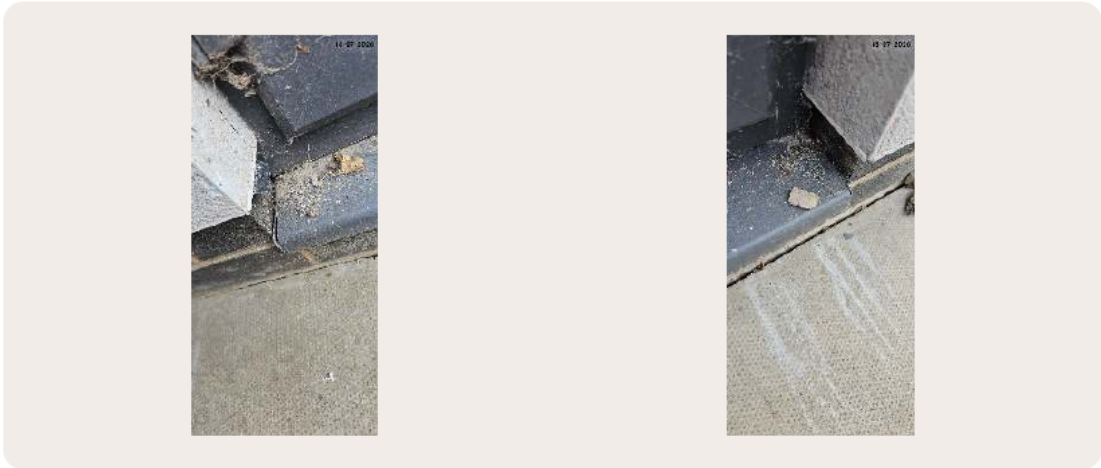
# Defect 201

The French door sill junctions have not been sealed.

External and wet-area junctions should be continuously sealed to reduce the risk of water ingress, staining and deterioration. Open or poorly finished joints can allow moisture to enter concealed interfaces.

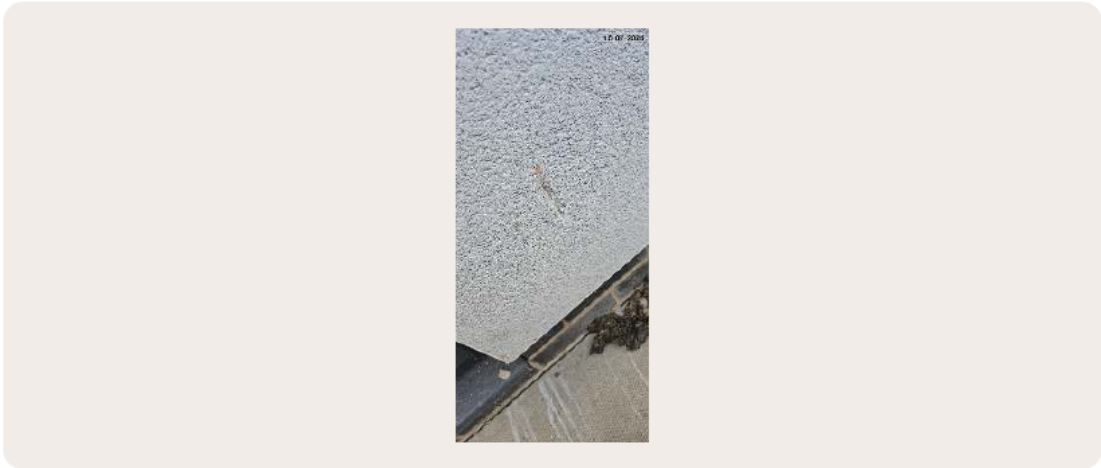
# Defect 202

**OBSERVATION**  
The render bead to the right-hand side of the French doors is scarred.

**WHY THIS MATTERS**  
Render, movement joints and bead details are important for water shedding, crack control and long-term durability. Damaged or incorrectly formed details may lead to cracking and staining.

**RECOMMENDED ACTION**  
The renderer, coordinating with the bricklayer where necessary, should repair or replace the affected detail in accordance with the approved render system and manufacturer guidance.

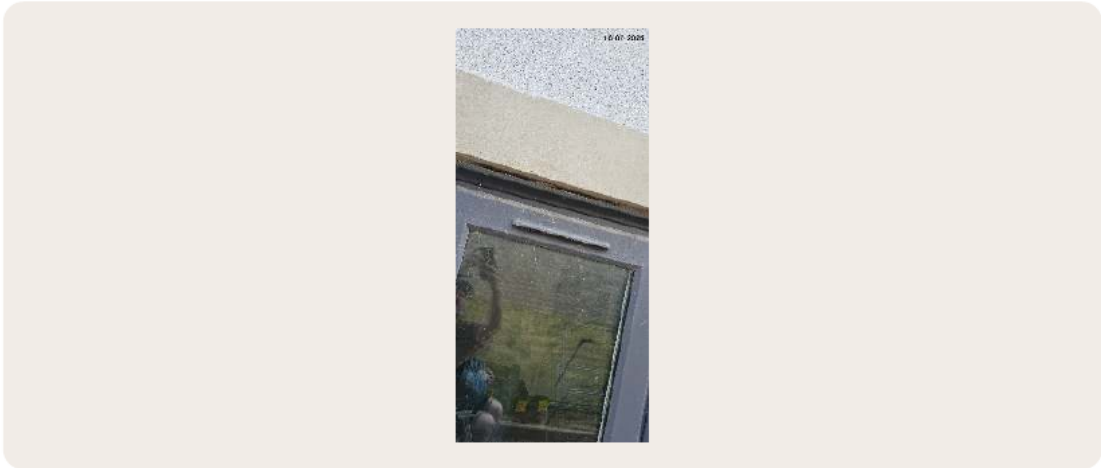
# Defect 203

**OBSERVATION**  
The stone head is not fully bedded.

**WHY THIS MATTERS**  
Masonry, stone, lintel, sill and cavity drainage details should be complete, stable and capable of shedding water. Open joints or incomplete bedding may affect durability and weather resistance.

**RECOMMENDED ACTION**  
The bricklayer should inspect the affected detail and complete the required bedding, pointing, drainage, cleaning or replacement work in accordance with the approved design and product guidance.

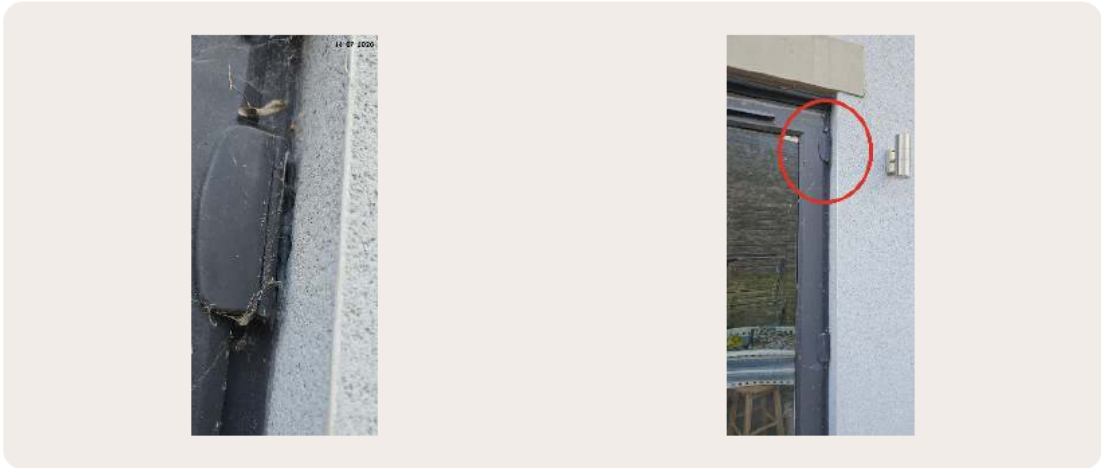
# Defect 204

**OBSERVATION**  
The mastic finish behind the hinge is poor.

**WHY THIS MATTERS**  
External and wet-area junctions should be continuously sealed to reduce the risk of water ingress, staining and deterioration. Open or poorly finished joints can allow moisture to enter concealed interfaces.

**RECOMMENDED ACTION**  
Remove unsuitable or incomplete material, clean and prepare the joint, then apply a compatible sealant to form a neat, continuous and durable weather seal.

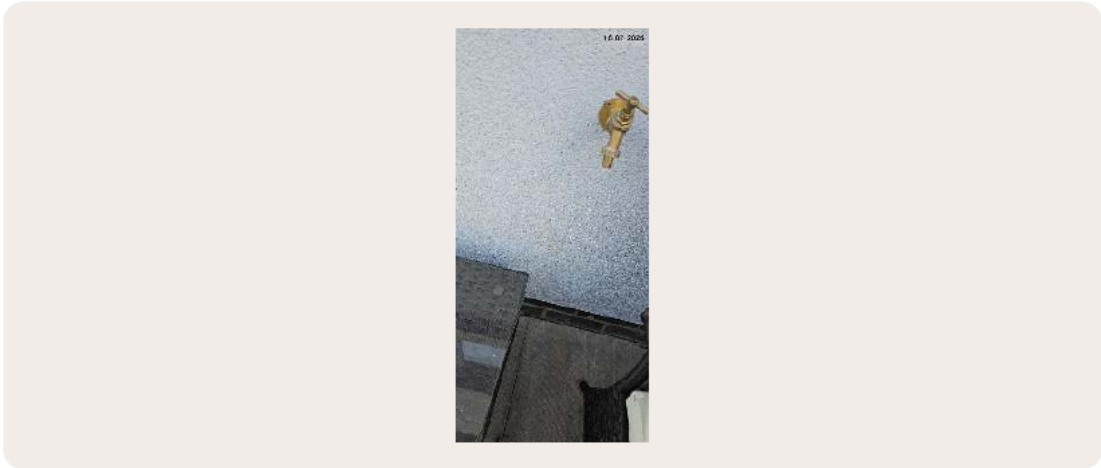
# Defect 205

The render below the outside tap is scarred.

Render, movement joints and bead details are important for water shedding, crack control and long-term durability. Damaged or incorrectly formed details may lead to cracking and staining.

The renderer, coordinating with the bricklayer where necessary, should repair or replace the affected detail in accordance with the approved render system and manufacturer guidance.

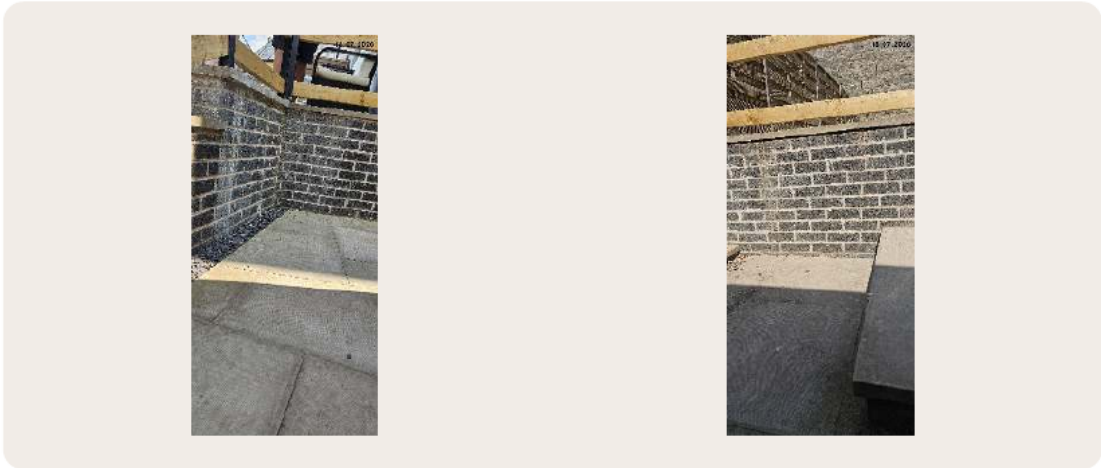
Defect 206

**OBSERVATION**  
No drainage weep holes are visible within the retaining walls.

**WHY THIS MATTERS**  
Retaining walls should incorporate the drainage and pressure-relief measures required by the approved design. Inadequate drainage can allow water pressure to build behind the wall, increasing the risk of staining, movement or deterioration.

**RECOMMENDED ACTION**  
The groundworker should obtain and review the approved retaining-wall and drainage details, confirm whether weep outlets or another drainage system is required, and complete the designed drainage arrangement with a suitable discharge point. Make good disturbed finishes and provide completion evidence.

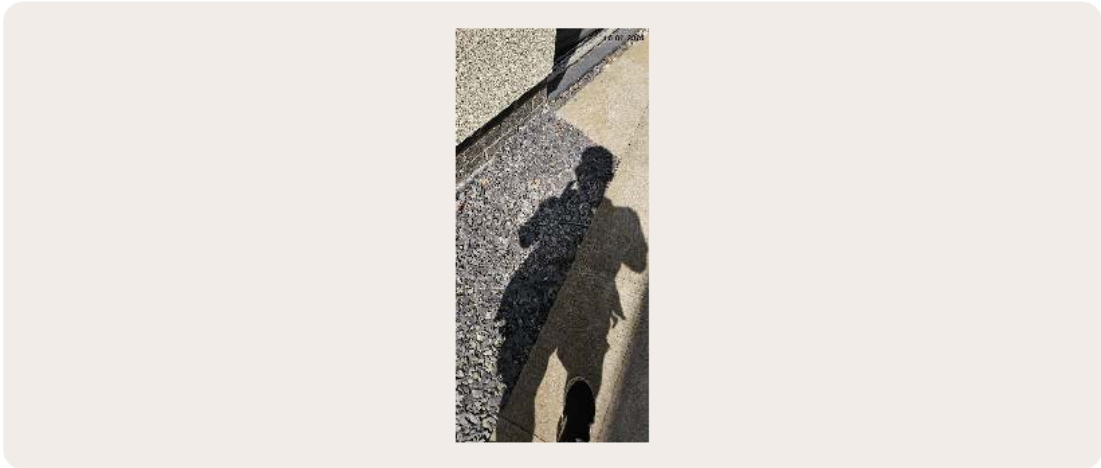
# Defect 207

The electrical supply to the garage is not suitably protected.

Electrical items should be securely installed and protected against damage. Visible damage, unsuitable fixings or incomplete external protection may present a safety risk.

Arrange inspection and remedial work by a competent electrician. Isolate the item where necessary, repair or replace affected parts and provide updated electrical confirmation where required.

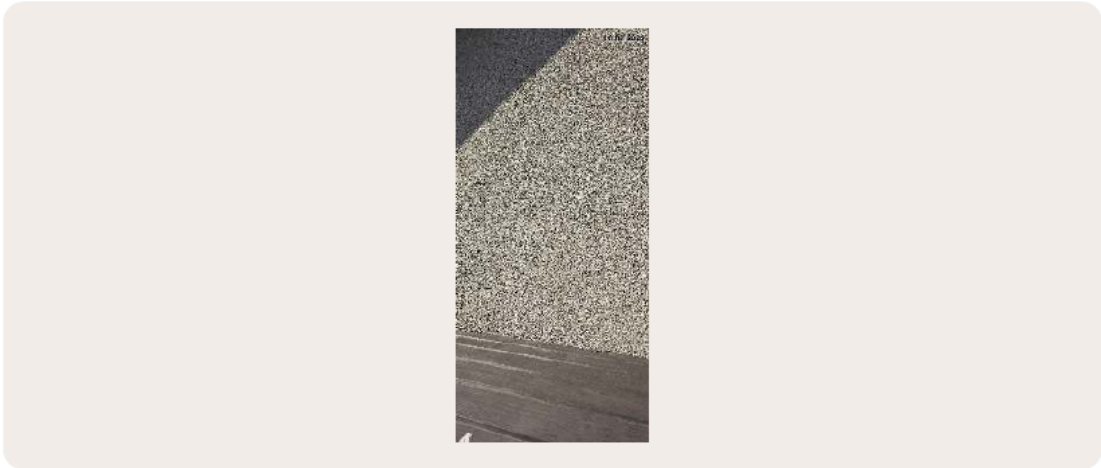
# Defect 208

**OBSERVATION**  
The garage render is scarred.

**WHY THIS MATTERS**  
Render, movement joints and bead details are important for water shedding, crack control and long-term durability. Damaged or incorrectly formed details may lead to cracking and staining.

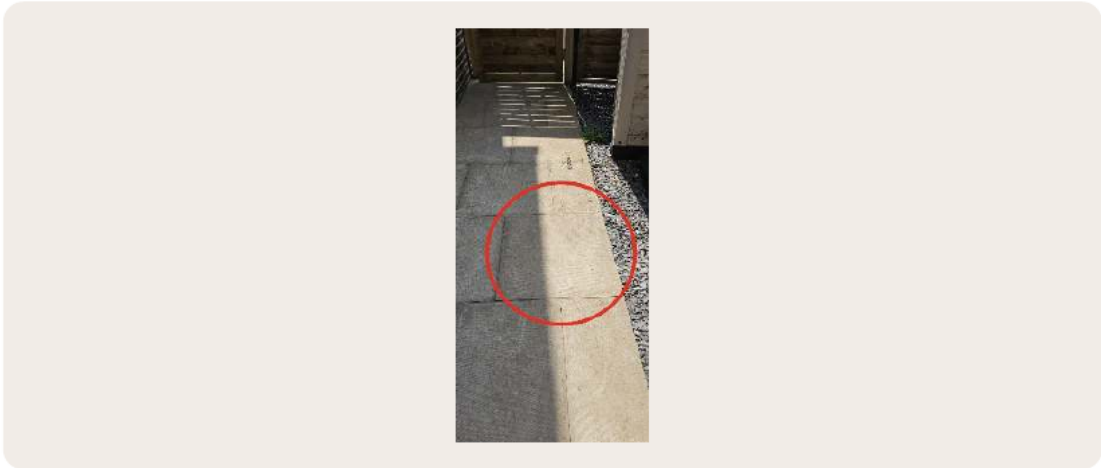
# Defect 209

OBSERVATION  
A paving slab is rocking under normal use.

WHY THIS MATTERS  
External routes, steps and level changes should be safe for normal use. Unequal risers, unstable paving or unprotected changes in level increase the risk of trips and falls.

RECOMMENDED ACTION  
Make the area safe promptly. Reconstruct or adjust the steps, paving or levels as required to provide a stable and consistent access arrangement.

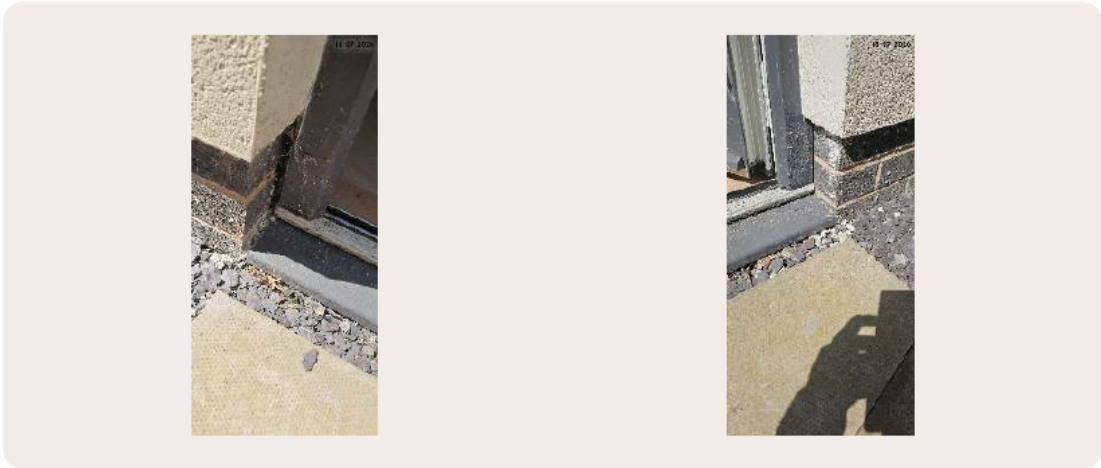
# Defect 210

**OBSERVATION**  
The garage door perimeter has not been sealed.

**WHY THIS MATTERS**  
External and wet-area junctions should be continuously sealed to reduce the risk of water ingress, staining and deterioration. Open or poorly finished joints can allow moisture to enter concealed interfaces.

**RECOMMENDED ACTION**  
Remove unsuitable or incomplete material, clean and prepare the joint, then apply a compatible sealant to form a neat, continuous and durable weather seal.

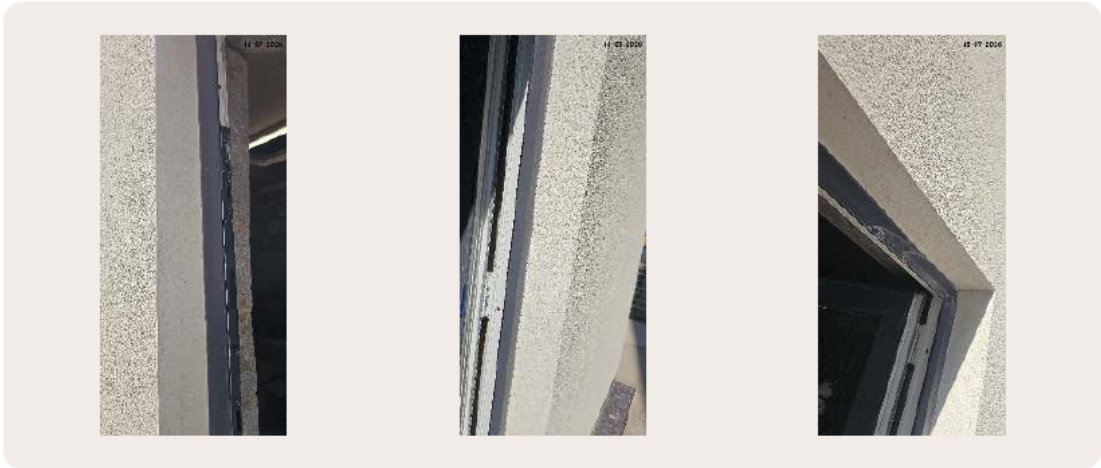
# Defect 211

The garage door render reveals and head have not been scratched back.

Render, movement joints and bead details are important for water shedding, crack control and long-term durability. Damaged or incorrectly formed details may lead to cracking and staining.

The renderer, coordinating with the bricklayer where necessary, should repair or replace the affected detail in accordance with the approved render system and manufacturer guidance.

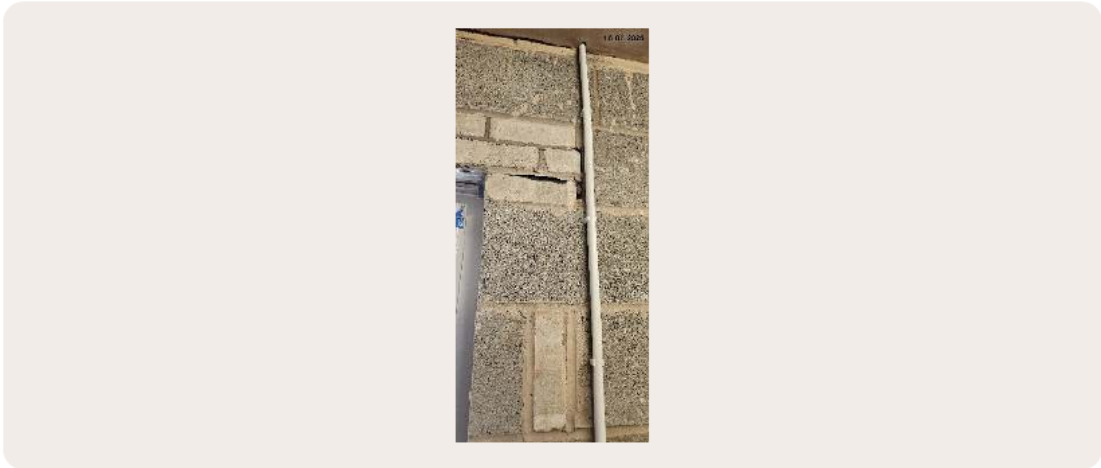
# Defect 212

Joints to the brickwork supporting the lintel over the garage door are incomplete.

The bricklayer should inspect the affected detail and complete the required bedding, pointing, drainage, cleaning or replacement work in accordance with the approved design and product guidance.

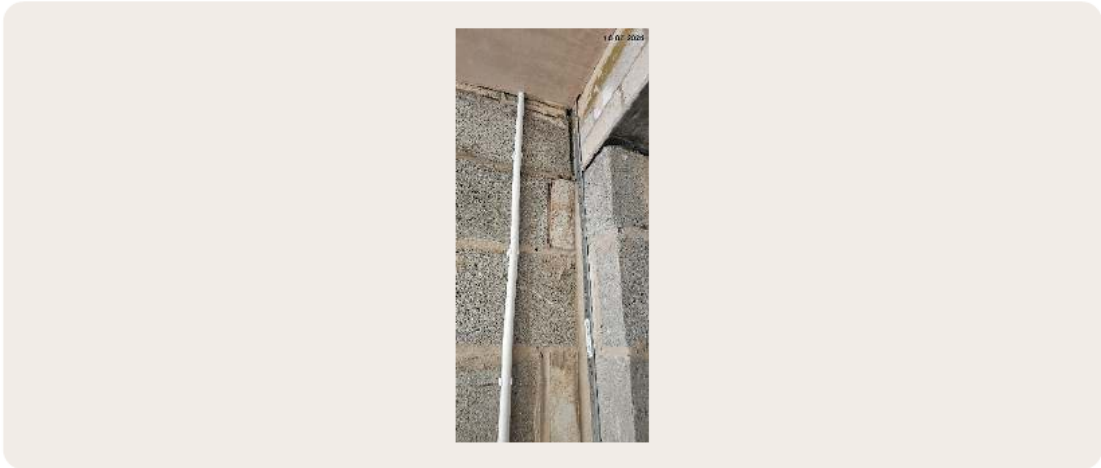
# Defect 213

A perpend joint, or perp, in the garage brickwork is open.

The bricklayer should inspect the affected detail and complete the required bedding, pointing, drainage, cleaning or replacement work in accordance with the approved design and product guidance.

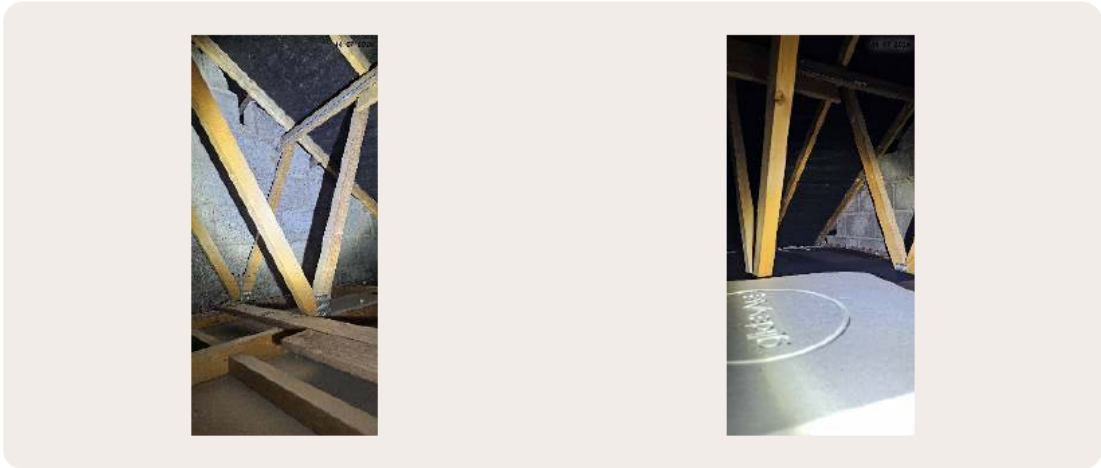
# Defect 214

**OBSERVATION**  
Roof ladder framing has not been built into the garage roof construction.

**WHY THIS MATTERS**  
The verge and roof-edge construction should be fully supported and completed in accordance with the approved roof and masonry details. Missing support can affect stability, alignment and the durability of the completed edge detail.

**RECOMMENDED ACTION**  
The bricklayer should coordinate with the roof carpenter or roofer and follow the approved construction detail to form the required support and interface. Any disturbed masonry, roof components and finishes should be made good, and the completed arrangement should be confirmed by the site technical team.
