# Professional Snagging Inspection Report

Post-completion inspection

Inspection date: 18 July 2026

South Wales Snagging Co was instructed to undertake a visual, non-destructive post-completion snagging inspection of an anonymised new-build property in South Wales. This report records visible defects, incomplete items and areas requiring developer or aftercare attention based on the condition observed on 18 July 2026.

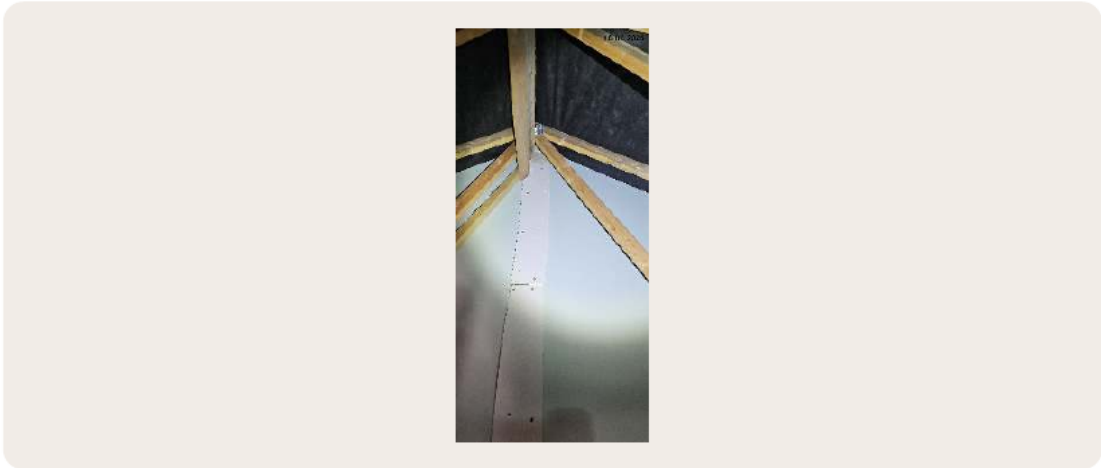
# Defect 215

**OBSERVATION**  
Firestopping to the party wall spandrel is inadequate.

**WHY THIS MATTERS**  
Party wall fire separation should be continuous and complete to restrict the passage of fire and smoke. Inadequate firestopping is a significant life-safety concern.

**RECOMMENDED ACTION**  
A competent firestopping contractor should rectify the party wall spandrel in accordance with the approved fire strategy and provide photographic and product evidence of completion.

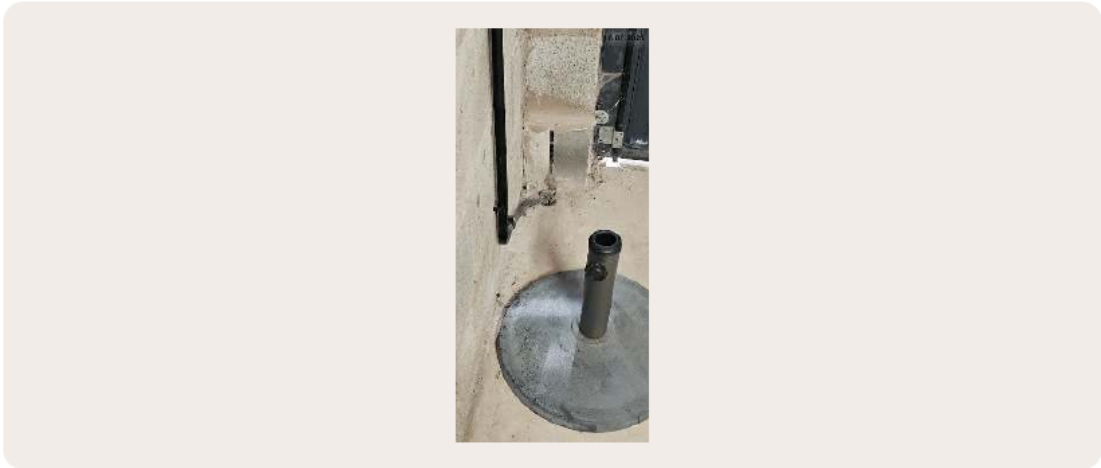
# Defect 216

**OBSERVATION**  
A perpend joint, or perp, at the garage door reveal is open.

**WHY THIS MATTERS**  
Masonry, stone, lintel, sill and cavity drainage details should be complete, stable and capable of shedding water. Open joints or incomplete bedding may affect durability and weather resistance.

**RECOMMENDED ACTION**  
The bricklayer should inspect the affected detail and complete the required bedding, pointing, drainage, cleaning or replacement work in accordance with the approved design and product guidance.

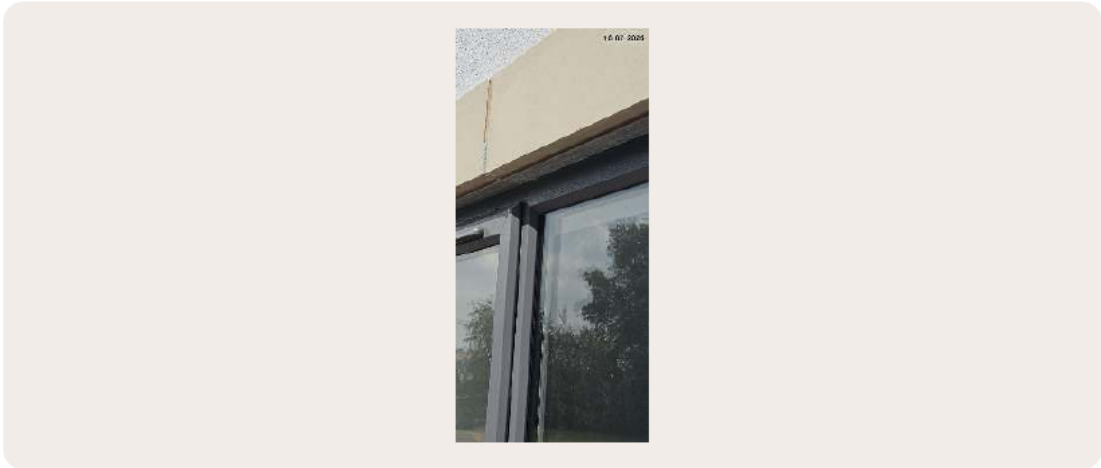
# Defect 218

**OBSERVATION**  
The lounge window head has not been sealed.

**WHY THIS MATTERS**  
External and wet-area junctions should be continuously sealed to reduce the risk of water ingress, staining and deterioration. Open or poorly finished joints can allow moisture to enter concealed interfaces.

**RECOMMENDED ACTION**  
Remove unsuitable or incomplete material, clean and prepare the joint, then apply a compatible sealant to form a neat, continuous and durable weather seal.

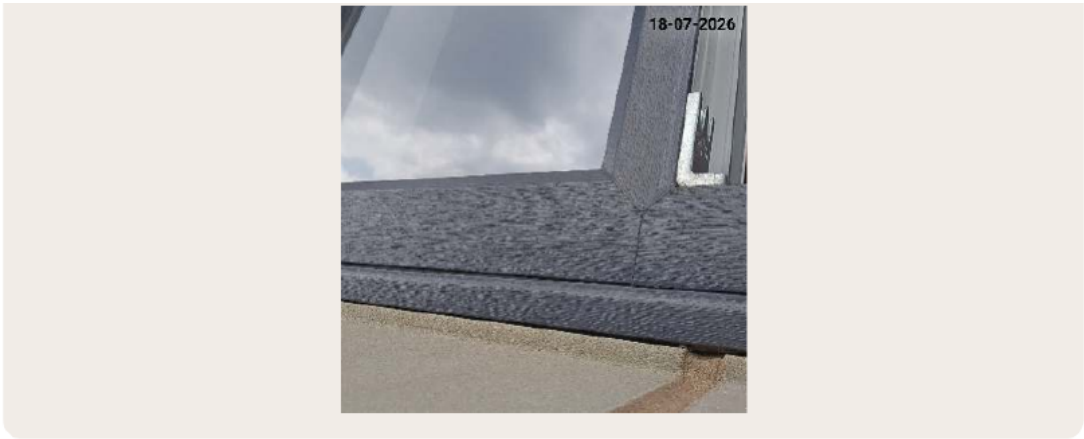
# Defect 220

**OBSERVATION**  
At recorded first-floor window location 1 of 4, the window-frame sill drip terminates behind the stone sill upstand and does not project sufficiently to discharge rainwater clear of the junction.

**WHY THIS MATTERS**  
The frame sill drip should project beyond the stone sill upstand so rainwater is discharged clear of the window-to-sill junction. The current arrangement may allow water to track behind the upstand, leading to persistent wetting, staining or moisture penetration.

**RECOMMENDED ACTION**  
The window fitter should install a suitable proprietary oversill or window manufacturer-approved sill extension. The completed drip should project beyond the stone sill upstand, be securely fixed and be neatly weather sealed.

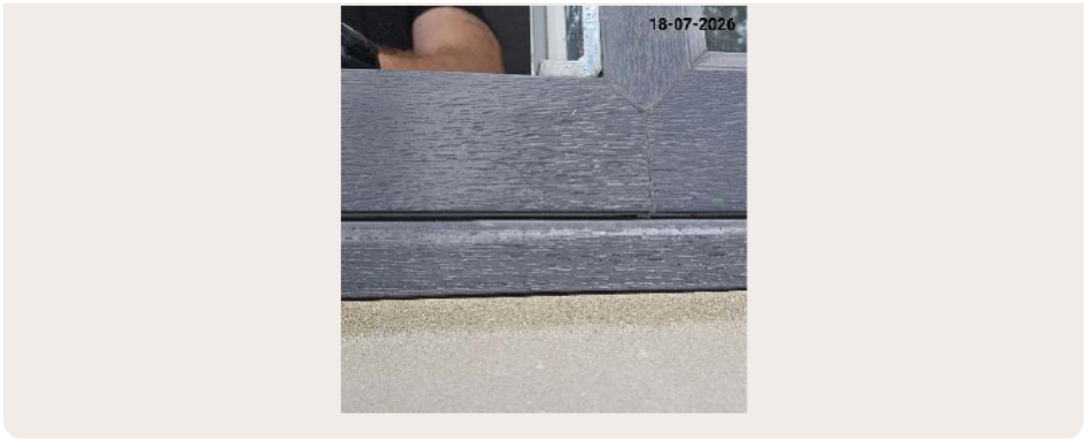
# Defect 221

**OBSERVATION**  
At recorded first-floor window location 2 of 4, the window-frame sill drip terminates behind the stone sill upstand and does not project sufficiently to discharge rainwater clear of the junction.

**WHY THIS MATTERS**  
The frame sill drip should project beyond the stone sill upstand so rainwater is discharged clear of the window-to-sill junction. The current arrangement may allow water to track behind the upstand, leading to persistent wetting, staining or moisture penetration.

**RECOMMENDED ACTION**  
The window fitter should install a suitable proprietary oversill or window manufacturer-approved sill extension. The completed drip should project beyond the stone sill upstand, be securely fixed and be neatly weather sealed.

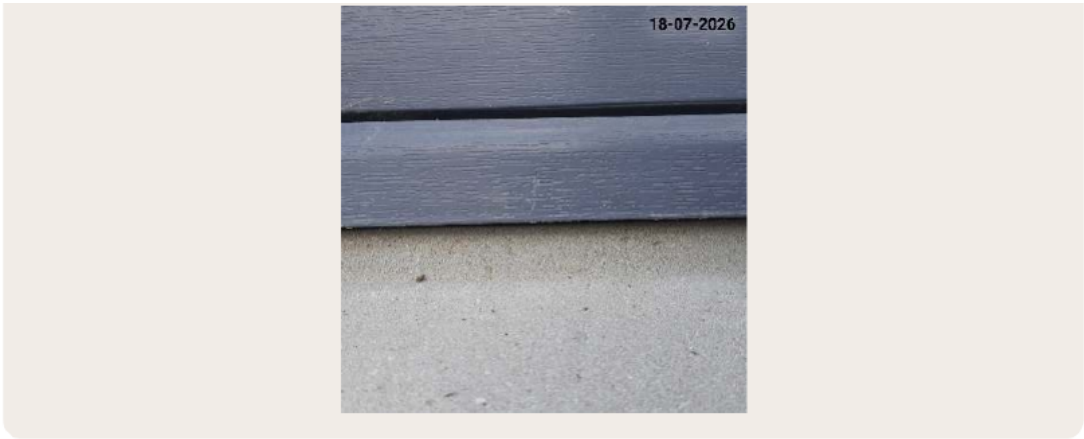
# Defect 222

**OBSERVATION**  
At recorded first-floor window location 3 of 4, the window-frame sill drip terminates behind the stone sill upstand and does not project sufficiently to discharge rainwater clear of the junction.

**WHY THIS MATTERS**  
The frame sill drip should project beyond the stone sill upstand so rainwater is discharged clear of the window-to-sill junction. The current arrangement may allow water to track behind the upstand, leading to persistent wetting, staining or moisture penetration.

**RECOMMENDED ACTION**  
The window fitter should install a suitable proprietary oversill or window manufacturer-approved sill extension. The completed drip should project beyond the stone sill upstand, be securely fixed and be neatly weather sealed.

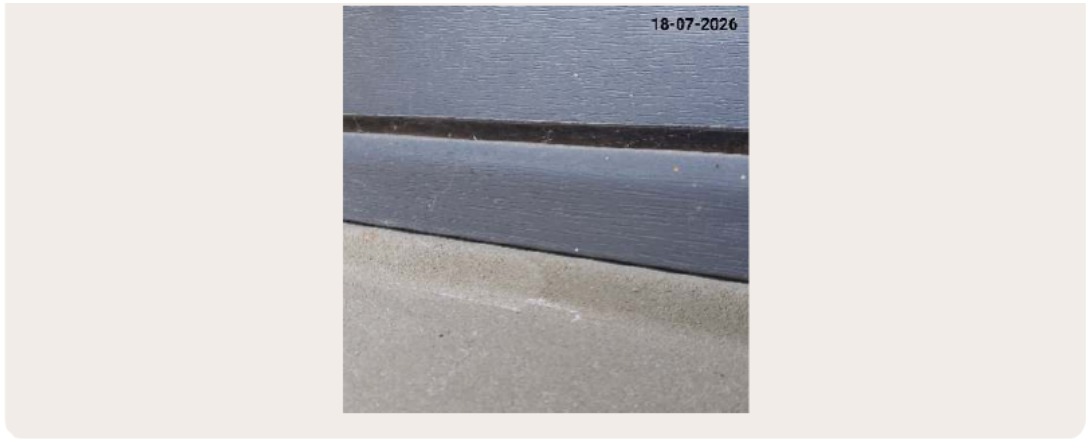
# Defect 223

**OBSERVATION**  
At recorded first-floor window location 4 of 4, the window-frame sill drip terminates behind the stone sill upstand and does not project sufficiently to discharge rainwater clear of the junction.

**WHY THIS MATTERS**  
The frame sill drip should project beyond the stone sill upstand so rainwater is discharged clear of the window-to-sill junction. The current arrangement may allow water to track behind the upstand, leading to persistent wetting, staining or moisture penetration.

**RECOMMENDED ACTION**  
The window fitter should install a suitable proprietary oversill or window manufacturer-approved sill extension. The completed drip should project beyond the stone sill upstand, be securely fixed and be neatly weather sealed.
