# Professional Snagging Inspection Report

Pre-completion inspection

**Sample Development - Plot XX**

Development: Sample Development | Plot XX | Developer: Anonymised | Total defects: 95

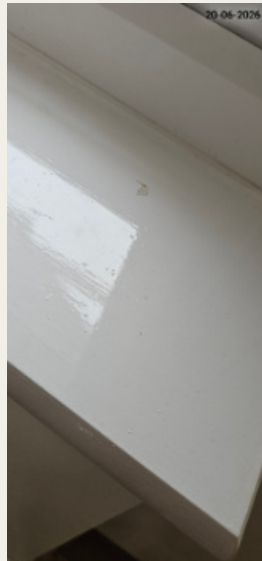
## Defect 7

**The paint finish to the window sill adjacent to the front door is poor.**

External envelope defects can affect durability, weather resistance or the finished appearance of the home if not corrected before handover.

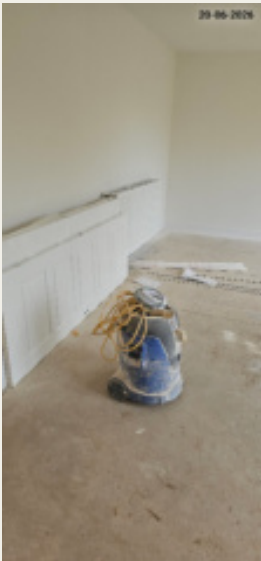
Defect 8

Access materials and construction debris remain within the property.

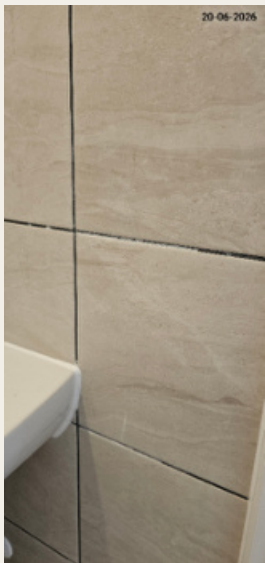
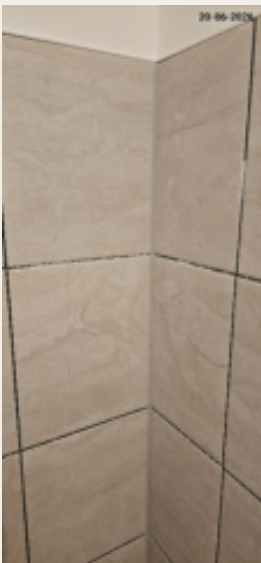
The grout colour is inconsistent in several areas.

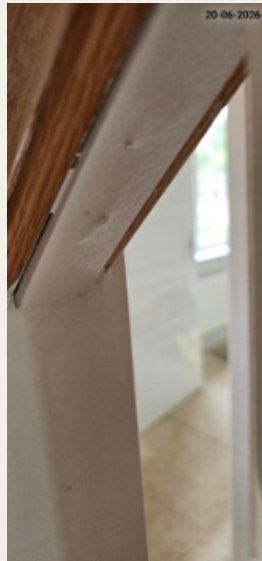
**The finish is poor where the balustrade is fixed to the newel post.**

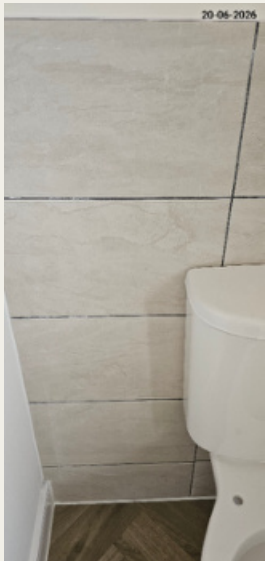
Grout discolouration is present to the en suite wall tiling.

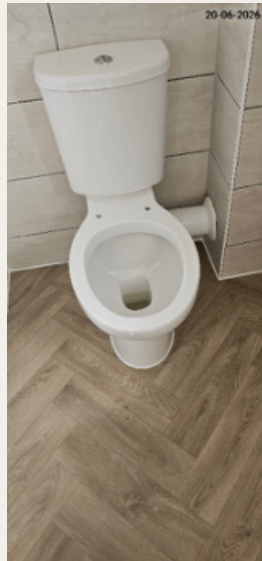
## Defect 44

**OBSERVATION****The toilet seat is missing.****WHY THIS MATTERS**

Wet areas and sanitary fittings should be complete, secure and neatly finished to reduce the risk of water ingress, staining, poor hygiene or early deterioration.

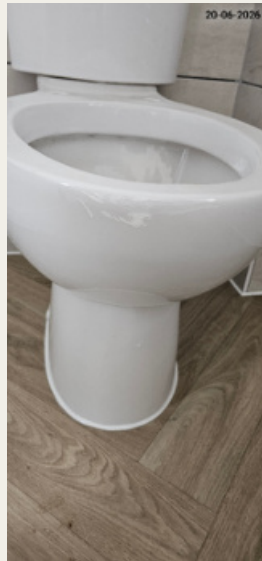
**OBSERVATION****Paint contamination is present on the toilet pan.****WHY THIS MATTERS**

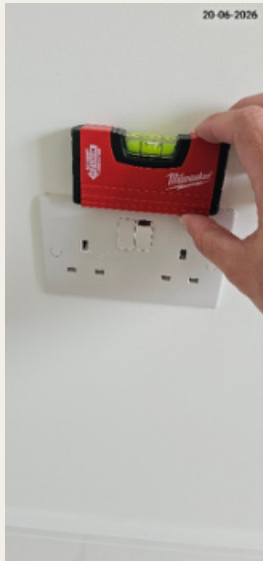
**OBSERVATION****A socket faceplate is out of level.****WHY THIS MATTERS**

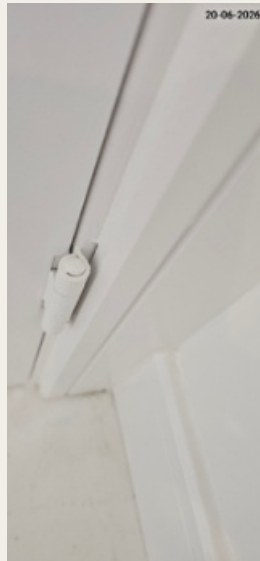
## Defect 64

**Architraves have not been caulked behind the hinges and paint contamination is present on the hinges.**

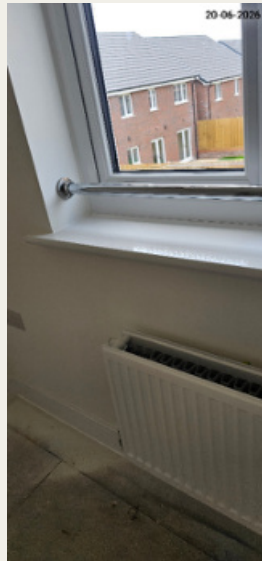
## Defect 68

**OBSERVATION****Excessive movement was identified to the safety rail.****WHY THIS MATTERS**

Joinery and ironmongery should be secure, aligned and properly finished to allow correct use and reduce the risk of damage or early failure.

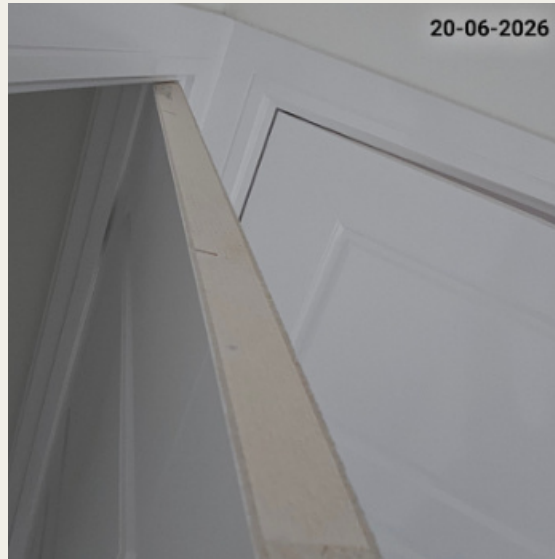
## Defect 74

**OBSERVATION****The top of the door has not been decorated.****WHY THIS MATTERS**

The item falls below the finish expected at handover and should be corrected to provide a clean, complete and consistent new home finish.

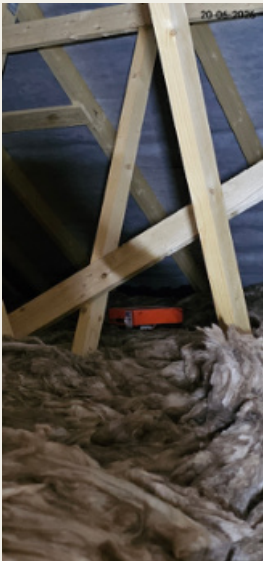
Excess materials and construction debris remain within the loft.

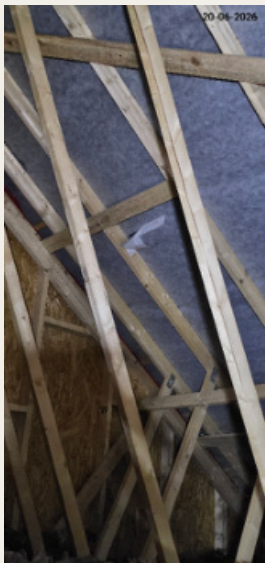
Issue 77: Loft - Damaged felt

An external envelope or roof related defect was identified: Damaged felt.

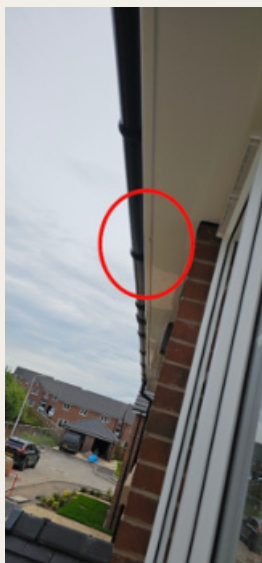
**OBSERVATION****Damage is present to the fascia.****WHY THIS MATTERS**

External envelope defects can affect durability, weather resistance or the finished appearance of the home if not corrected before handover.

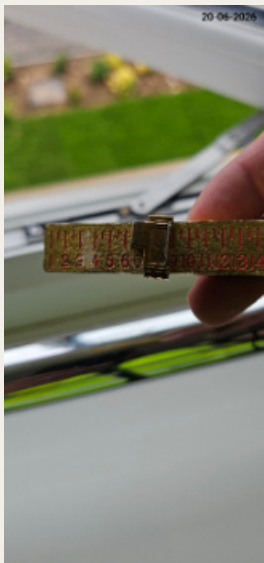
Issue 82: Bedroom 1 - Inadequate clearance beneath plastic sill to stone sill for differential settlement

There is inadequate clearance beneath the plastic sill and the stone sill for differential settlement.

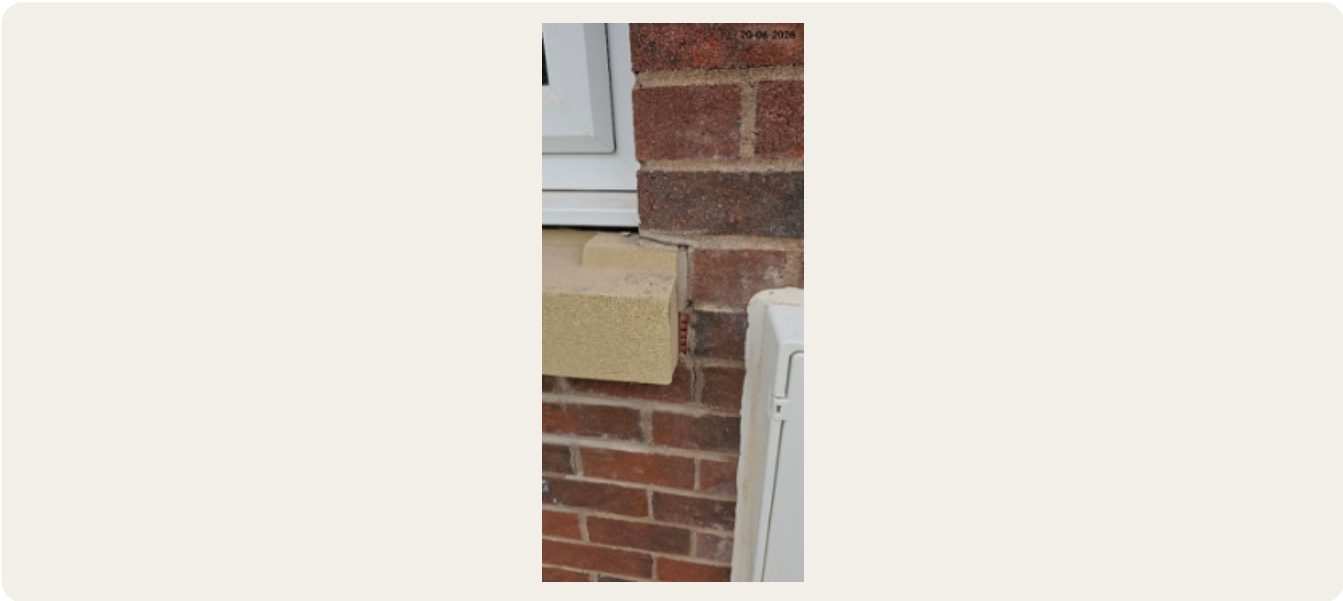
The mortar finish beneath the front sill is poor.

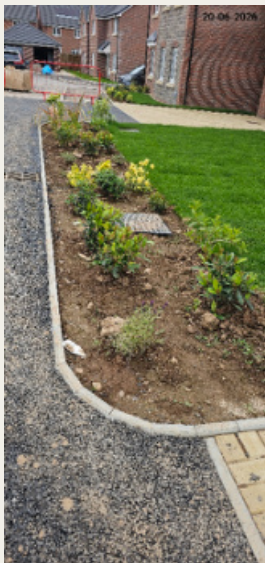
Landscaping to the front of the property is incomplete.

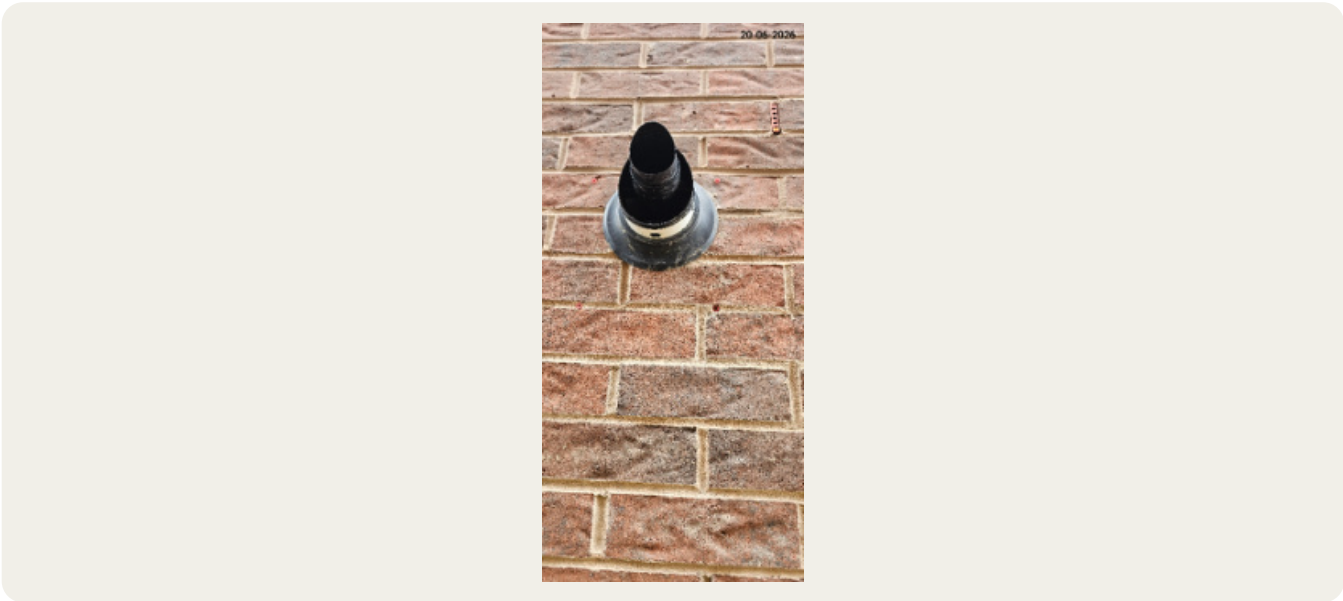
Redundant wall plugs are present to the external brickwork.

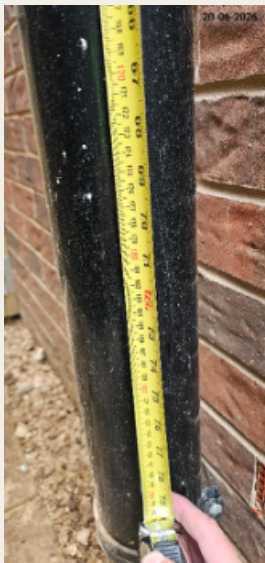
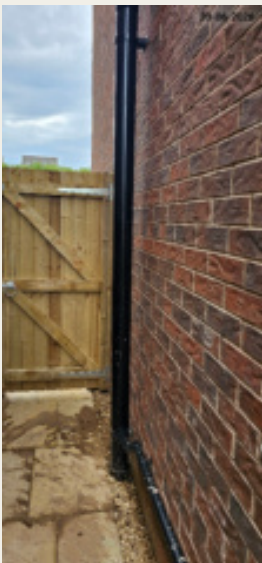
A bracket is missing from the soil and vent pipework.

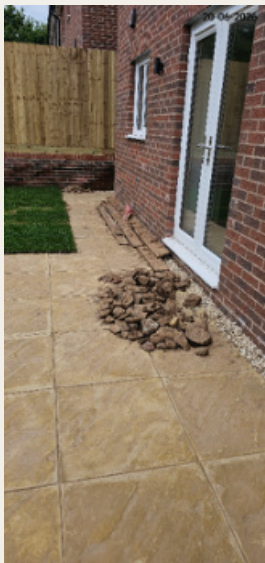
Garden arisings and debris have been left on the patio.

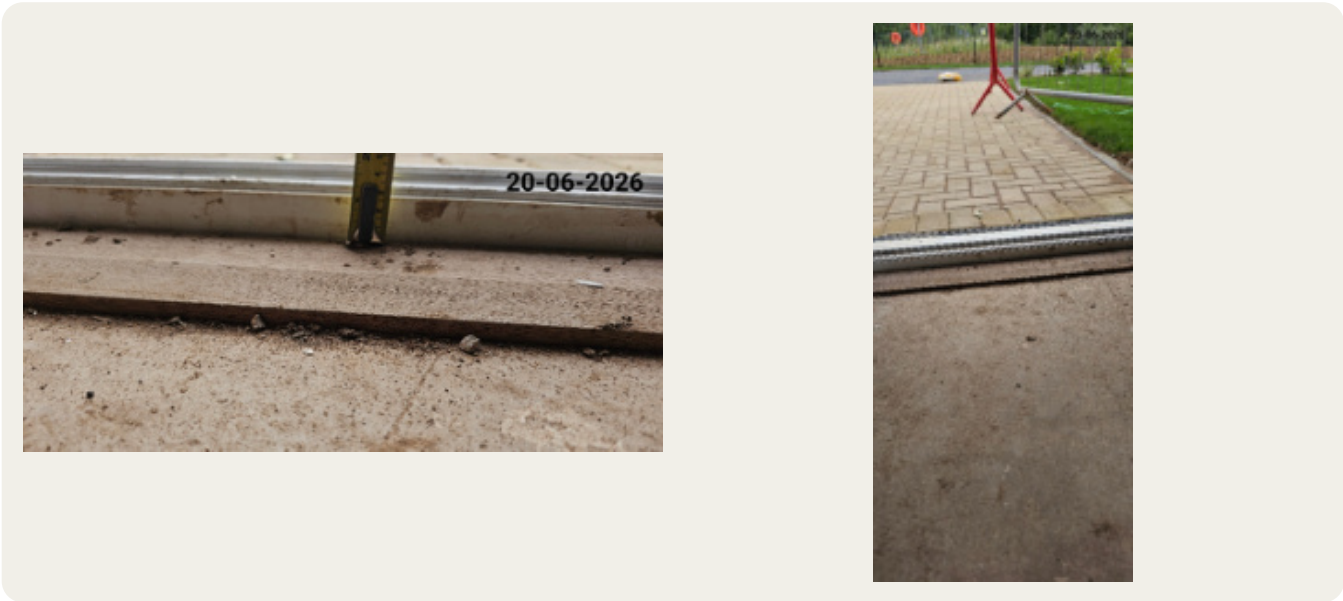
The entrance threshold detail requires attention: Threshold stepdown exceeds 15mm.
